AIRPROX REPORT No 2015178

Date: 1 Oct 2015 Time: 1947Z Position: 5147N 00008W Location: BPK VOR

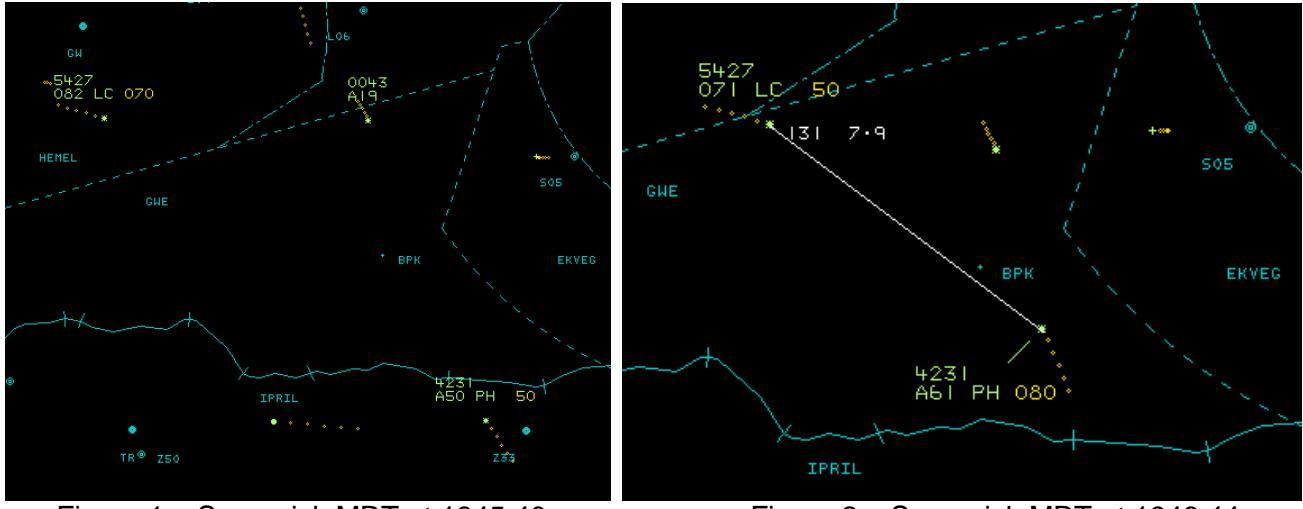
Figure 2 – Swanwick MRT at 1946:44.

At 1946:18, the controller instructed the E190 (B) pilot to descend to 6000ft and to turn right heading 120°. At 1946:44, the controller instructed the E190 (A) pilot to climb to FL100 and to expedite the climb. The two aircraft were 7.9nm apart at this time. (Figure 2).

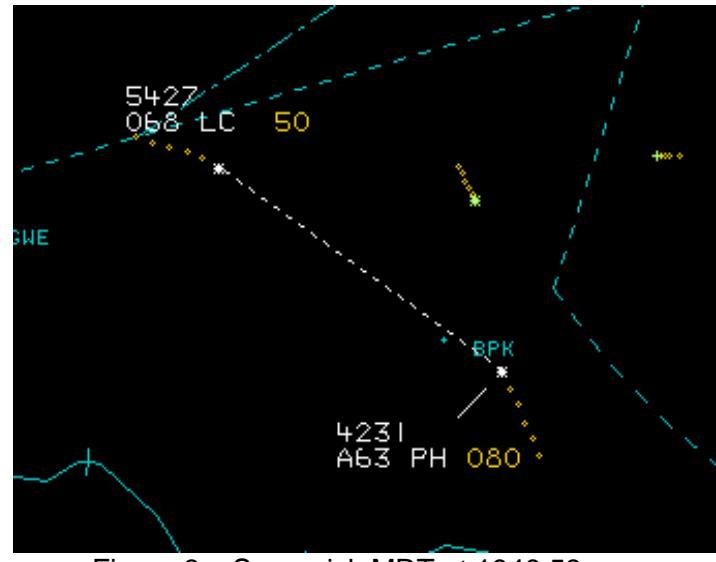
Figure 3 – Swanwick MRT at 1946:53.

At 1946:53, the Short Term Conflict Alert (STCA) started to flash on the controller's radar display. (Figure 3).

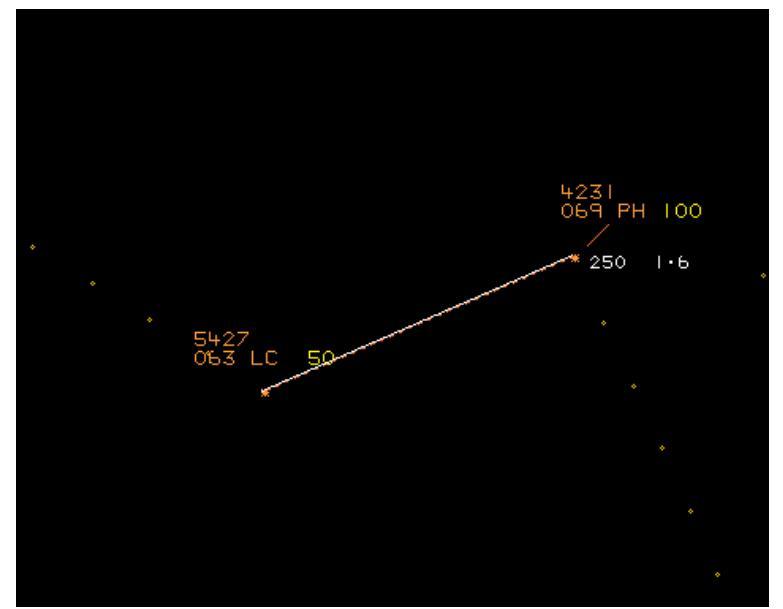
Figure 4 – Swanwick MRT at 1947:26 (CPA)

At 1947:02, the controller instructed the E190 (B) pilot to turn right onto heading 140°. This was not acknowledged on first transmission so a second transmission was made. During this second transmission the controller made a correction and gave an avoiding action turn onto heading 155°. CPA occurred at 1947:26 with 1.6nm lateral and 600ft vertical displacement (Figure 4).

Although the controller gave an avoiding action turn the heading was not sufficient and the instruction was not made early enough to prevent a loss of separation.
