## PART A: SUMMARY OF INFORMATION REPORTED TO UKAB

An Airprox was reported when a Viking glider and a PA28 flew into proximity at 1120 on 7<sup>th</sup> April 2014 at Arbroath Glider Site. Both pilots were operating under VFR in VMC, the Viking pilot in communication with Condor Radio and the PA28 pilot in receipt of a non-surveillance Basic Service from Dundee.

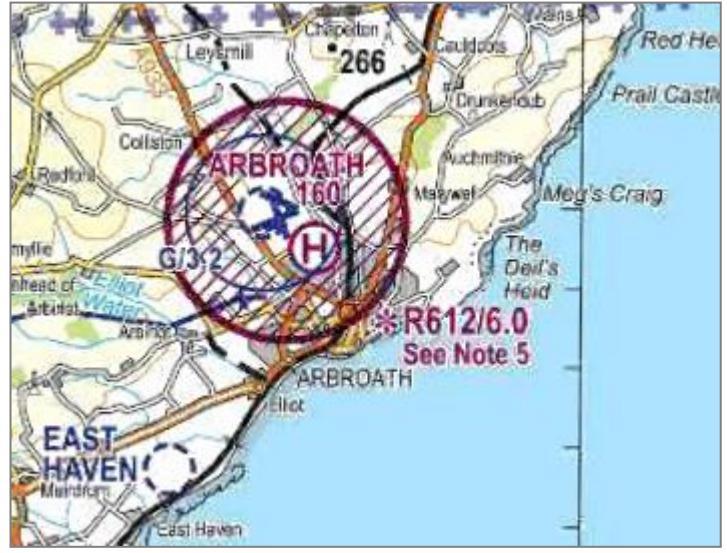
Figure 1

Dundee provide an Approach/Aerodrome service without the use of any surveillance equipment. Area radar recordings did not show the incident. Arbroath gliding site is situated within EG R612 Arbroath, 1.5nm radius centred at 563449N 0023645W from surface to 6000ft, see Figure 1.
