AIRPROX REPORT No 2014039

| Date/Time: | 14 Apr 2014 1235Z | |
| <u>Position</u> : | 5403N 00114W (Linton-on-Ouse Visual Circuit) | |

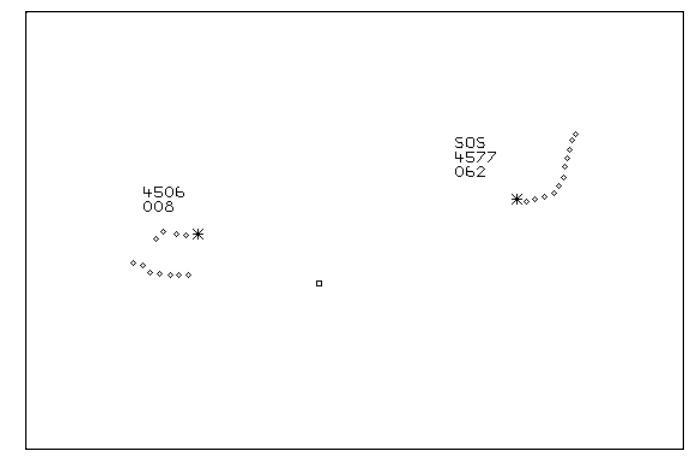
At, 1231:49, as per Figure 1, the pilot of Tucano (B) asked to join the visual circuit and the call was repeated at 1231:54. The Tower Controller replied with, "[Tucano callsign] *Linton tower, pan acknowledged, join RW 28RH, QFE 1022, pair in.*" The details were correctly readback by the Tucano at 1232:08.

Figure 1: At 1231:49 as emergency Tucano called for visual join (Lead of Tucano pair squawking 4506; Tucano (B) squawking 4577/SOS).

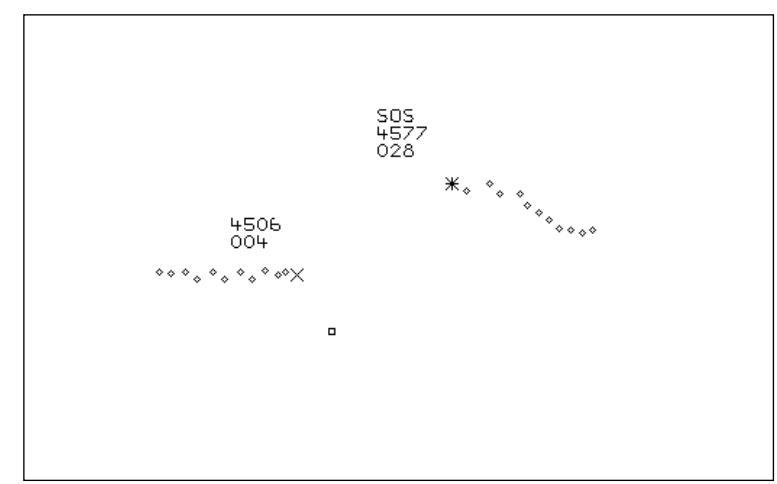
At 1232:17, the pilots of the pair were informed of an emergency aircraft northeast at 2nm. At 1232:25, as per Figure 2, the leader of the pair replied with, "...noted, we will be coming onto dead-side and departing VFR east after extending on runway track."

Figure 2: Aircraft geometry at 1232:25.

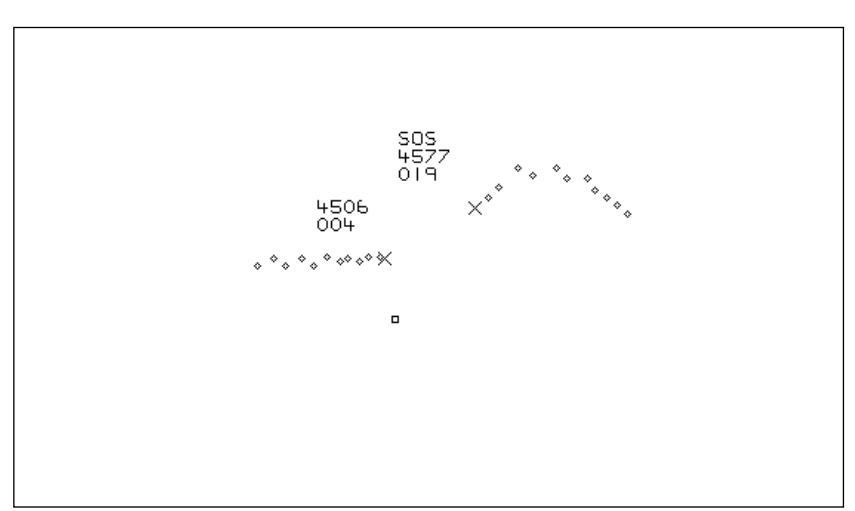
At 1232:37, as per Figure 3, the pilot of Tucano (B) reported, "[callsign] *is late initials, visual with the other Tucano*." The controller replied with the surface wind and called the Departures Controller to request a release for the formation departing VFR to the east.

Figure 3: At 1232:37 when the pilot of Tucano (B) reported visual with the formation.

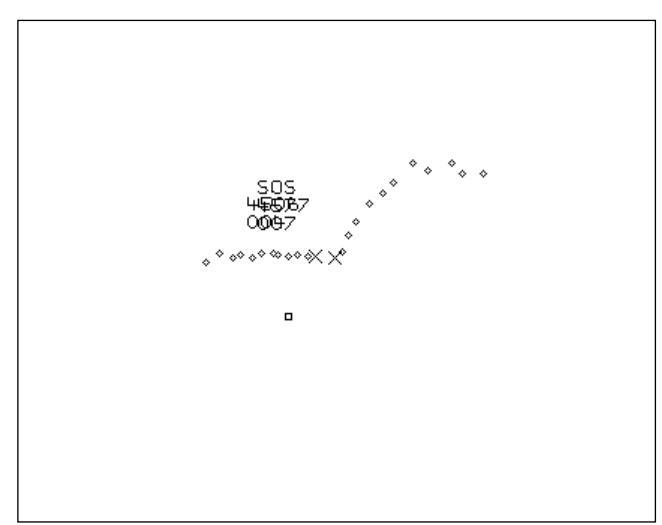
On radar replay the CPA was at 1232:54 with 0.1nm lateral separation and 200ft vertical separation, as per Figure 4. The flight-profile of Tucano (B) would suggest a line-up for RW21.

Figure 4: CPA at 1232:54.
