AIRPROX REPORT No 2013168

<u>Date/Time</u> : 26 Nov 2013 1256Z		Diagram based on radar data and pilot reports
5224N 00106W (5.5nm south of E	Bruntingthorpe)	Patienter und Star Antes Market Sameras Patienter und Star Market Market Sameras Mindeau Mindeau
London FIR	(<u><i>Class</i></u> : G)	1881 [188]
<u>Aircraft 1</u>	<u>Aircraft 2</u>	
Merlin	PA28	BITTESWELL CAPITY
HQ JHC	Civ Trg	UESTATE WINDFALL
1500ft QNH (1039hPa)	2000ft (1039hPa)	A015r 1256 CPA 1421:32 200ft V 0.2nm H
VMC	VMC	Merlin A016
50km	10km	RA28 A018
Separation:		PA20 NOT TAX
0ft V/100m H	2-300ft V/5-600m H	A019 NM
Separation:		
200ft V/0.2nm H		DRAYCOTT
	5224N 00106W (5.5nm south of E London FIR <u>Aircraft 1</u> Merlin HQ JHC 1500ft QNH (1039hPa) VMC 50km <u>Separation</u> : 0ft V/100m H <u>Separation</u> :	5224N 00106W(5.5nm south of Bruntingthorpe)London FIR(Class: G)Aircraft 1Aircraft 2MerlinPA28HQ JHCCiv Trg1500ft2000ftQNH (1039hPa)(1039hPa)VMCVMC50km10kmSeparation:2-300ft V/5-600m H

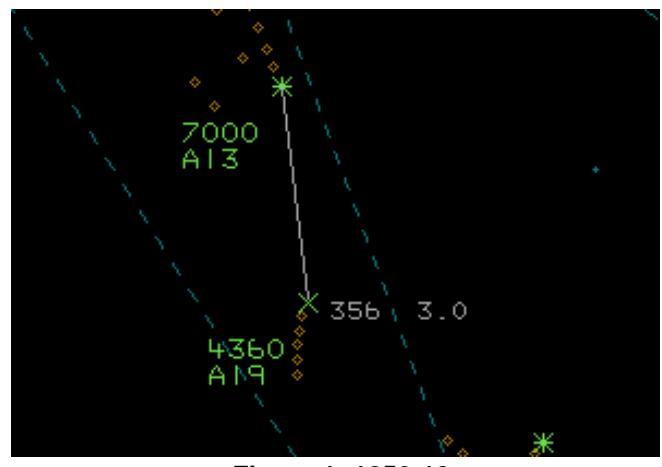
Figure 1: 1256:10

At 1256:10 the PA28 (displaying SSR code 4360) was tracking north-bound indicating 1900ft and converging with the Merlin which was south-bound at 1300ft displaying SSR code 7000 (Figure 1).

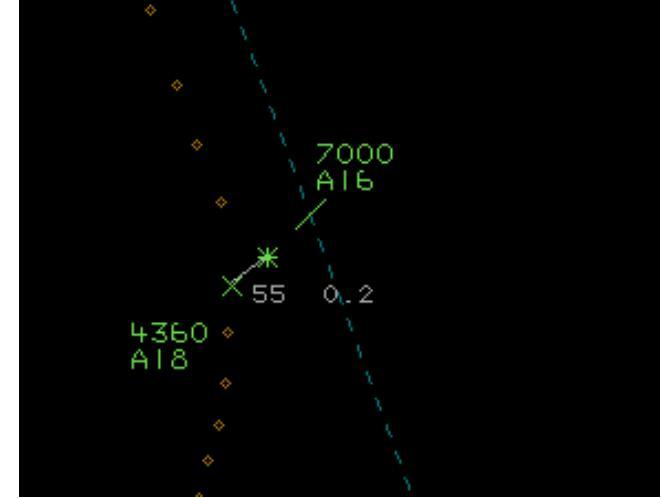
The Merlin climbed to 1700ft and the two aircraft continued to converge. At 1257:00 the two aircraft were 0.2nm apart with the PA28 at 1800ft and the Merlin having descended to 1600ft (CPA - Figure 2).

the pilot of the PA28 stated that he saw the Figure 2: 1257:00 Merlin approximately 1nm away and observed the Merlin turn to port and descend.

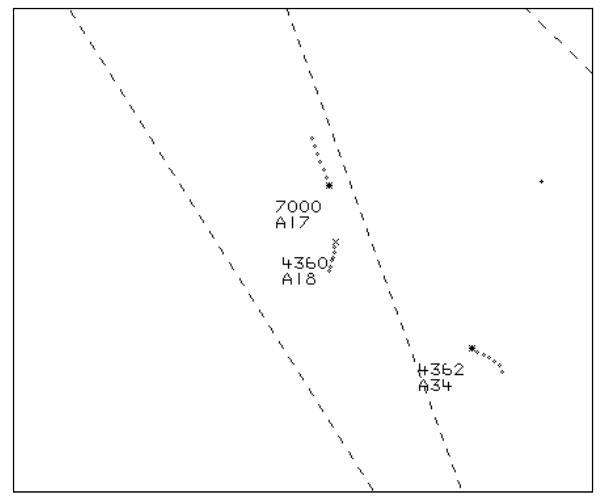
Figure 3 details the aircraft geometry at 1nm separation and Figure 4 at 0.5nm. The Merlin was squawking 7000 and the PA28 was squawking 4360.

Figure 3: Aircraft geometry at 1256:43 at 1 nm separation.

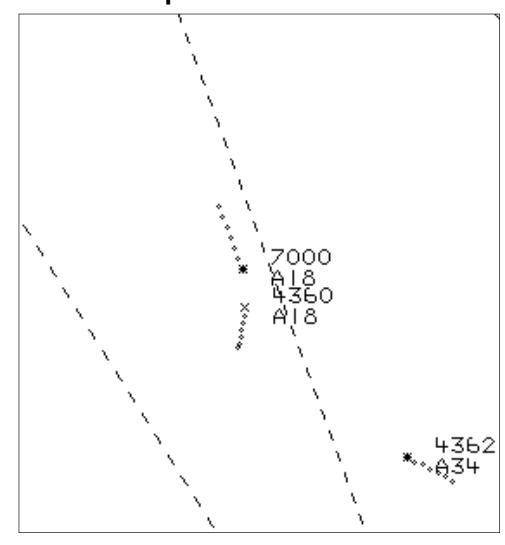
Figure 4: Aircraft geometry at 1256:51 at 0.5 nm separation.
