## AIRPROX REPORT No 2012141

## PART A: SUMMARY OF INFORMATION REPORTED TO UKAB

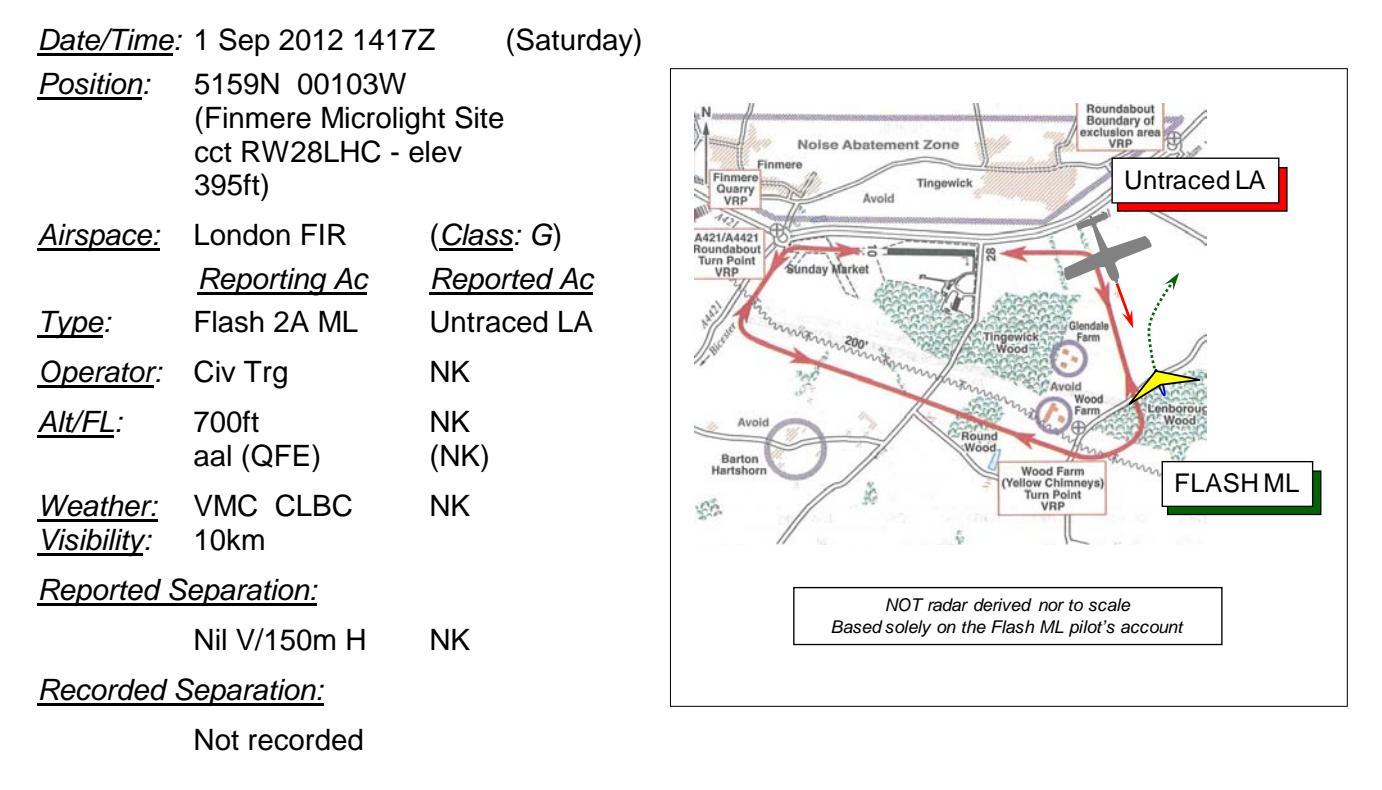
**THE MAINAIR FLASH 2A FLEXWING MICROLIGHT PILOT (FLASH ML)** reports that he was conducting a training flight with a student in the LHC to RW28 at Finmere. As they turned onto the promulgated L base leg heading  $350-360^{\circ}$  at 42kt, flying the cct pattern at 700ft aal [as he had depicted on the attached extract from a popular flight guide], both he and his student became aware of a high-wing light ac (LA) approaching head-on at exactly the same height, some 500m away when first seen. As the LA was relatively slow moving, it gave them 2-3 seconds to determine whether its pilot would take avoiding action, but the LA pilot did not do so, even though he had encroached into a live cct at a low height. The pilot of the other ac – a high-wing grey and blue coloured ac, which he thought was a distinctive type of vintage ac [registration provided] - did not deviate from his course even slightly, which suggested that the LA pilot was not maintaining a forward lookout. They took 'immediate avoiding action' by banking sharply to the R and the oncoming LA passed within 150m at exactly the same height of 700ft aal; he assessed the Risk of collision as 'high – certain'.

<u>Cause</u>: The pilot of the untraced Light Aircraft did not comply with Rule 12 and flew into conflict with the Flash 2A on the base leg for RW28 at Finmere ML site.
