## AIRPROX REPORT No 2023140

Date: 24 Jun 2023 Time: 1502Z Position: 5355N 00106W Location: Naburn Marina

An Airprox was reported when an RV4 and a RF4D flew into proximity at Naburn Marina VRP at 1502Z on Saturday 24<sup>th</sup> June 2023. Both pilots were operating under VFR in VMC, the RV4 pilot in receipt of an Air-to-Ground Communication Service from Leeds East and the RF4D pilot listening out on the Breighton frequency.

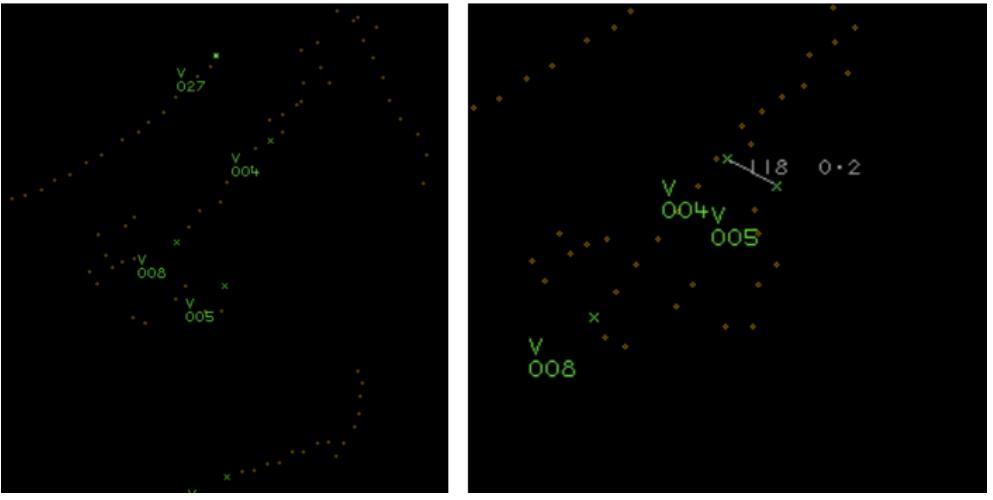
Figure 1- 1500:37 Figure 2 – 1500:51 other proximate aircraft.

An analysis of the NATS radar replay was undertaken and the RF4D was positively identified from Mode S data. The pilot of the RV4 kindly supplied GPS track data for their flight and although it was not possible to identify them on the radar replay, it was possible to track them via ADS-B. When questioned about the transponder the pilot of the RV4 had stated that they had no previous problems. The difficulty of determining a radar track for the RV4, even as a primary target, was compounded by the total number of returns at the time. The RF4D had conflicted with a number of other aircraft tracks after entry into the RA(T) (Figures 1 and 2).

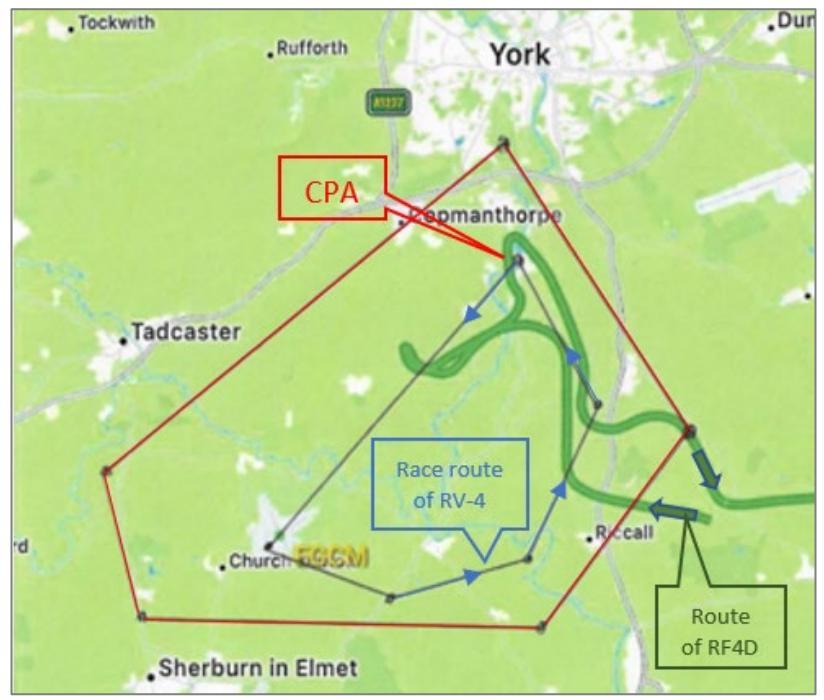
Figure 3 – RA(T) and aircraft routes.

The track of the RF4D had also been supplied via ADS-B data and plotted onto a chart containing the position of the RA(T) and the race-track pattern followed by the competing aircraft pilots (Figure 3).
