ASSESSMENT SUMMARY SHEET FOR UKAB MEETING ON 14 DEC 2011

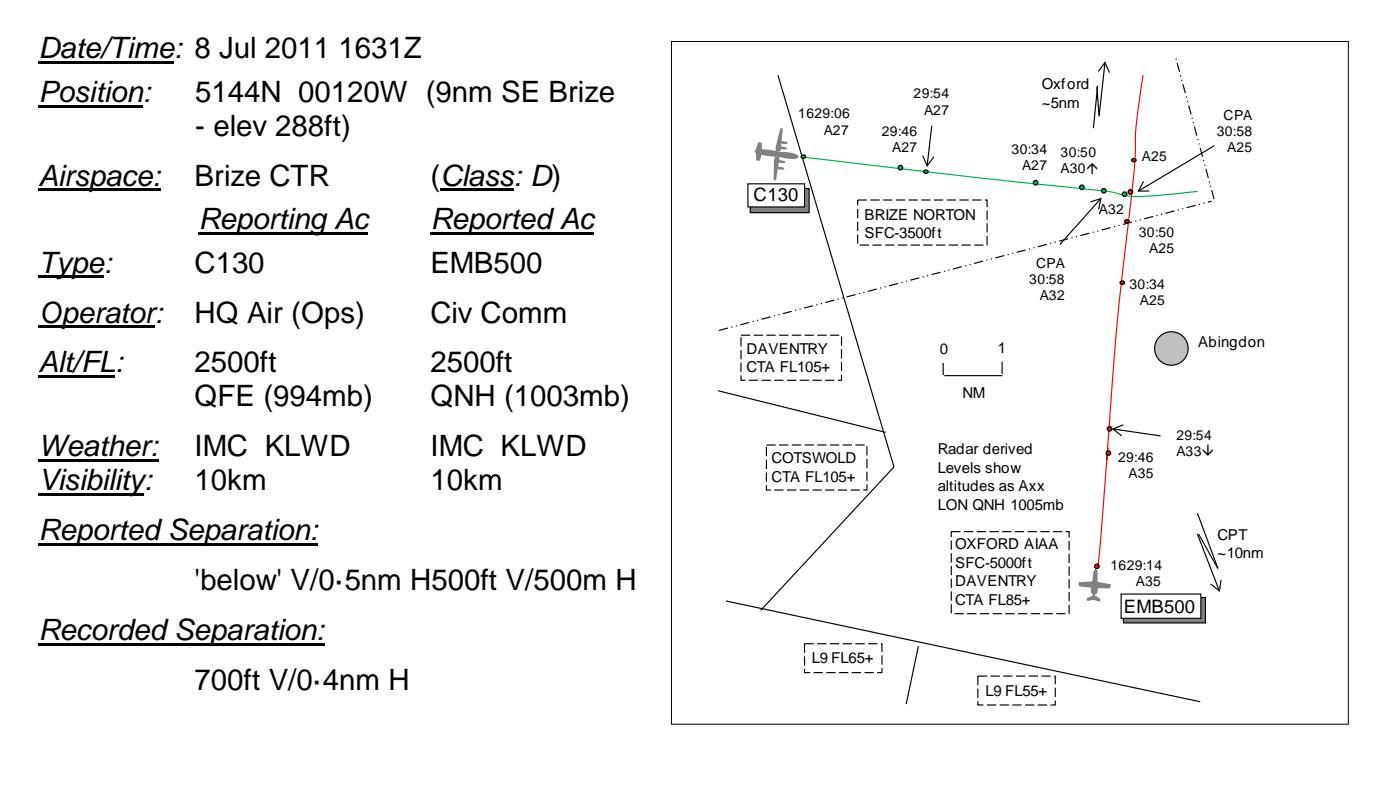
It appeared to Members that there were differing expectations on the EMB500 flightdeck and within Oxford ATC. The transmission made by the EMB500 flight asking, "...is it possible to talk to Brize to get us lower down to MSA ... " was made with the intent that Oxford coordinate with Brize for clearance into the CTR whereas the Oxford APP took this to mean that the crew wanted to leave the frequency to speak to Brize for further descent to MSA which she could give, believing the flight was routeing E of the CTR. Controller Members noted that the VDF should have alerted the APP to the EMB500's bearing from Oxford and the possibility that a descent would put it into CAS. However, Members agreed that the subsequent executive instruction given to the EMB500 flight by Oxford APP under the PS to descend to 2500ft had led to it entering the CTR without clearance and into conflict with the C130, which was the cause of the Airprox. With hindsight, had the crew stated that their request for descent to a lower altitude was a request to enter the CTR it would have been clear to the APP what the crew intended. She had not instructed the crew to remain outside CAS at the time and the EMB500 crew did not query whether they were cleared to enter the CTR during the descent. A salutary lesson to aircrew is to ensure that a positive clearance is received before entering CAS. The Brize controller had been pre-noted by Oxford about the EMB500 and had declined to work the flight as it was, at the time, only descending to 3500ft. It was when he was dealing with AC3 that the EMB500 had descended below 3500ft; this was noticed shortly afterwards as it entered the CTR and avoiding action was given. The C130 crew followed the TCAS RA guidance and climbed and as they did so they saw the EMB500 crossing ahead from R to L and below. The EMB500 crew saw the C130 as proximate traffic on TCAS before a TA was generated as it converged from the W. The PNF queried the C130's presence and was informed of the CTR infringement during which time they visually acquired the C130, climbing, before it passed above and behind. These elements, when combined allowed the Board to conclude that the risk of collision had been quickly and effectively removed.

<u>Cause</u>: Oxford APP descended the EMB500 to 2500ft which put it into CAS without clearance and into conflict with the C130.

It is strongly recommended that standard routings are identified and utilised for both departures and arrivals at Oxford Airport. There are currently no official, published departures to the S of Oxford nor any published arrivals from the S of Oxford. This should be addressed with some urgency.

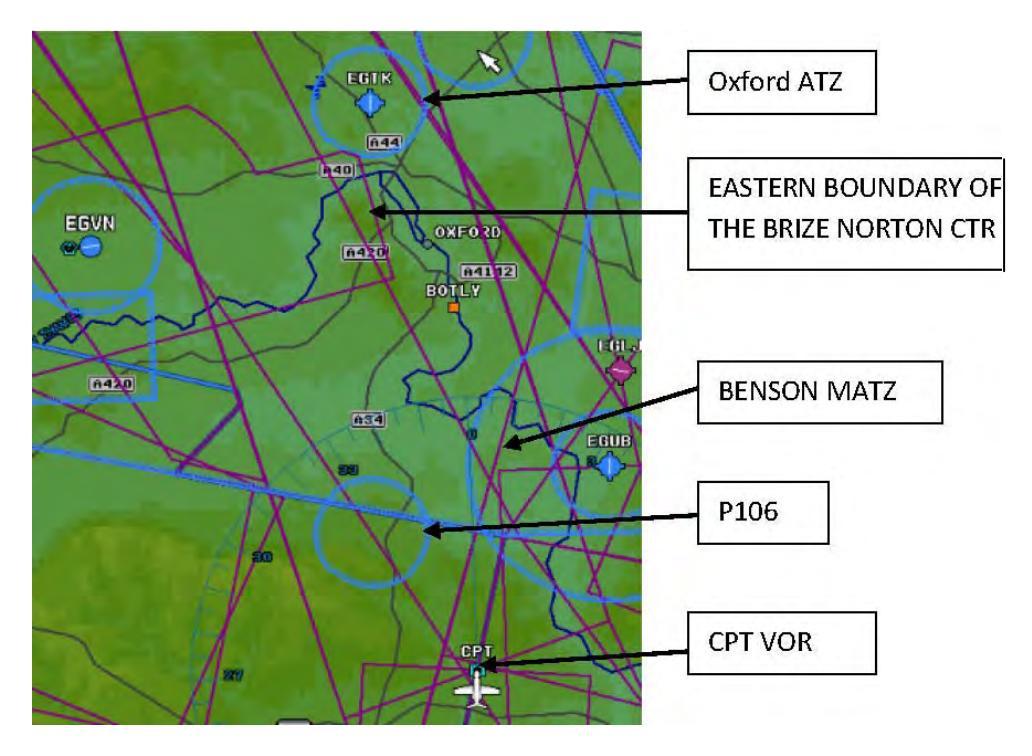
The EMB500 (Phenom) fleet are equipped with integrated electronic navigation systems. The MFD display (example shown below) available to the crew shows very clearly the location of the Brize Norton CTR and this display was in use by the crew at the time of the incident. It supports the position that the crew were completely aware of their position with respect to the zone. It may also explain why the turn to the R to exit the zone was not noted by the Brize controller as the crew would see exactly when they had turned sufficiently to exit the zone prior to resuming their track to the OX NDB.

The above display is in an expanded view. When operating closer to Oxford the depiction is scalable and the proximity of any CAS is very clear.

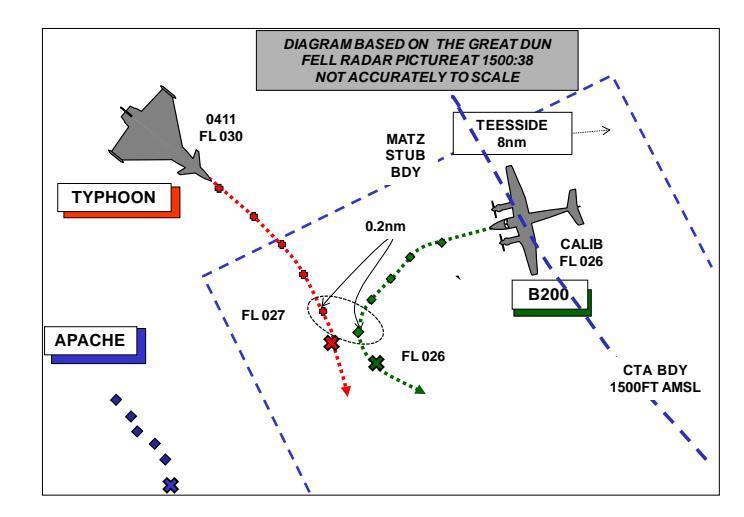
Controller Members agreed that Leeming APP had passed accurate and timely TI to the Typhoon crew regarding the BE200 and the Apache; they updated that TI and informed DTV (ATSA) of the both the presence of the Typhoon and that it was conducting a published TACAN approach. The HQ Air Flight Safety Member noted that it was disappointing that neither crew took any action on receipt of TI and both pressed on into the developing conflict.

<u>Cause</u>: Effectively non-sightings by the BE200 pilot and the Typhoon Instructor.

Degree of Risk: A.

- 1. It is recommended the ATSU ensure that controllers are reminded of the need to determine the intentions of pilots conducting unusual types of exercises or approaches, especially in situations that are likely to involve the overlapping RWs and the requirement for close liaison or coordination by both airfields.
- 2. It is recommended that the ATSU reminds controllers of MATS Pt1 requirement to advise pilots if a service commences, terminates or changes when they are operating outside controlled airspace or when they cross the boundary of controlled airspace.'

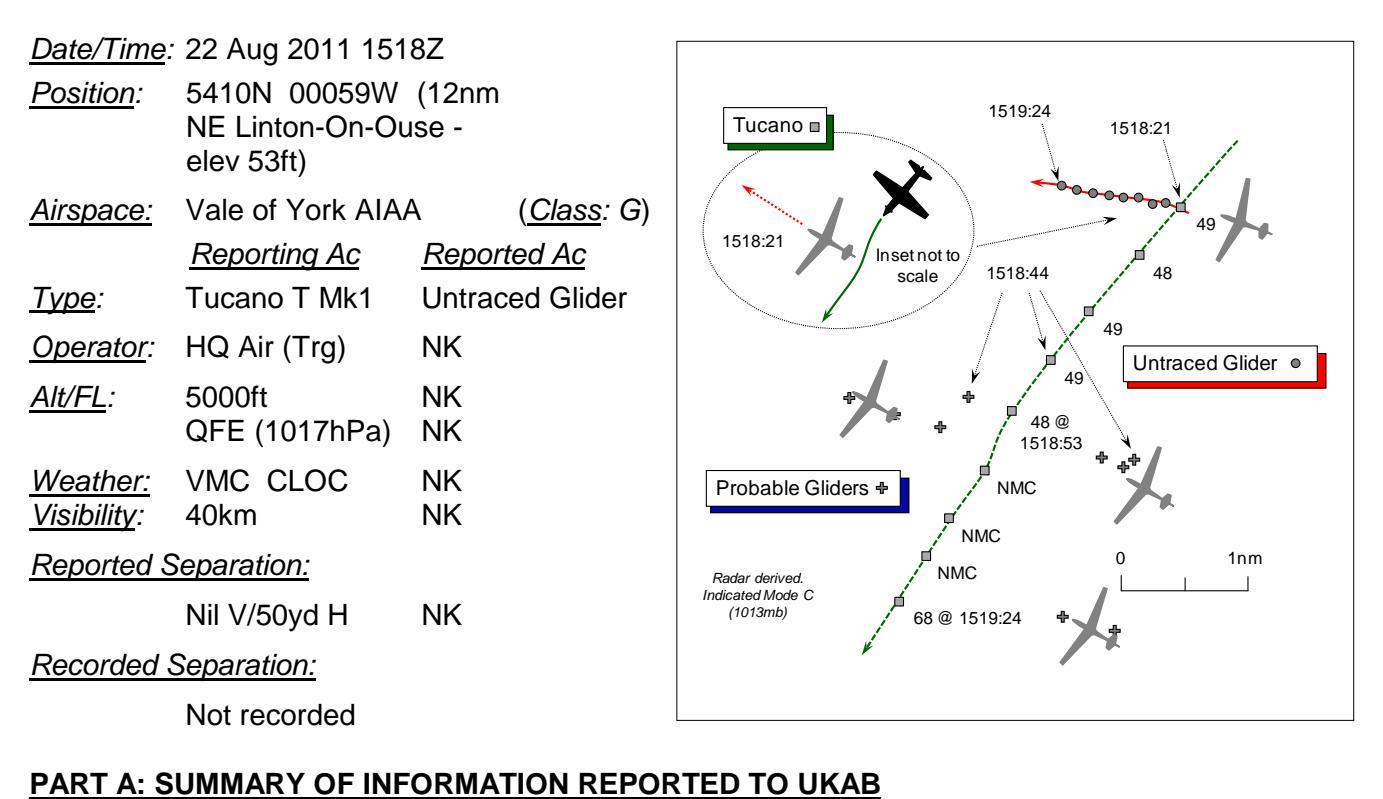
The Tucano crew had acquired two gliders - one to port and one to starboard - at a similar height about 2nm away, alerting them to the presence of gliders in the immediate vicinity. The PF then observed the subject untraced glider less than 100yd directly ahead at the same height, crossing from L to R. Accepting that white gliders flying straight at the same level are difficult to spot, pilot Members agreed that at this short range, the late sighting by the Tucano crew was part of the Cause. It was unfortunate that the glider pilot could not be traced, but if the glider pilot had been aware of the Tucano passing this close it seemed inconceivable that he would not have responded with an Airprox report. This suggested to the Board that the glider pilot had probably not seen the Tucano as it passed astern, and this was the other part of the Cause. The Board agreed unanimously that this Airprox had resulted from a probable non-sighting by the glider pilot and a late sighting by the Tucano crew.

Cause:	A probable non-sighting by the glider pilot and a late sighting by the Tucano
	crew.

Degree of Risk: B.
