AIRPROX REPORT No 2016087

Date: 22 May 2016 Time: 1057Z Position: 5138N 00048W Location: 2nm NE Wycombe airfield Elevation 520ft

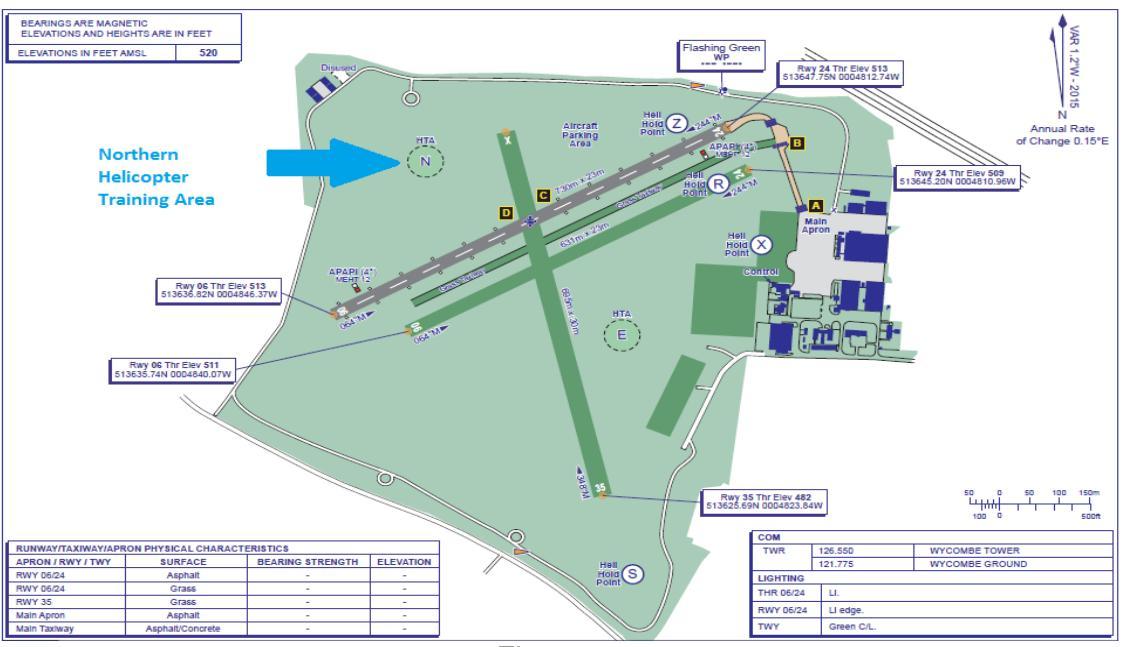
Figure 1.

At 1053:40, the R22 pilot called again; the controller passed the fixed-wing runway in use which was RW24, that Helicopter Training Area (HTA) November was also in use (Figure 1) and the QFE of 988hPa. This information was read back by the R22 pilot apart from the QFE, which was read back incorrectly as 998hPa. The R22 pilot reported that he had just passed Princes Risborough. The controller then cleared the R22 pilot to join *"…low-level into November"*, requested the R22 pilot to check the QFE and passed the correct QFE again. The R22 pilot again incorrectly read back the QFE as 998hpa and stated that he was *"unfamiliar with the airport as well"*. Once again the Aerodrome controller passed the QFE to the R22 pilot which was then correctly read back.

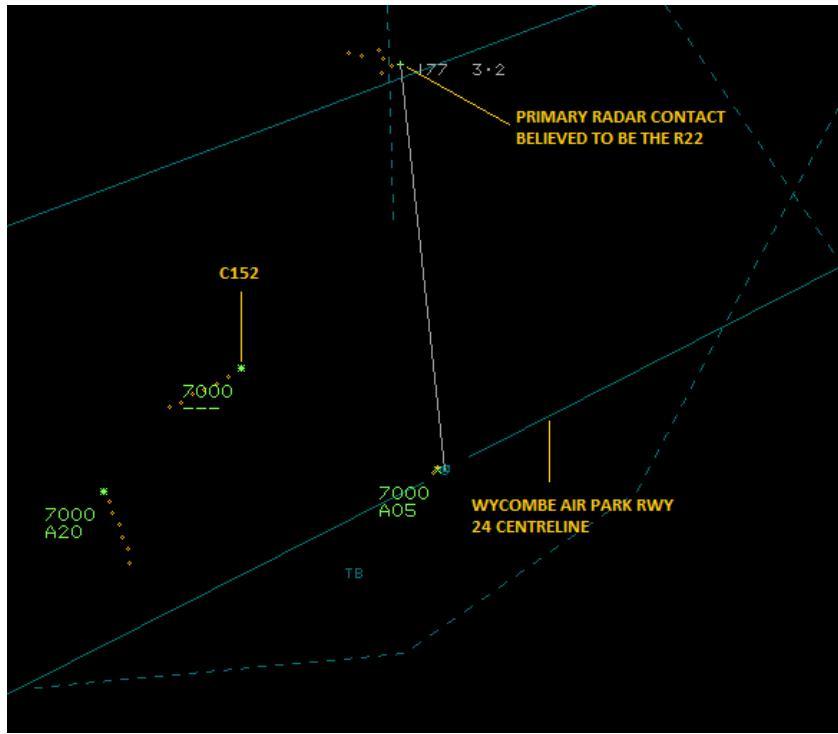
Figure 2 – Swanwick MRT at 1056:30.

At 1056:30 (Figure 2), the C152 pilot reported downwind RW24 for a touch-and-go. At this time the primary radar contact, believed to be the R22, was 3.2nm north of Wycombe Air Park. In reply the controller instructed the C152 pilot to *"report final number one"*.

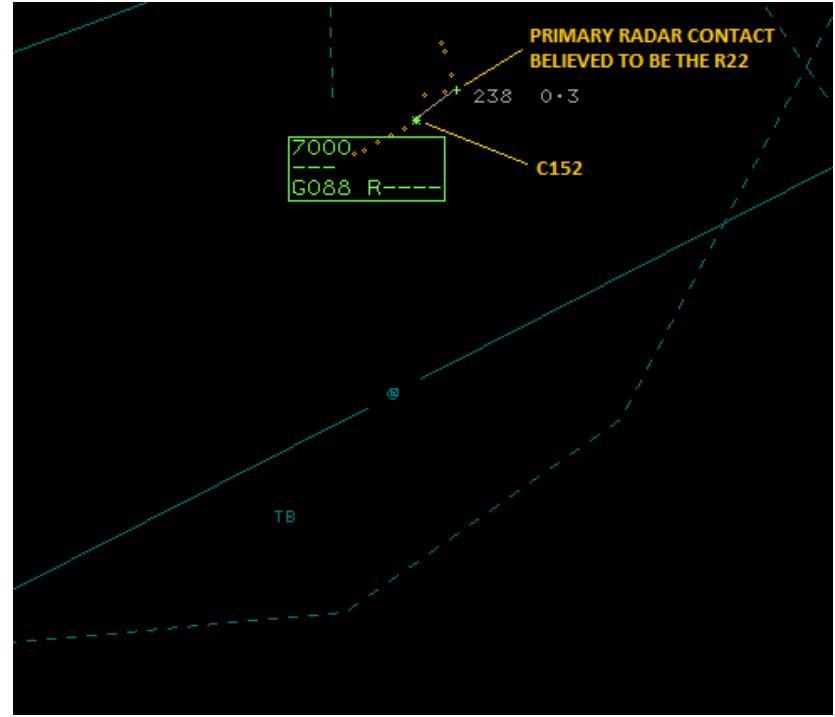
Figure 3 – Swanwick MRT at 1057:53.

At 1057:53 (Figure 3), the R22 pilot reported at the 'Golden Ball' (2.15nm north of Wycombe Air Park) with the *"circuit in sight"*. Coincident with the R22 reporting at the 'Golden Ball' there was a watch change occurring in the Visual Control Room (VCR). The outgoing controller instructed the R22 pilot to remain north of RW24 at all times and passed Traffic Information on another helicopter which was on the ground at HTA November. After this transmission, the incoming controller took over control of the watch.

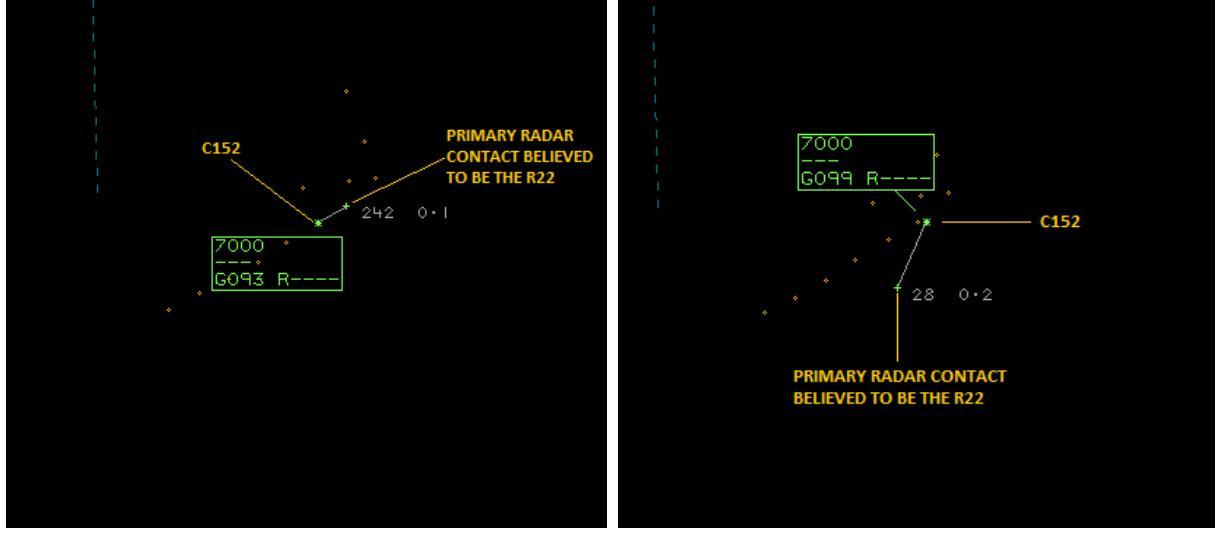
Figure 4 – Swanwick MRT at 1057:55.

At 1057:55 (Figure 4), the primary radar contact believed to be the R22 was 2nm north-east of Wycombe Air Park.

The CPA between the primary radar contact believed to be the R22 and the C152 occurred between 1057:55 and 1057:58 (Figure 5) with a minimum horizontal distance of less than 0.1nm.

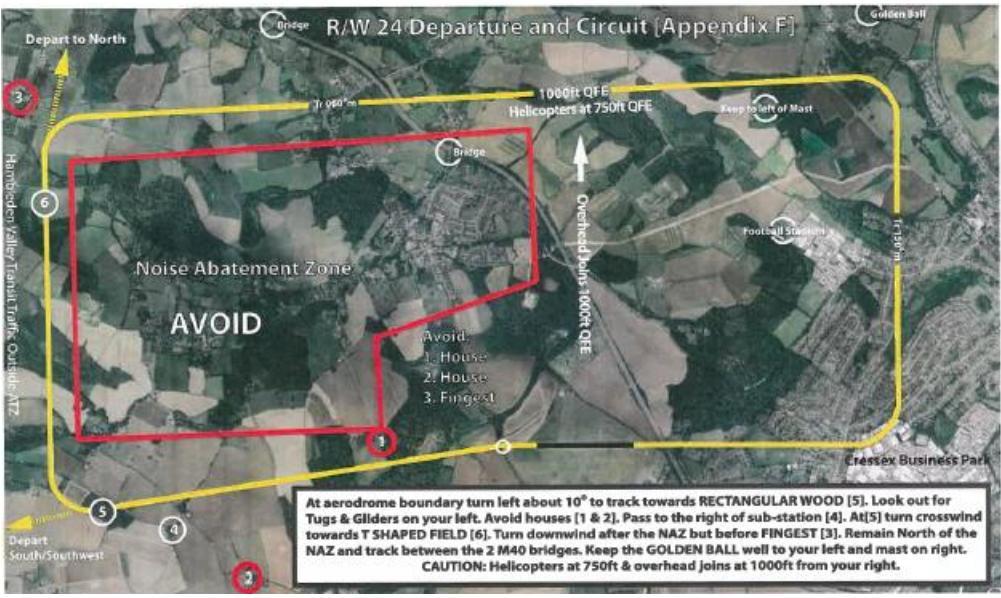
Figure 6 – Wycombe Air Park MATS Part. 2 Appendix F.

At interview, the outgoing controller explained that when the fixed-wing circuit on RW24 (Figure 6) is active, inbound helicopter pilots from the north are normally issued with a clearance to join low-level into HTA November. The inbound R22 pilot was initially passed this clearance. As the R22 pilot approached the aerodrome however, the controller, who was not familiar with the R22's callsign, suspected that he was visiting Wycombe, and, therefore, issued a more detailed joining clearance than is routine. The controller specified that the R22 pilot was to join at 750ft on the Wycombe QFE, thereby, in the Wycombe Tower controller's mind, giving some assurance that the R22 would be de-conflicted from the fixed-wing circuit traffic. Indeed, the controller included the phrase "...to remain below the fixed-wing circuit" as part of the R22 pilot's joining clearance. The clearance, including the height restriction, was correctly read back by the R22 pilot.

Helicopters leaving or joining the rotary circuit are to be given traffic information with regard to the helicopter and fixed wing circuits. When R/W 24/06 is in use helicopters must not join the rotary circuit through the fixed wing crosswind or base legs.

ATSI recommended that all controllers at Wycombe Air Park be reminded of their obligations published in both CAP 493 and the Wycombe Air Park Manual of Air Traffic Services Part 2 regarding the provision of Traffic Information.
