AIRPROX REPORT No 2022119

Date: 01 Jul 2022 Time: 1015Z Position: 5117N 00000E Location: 3NM SSW Biggin Hill

PART A: SUMMARY OF INFORMATION REPORTED TO UKAB

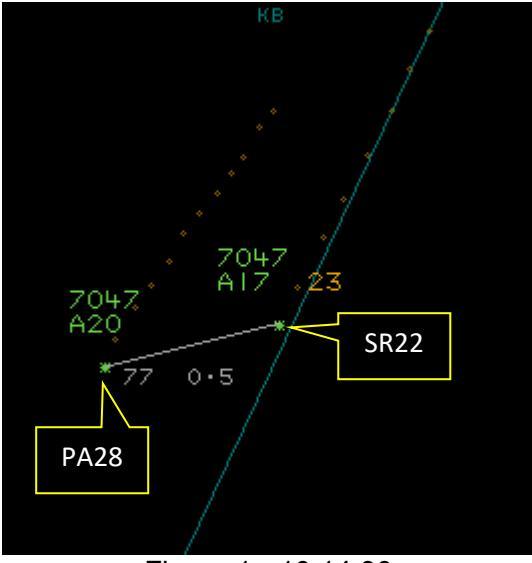
Figure 1 - 10:14.30

At 1014:30 the PA28 pilot checked in with the Approach controller and a Basic Service was agreed. (Figure 1)

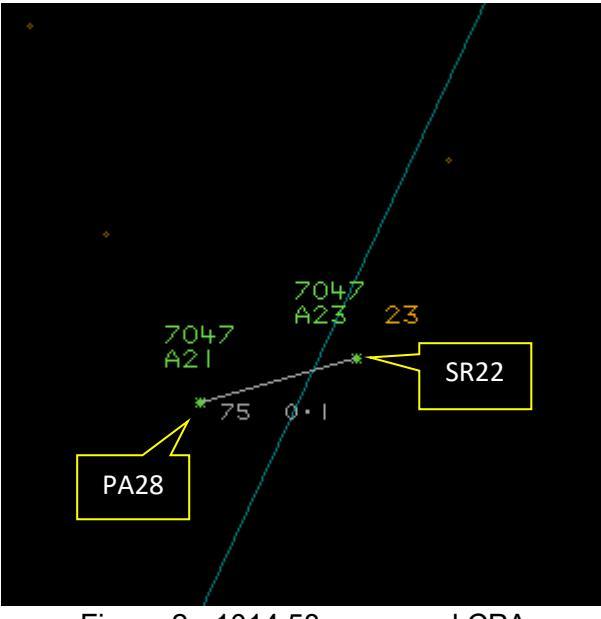
Figure 2 - 1014:58 measured CPA

At 1014:58 measured CPA was 0.1NM laterally and 200ft vertically - Figure 2. However, it's clear from Figure 4 that actual CPA would have been closer than 0.1NM.

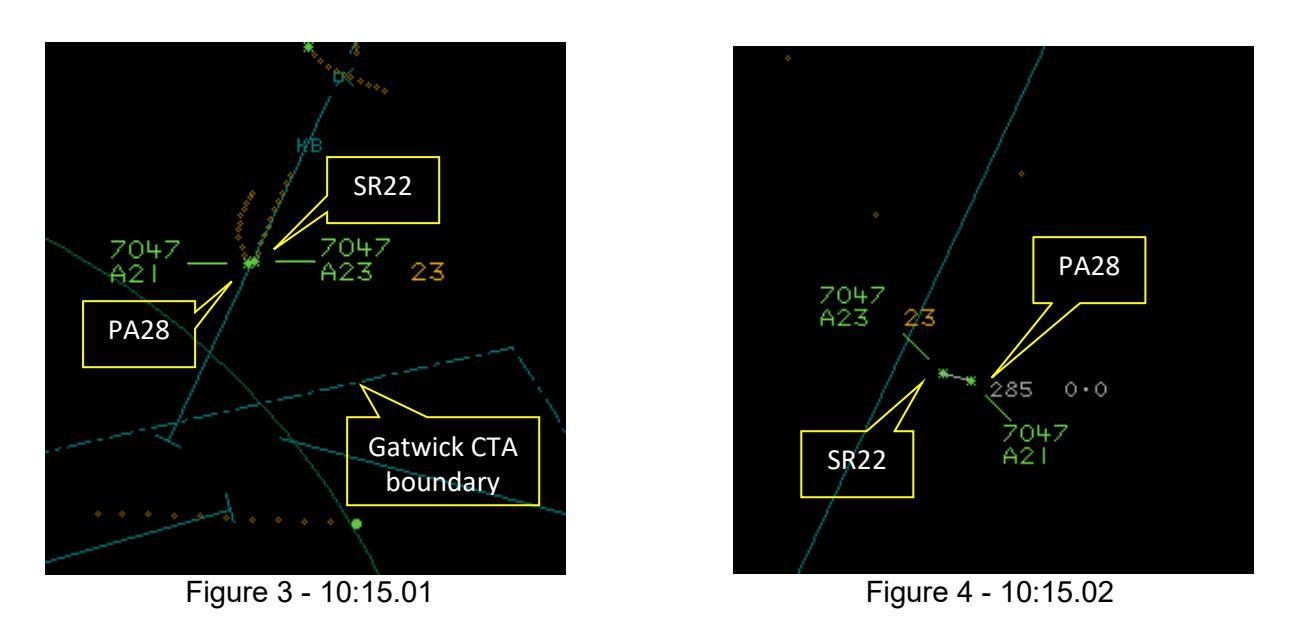
Figure 3 below, timed at 1015:01, depicts the location of the Airprox in relation to Gatwick controlled airspace. At 1015:02 the PA28 had passed underneath the SR22 after commencing their left turn at 2NM, Figure 4.
