AIRPROX REPORT No 2022239

Date: 10 Oct 2022 Time: 1031Z Position: 5200N 00306W Location: 3NM NE Talgarth

An Airprox was reported when a K13 and a C130 flew into proximity 3NM northeast of Talgarth at around 1031Z on Monday 10th October 2022. Both pilots were operating under VFR in VMC, neither was in receipt of an ATS.

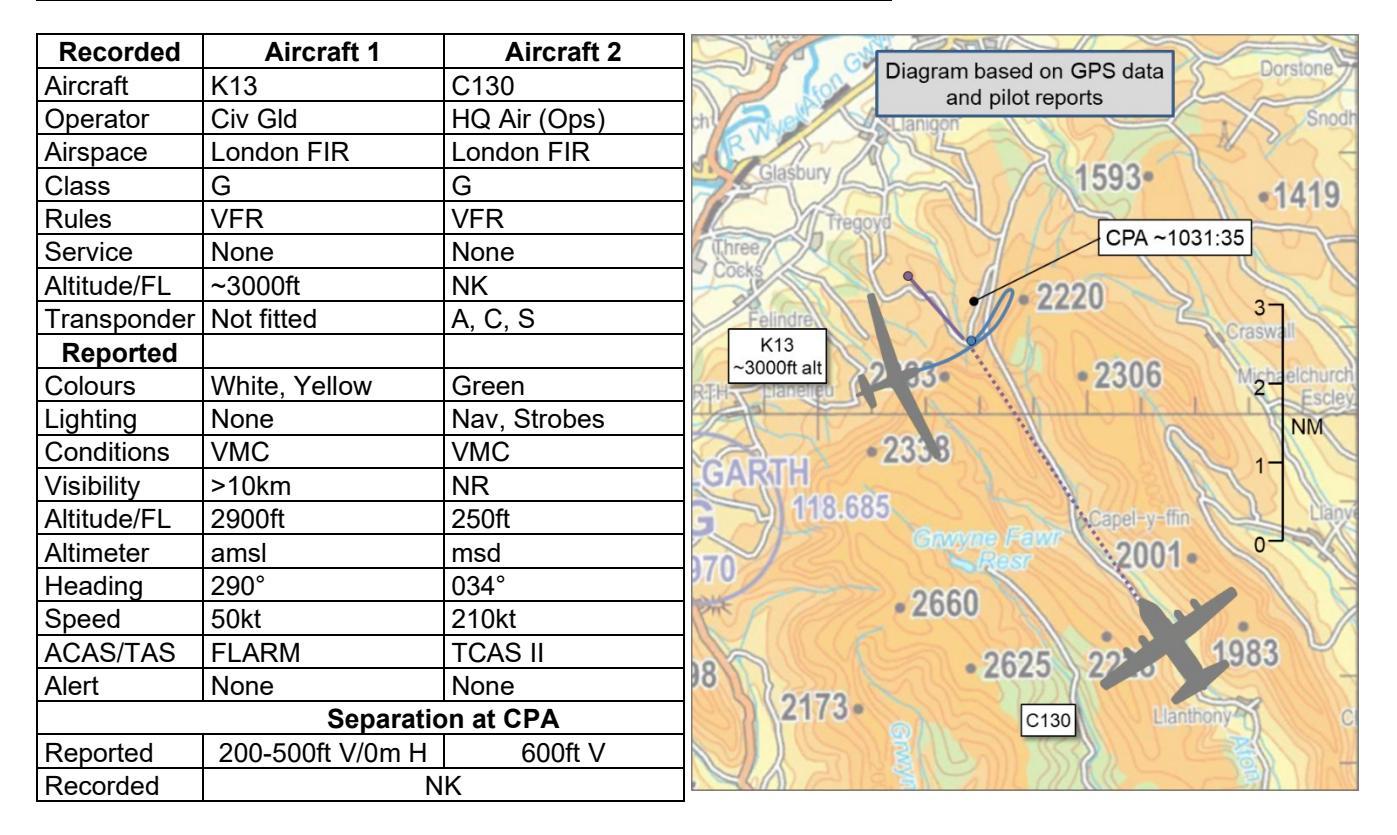
Analysis of the NATS radar replay was undertaken. The C130 could be identified through Mode S information, but disappeared from the radar 2min prior to the Airprox. Further analysis of a data analyser tool also showed the C130 2min prior to the Airprox with the aircraft fading and reappearing just after the Airprox. The K13 pilot supplied the UKAB secretariat with a GPS track. Therefore, using the data available, a representation of the Airprox was constructed for the diagram at the top of this report, but exact separation could not be measured.

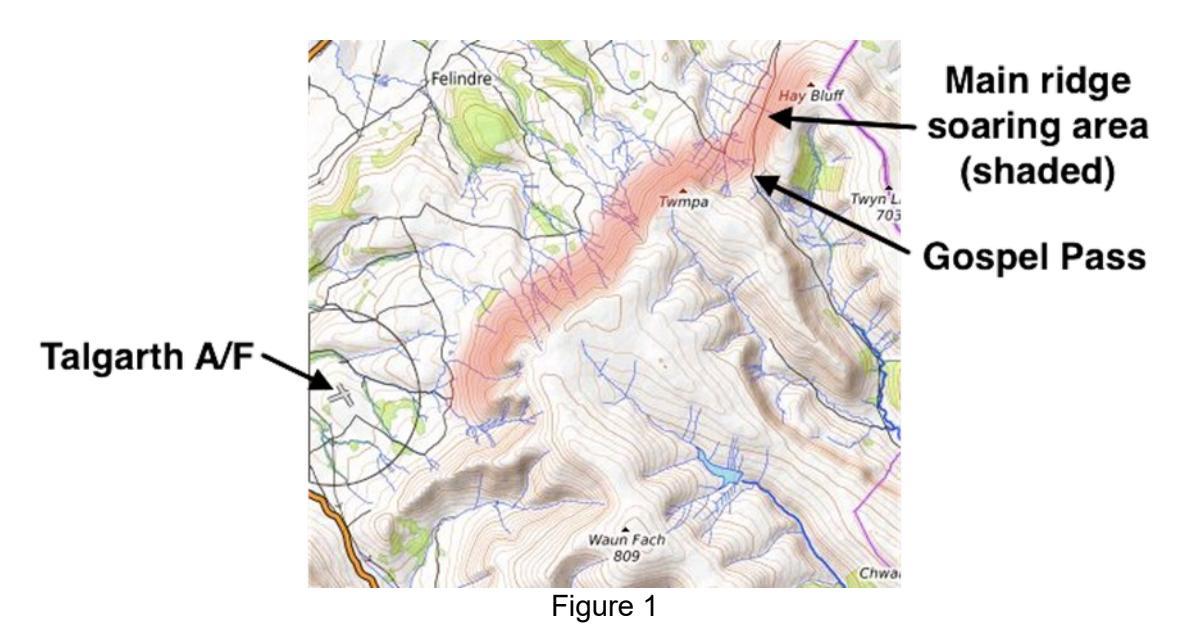
The ridge-line shown in Figure 1 between Talgarth gliding site (515848N 0031215W) and Hay Bluff (520122N 0030610W) is one of several in this area used by gliders and paragliders, either of which may be found soaring this ridge during daylight hours in even the lightest of winds between northerly and westerly. Gliders routinely fly within a couple of hundred feet of these deserted hill-faces, using an exemption to SERA.3105 and SERA.5005(f)³ that permits a hill-soaring glider to fly below 500ft AGL or closer than 150m (500ft) to any person, vessel, vehicle or structure (always provided that it does not recklessly endanger life or property of others). Low-flying military aircraft are frequently observed crossing Gospel Pass south-to-north at the same altitude, and there has been at least one previous Airprox here in near-identical circumstances (Airprox report 2015123).
