AIRPROX REPORT No 2022241

Date: 25 Sep 2022 Time: 1738Z Position: 5153N 00154W Location: 10NM E Gloucester

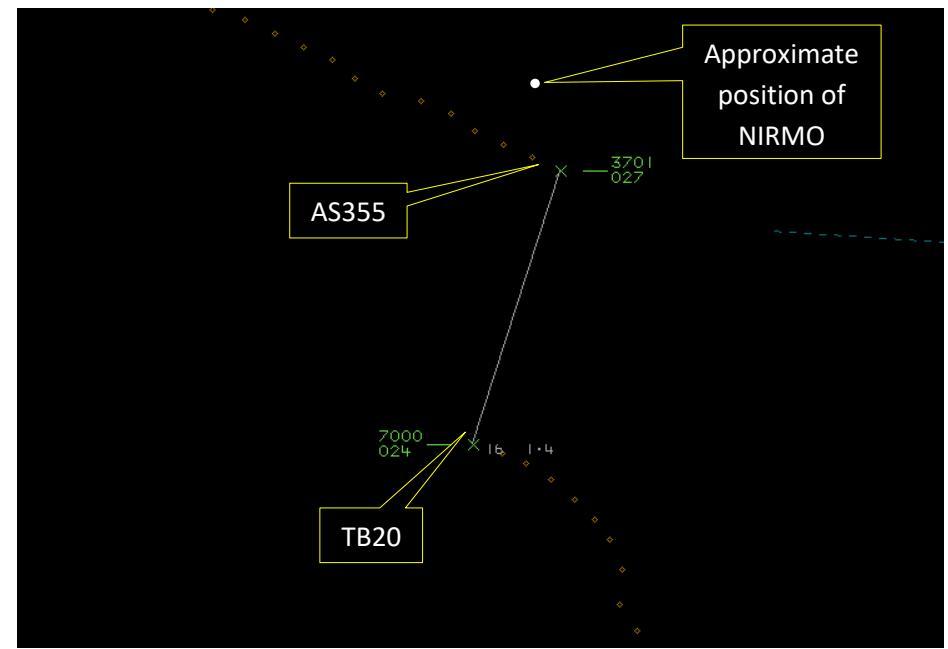
Figure 1 – CPA at 1738:23

An analysis of the NATS radar replay was undertaken and both aircraft could be positively identified from Mode S data (see Figure 1). The diagram was constructed and the CPA determined from the radar data.

The TB20 and AS355 pilots shared an equal responsibility for collision avoidance and not to operate in such proximity to other aircraft as to create a collision hazard.¹ If the incident geometry is considered as converging then the AS355 pilot was required to give way to the TB20.²
