AIRPROX REPORT No 2022271

Date: 06 Dec 2022 Time: ~1134Z Position: 5208N 00107W Location: 3NM S DTY

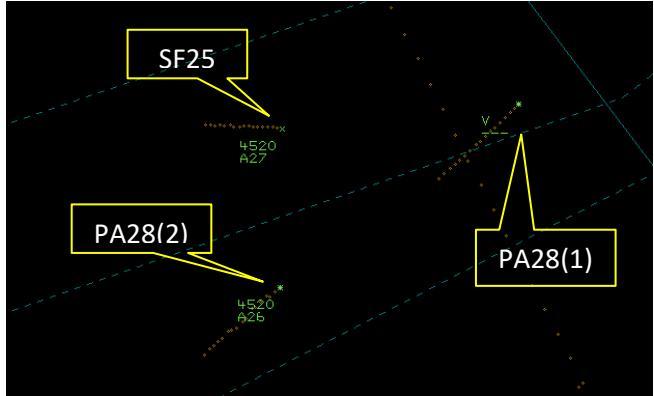
Figure 1 – 1131:19

An analysis of the NATS radar replay was undertaken. The SF25 could be identified on the radar using Mode S information, indicating 2700ft (radar QNH 1024hPa). At first it was believed that PA28(1) was the aircraft involved in the Airprox, due to it being maroon and white in colour, as reported by the SF25 pilot. However, following further analysis this aircraft could be identified, using Mode S information, and discounted as it crossed some miles ahead of the SF25, Figure 1. PA28(2) could be identified on the NATS radar via the Oxford squawk and their subsequent landing time. PA28(2) was indicating an altitude of 2600ft.

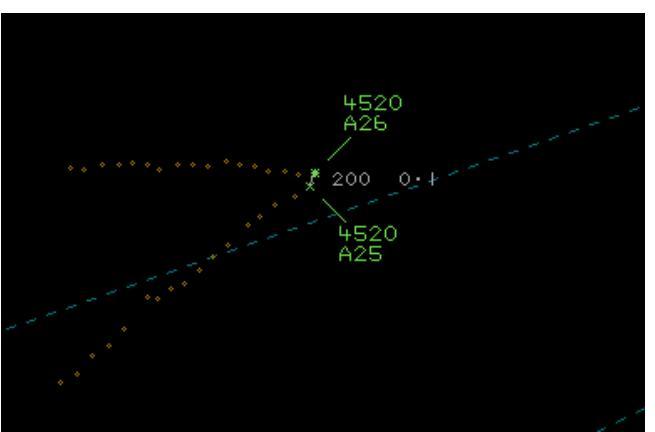
Figure 2 – Radar CPA 1133:47

The two aircraft continued to close until 1133:47 when they were 0.1NM and 100ft apart Figure 2.

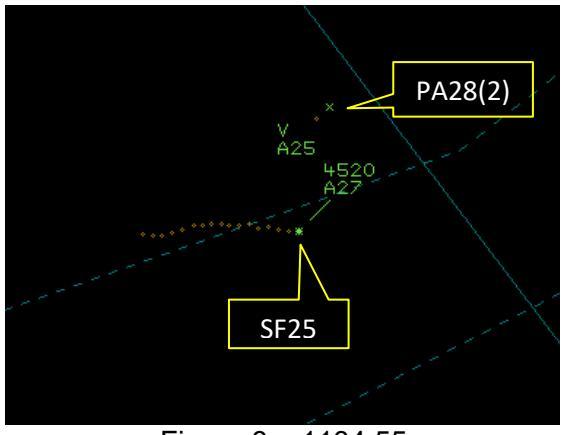
Figure 3 – 1134:55

The PA28(2) then disappeared from the radar until 1134:55 when it re-appeared in SSR only, now wearing a VFR (7000) squawk, to the northeast of the SF25, it is therefore probable that the two aircraft were closer than radar CPA would indicate.
