## AIRPROX REPORT No 2023021

Date: 23 Feb 2023 Time: 1431Z Position: 5157N 00049W Location: 11NM SW Cranfield

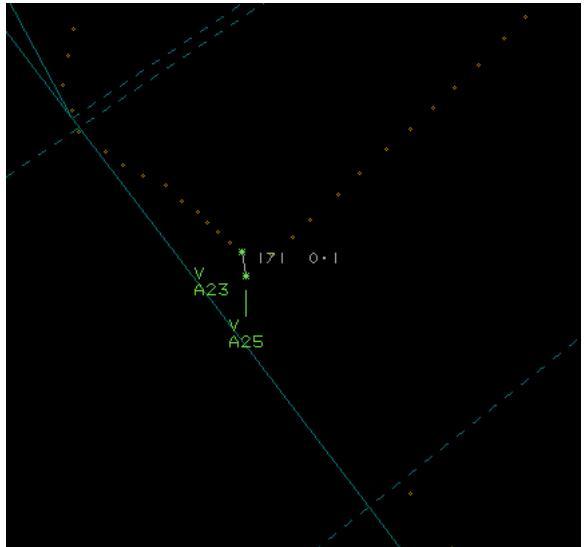
An analysis of the NATS radar replay was undertaken and both aircraft were detected and identified using Mode S data. CPA occurred at 1430:47, the aircraft were separated by 0.1NM horizontally and 200ft vertically.

1430:47 - CPA -200ft V/ 0.1NM H
