AIRPROX REPORT No 2023103

Date: 03 Jun 2023 Time: ~0945Z Position: 5213N 00137W Location: Wellesbourne Mountford ATZ

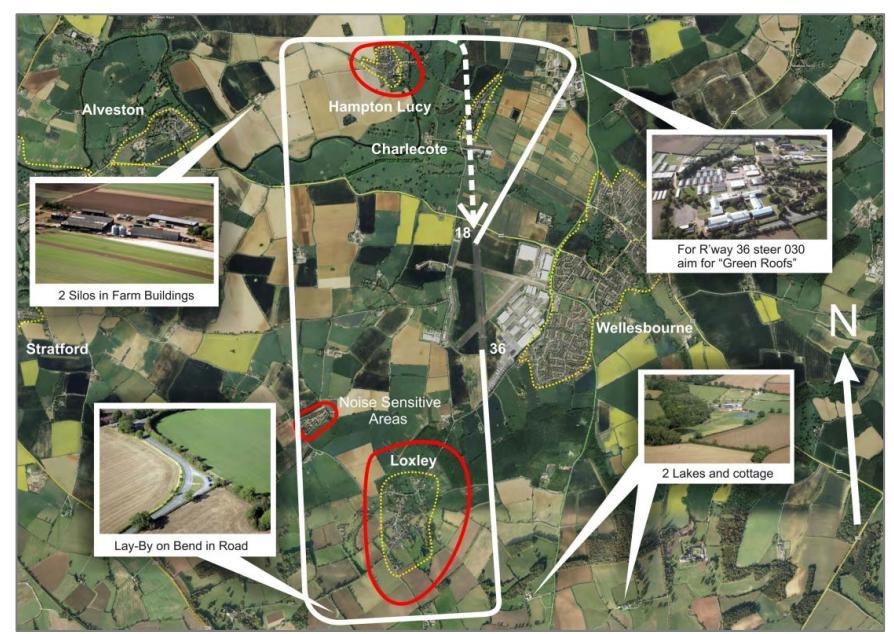
Figure 1 – The Wellesbourne visual circuit pattern

Runway 36 departures: At the airfield boundary turn right onto a track of 030° towards the green roofed buildings and climb to 1,000ft QFE before turning crosswind.

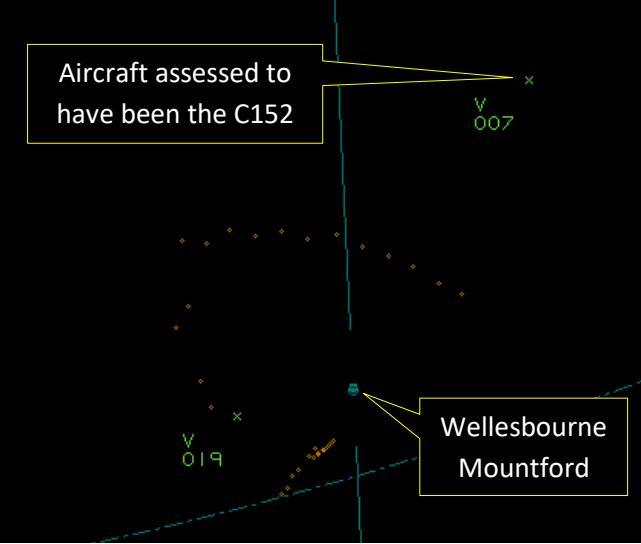
Figure 2 - 0944:22

An analysis of the NATS radar replay was undertaken. A primary-only radar contact was observed from 0944:22, at FL007 (1000ft), that subsequently appeared to have tracked 030° and then turned westwards (see Figure 2). This aircraft was assessed to have been the C152.

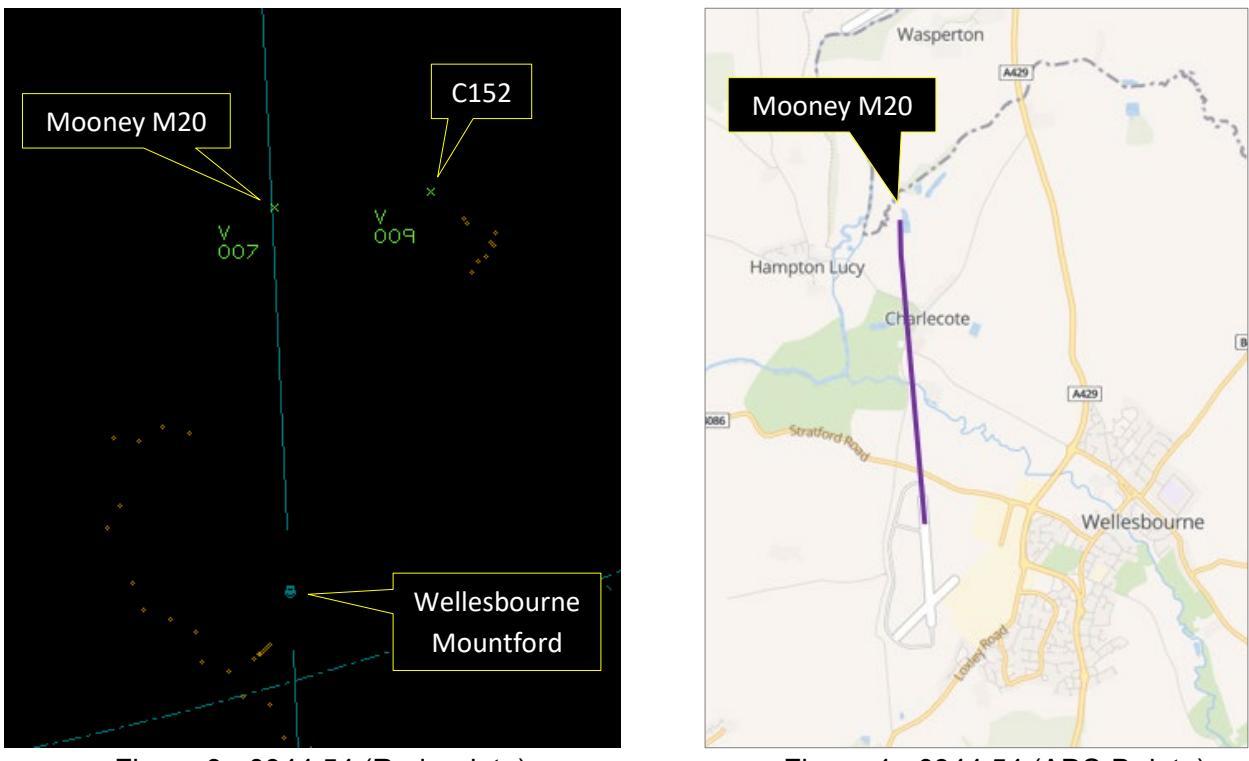
Figure 3 - 0944:54 (Radar data)

The Mooney M20 first appeared on radar at 0944:54 (see Figure 3), and could be positively identified from Mode S data. Both aircraft were observed on radar to be at Flight Levels so an appropriate conversion factor was used to determine their altitude. From a review of ADS-B track data, the Mooney M20 was observed to have followed the RW36 centreline after take-off (see Figure 4).

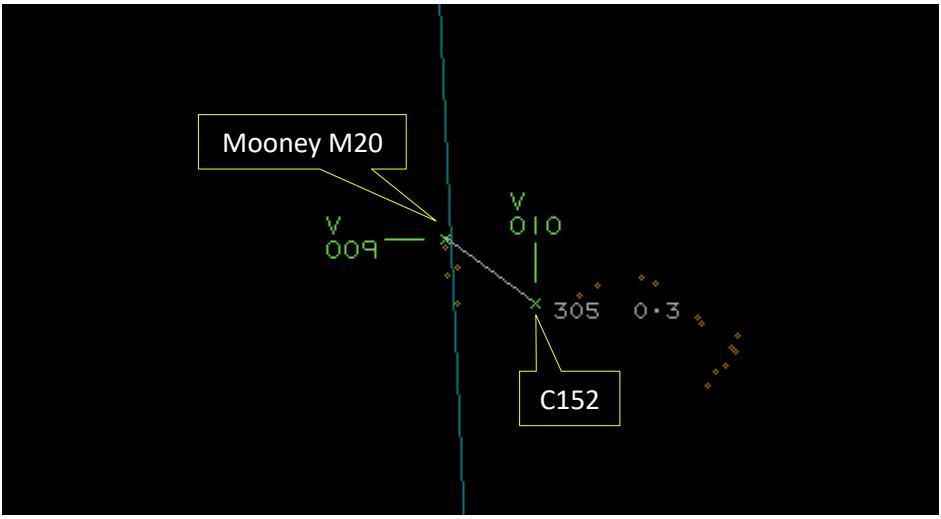
Figure 5 – 0945:10. Estimated time of CPA.

It was assessed that the radar returns from both aircraft provided imprecise positions and, as such, an estimation of the tracks has been shown in the diagram above. The exact time of CPA and the separation between the aircraft could not be determined precisely and have been shown as approximations.
