AIRPROX REPORT No 2023104

Date: 03 Jun 2023 Time: 1320Z Position: 5210N 00137W Location: Wellesbourne Mountford (159ft)

An Airprox was reported when 2 C152s flew into proximity at Wellesbourne Mountford at about 1320Z on Saturday 3rd June 2023. Both pilots were operating under VFR in VMC, both in receipt of an AFIS from the Wellesbourne AFISO.

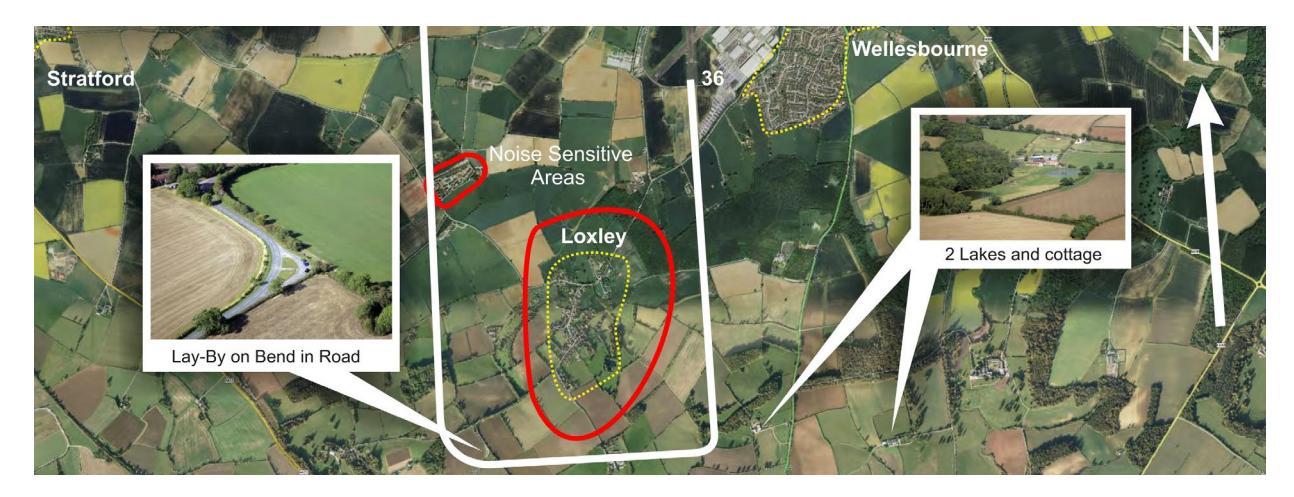
Both pilots shared an equal responsibility for collision avoidance and not to operate in such proximity to other aircraft as to create a collision hazard². An aircraft operated on or in the vicinity of an aerodrome shall conform with or avoid the pattern of traffic formed by other aircraft in operation³.

The southern end of the Wellesbourne Mountford visual circuit pattern is promulgated⁴ as follows:

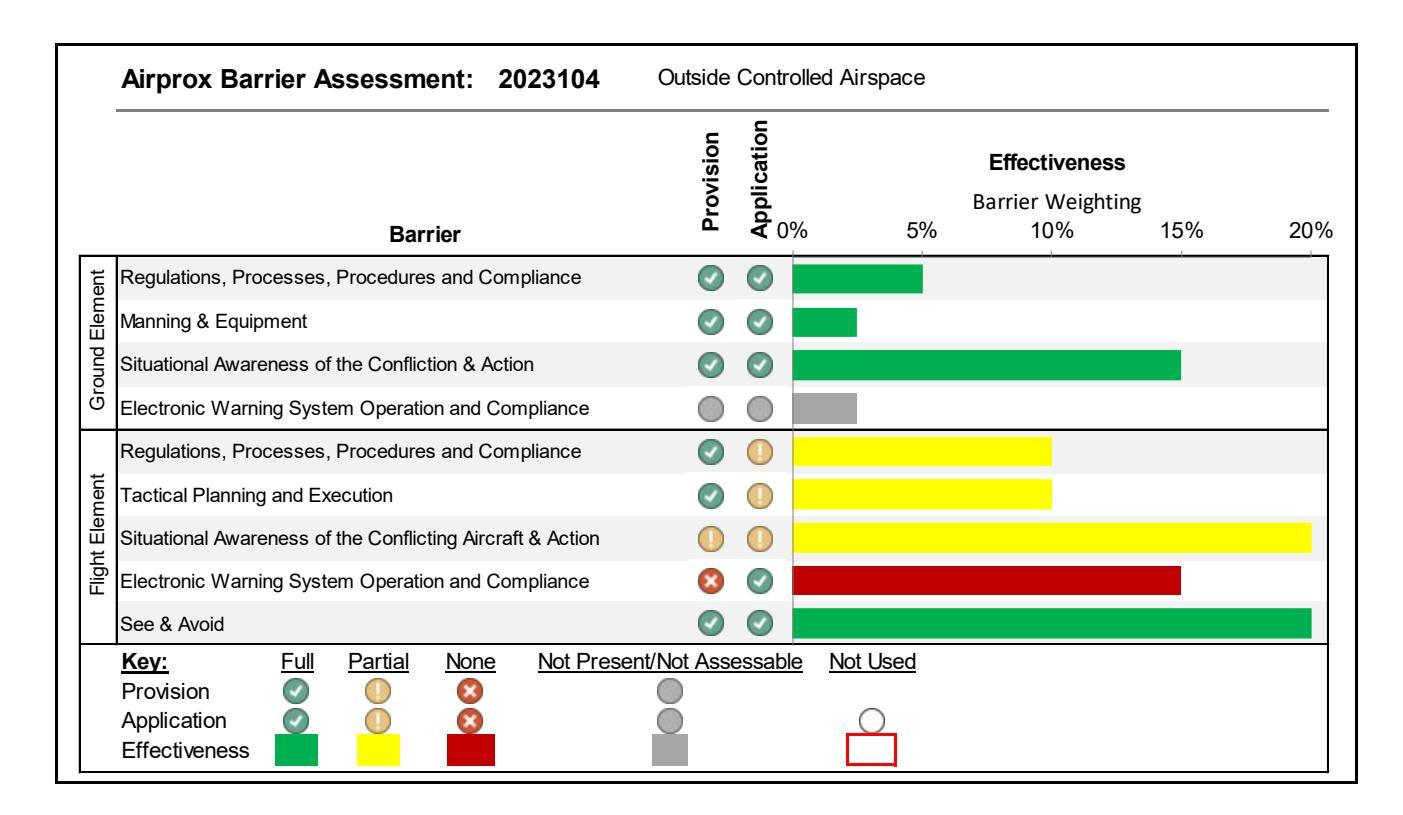
Safety Barrier Assessment⁵

Regulations, Processes, Procedures and Compliance were assessed as **partially effective** because the C152(B) student pilot did not integrate with the C152(A) ahead.

Tactical Planning and Execution was assessed as **partially effective** because the C152(A) instructor did not communicate their intention to fly a larger than promulgated circuit to the AFISO and other circuit traffic.

Situational Awareness of the Conflicting Aircraft and Action were assessed as partially effective because the C152(A) instructor had only generic situational awareness on the C152(B) and the C152(B) student pilot had incorrect situational awareness on the C152(A).

Electronic Warning System Operation and Compliance were assessed as **ineffective** because the C152(B) TAS was not able to detect the C152(A) because the C152(A) transponder was not selected on or was not functioning.
