### AIRPROX REPORT No 2023120

Date: 15 Jun 2023 Time: ~2016Z Position: 5313N 00412W Location: 1.3NM W Menai Bridge

## PART A: SUMMARY OF INFORMATION REPORTED TO UKAB

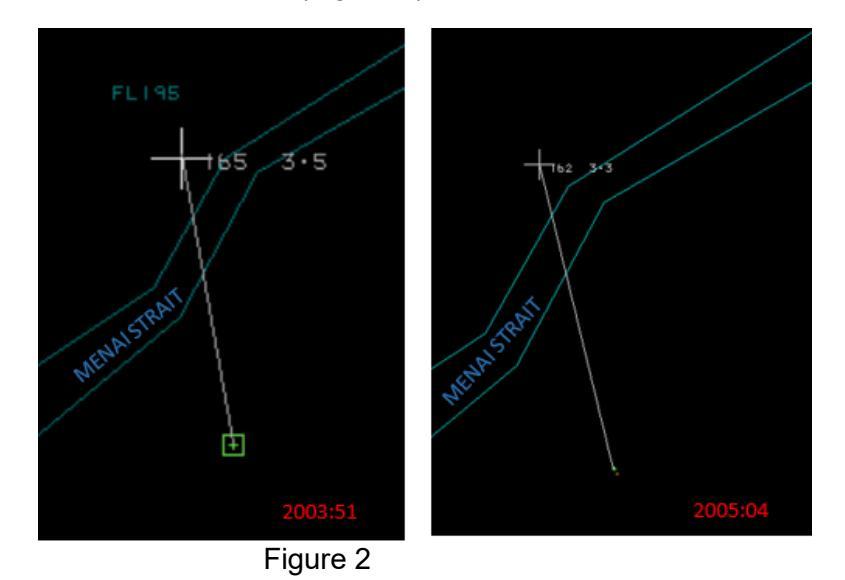
Figure 1

An analysis of the NATS radar replay was undertaken and neither aircraft were observed by radar or ADS-B tracker at the reported time, although there had been some primary radar returns to the southeast of the drone operator approximately ten minutes previously. On initial observation it was

estimated that an unidentified aircraft was manoeuvring in the direction of the operator by an initial primary radar observation at 2003:51 (Figure 1) and a second observation at 2005:04 (Figure 2).

However, there had been two other primary radar returns which may have indicated that either the first contact had circled back to nearby their earlier position at 2007:47 and travelled slightly further southwest at 2011:25. There were no further primary radar contacts after 2011:25 and nothing in the immediate vicinity of the drone operator.
