AIRPROX REPORT No 2023133

Date: 24 Jun 2023 Time: 1503Z Position: 5354N 00104W Location: 1NM SE Leeds East Marina

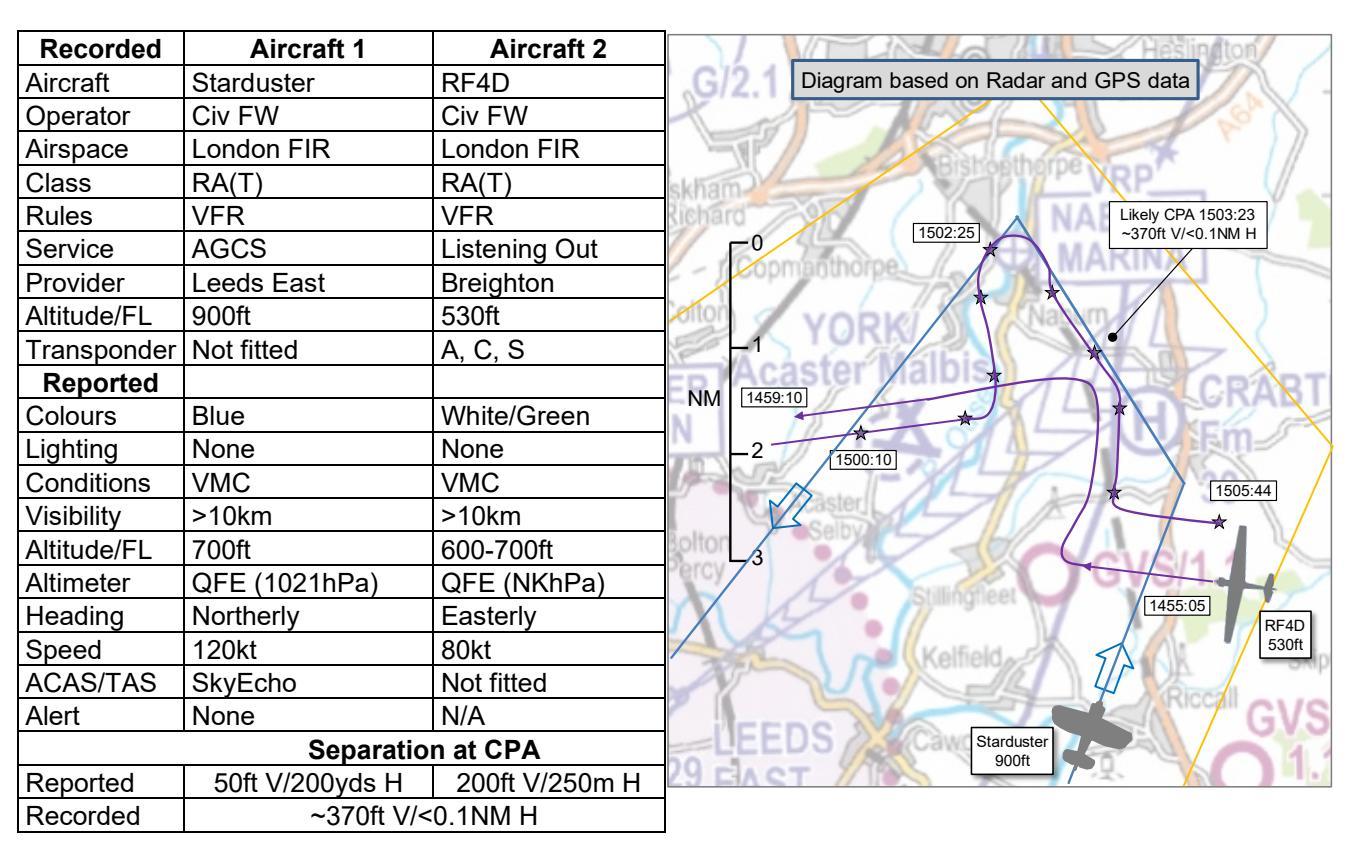
The RF4D flight plot aligned to the GPS plot of the Starduster showed the most likely point of Airprox to have been at 1503:23, approximately 1NM southeast of the Naburn Marina VRP with the Starduster heading towards that VRP at an altitude of 900ft and the RF4D, having turned around the same VRP in the opposite direction, tracking on a reciprocal heading at an altitude of 530ft.
