AIRPROX REPORT No 2023161

Date: 26 Jul 2023 Time: 1148Z Position: 5120N 00127W Location: Faccombe

PART A: SUMMARY OF INFORMATION REPORTED TO UKAB

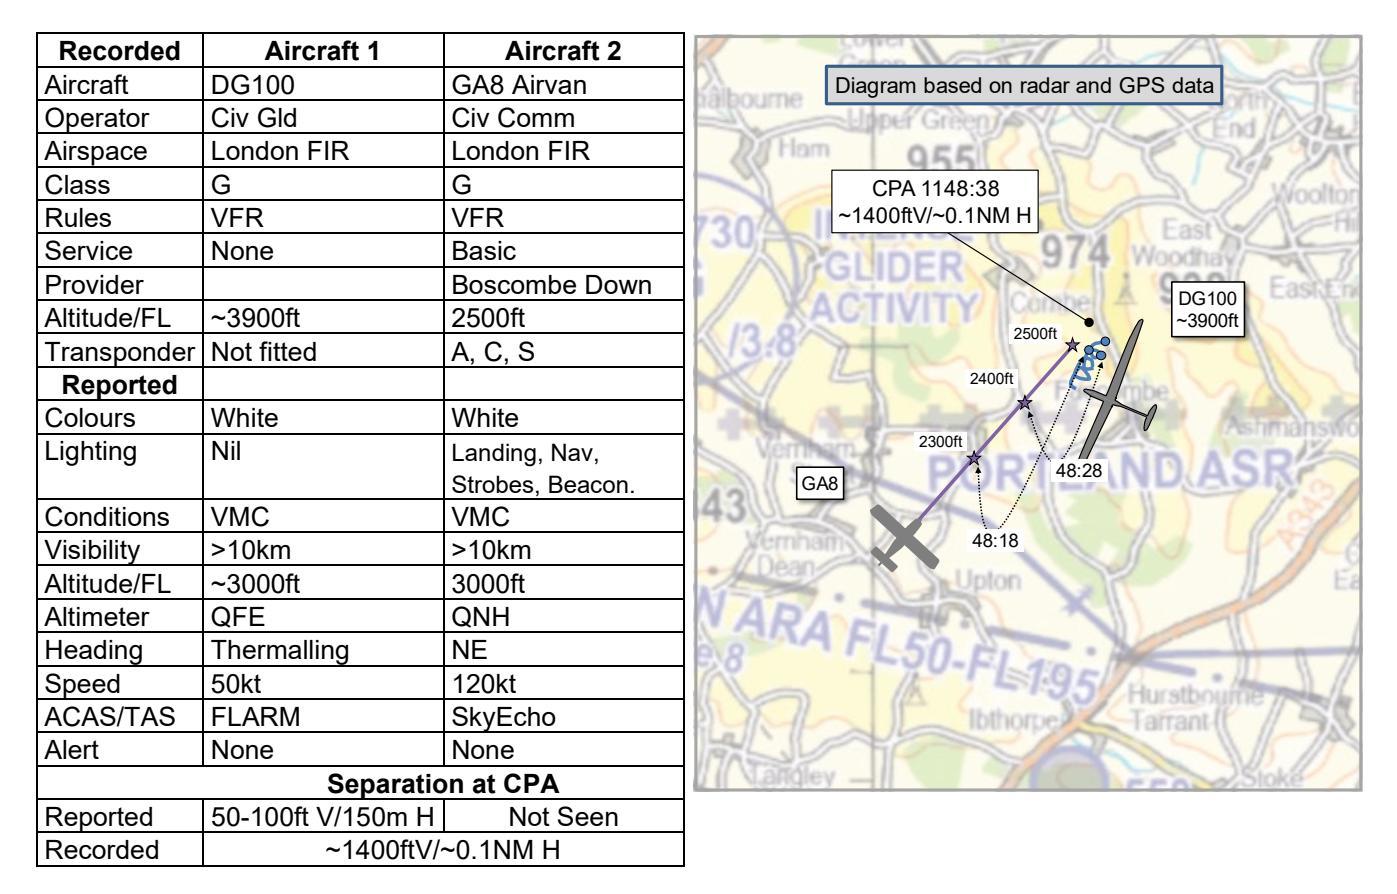
THE DG100 PILOT reports that they were on a local soaring flight from [departure airfield]. They were thermalling approximately 6.5km east of the [departure] airfield (notably overhead a wind turbine at Faccombe) whilst monitoring the airfield frequency. They were thermalling at approximately 2kts climb rate with right-hand turns. The first thing that alerted them to the other aircraft was the engine noise, then they sighted the aircraft whilst they were pointing towards the northeast, in the thermalling turn. They could identify the aircraft as a white, with a box-like fuselage, high-wing single prop. The angle to the side of the fuselage was too small to ascertain the side registration markings, however this was looked up on FlightRadar24 subsequently. As the aircraft quickly diverged after the sighting, they continued the right-hand thermalling turn, so did not sight it again until the next whole 360° turn. The aircraft appeared to be on the same heading with a lower altitude. They continued the flight without incident afterwards.

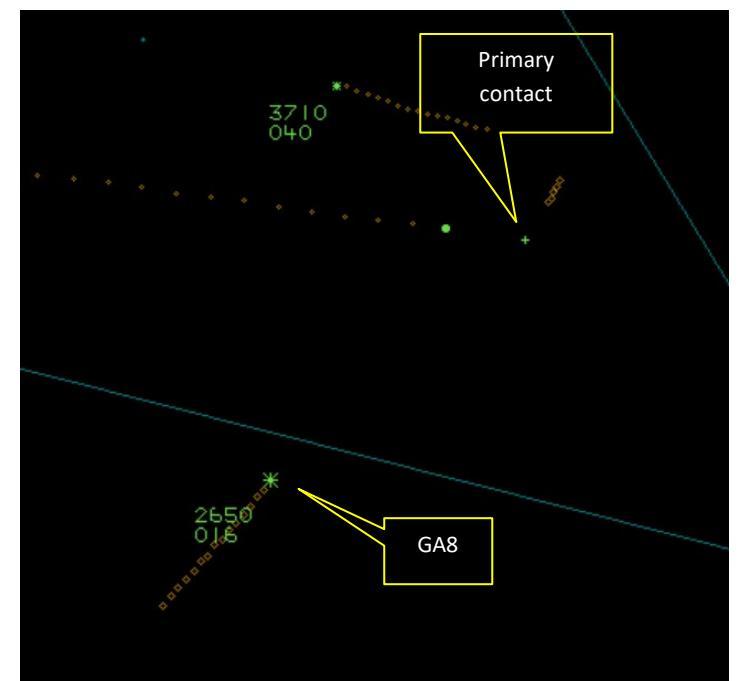
Figure 1 - 1146:47

An analysis of the NATS radar was undertaken. The GA8 could be identified using Mode S data, climbing to FL023, the Portland QNH was 1008hPa. A primary track could briefly be seen in the vicinity of the glider pilot's thermalling area, but this primary contact disappeared after just a few radar sweeps (Figure 1). The glider pilot supplied GPS data and the diagram at the top of the report has been compiled using the two data sources.

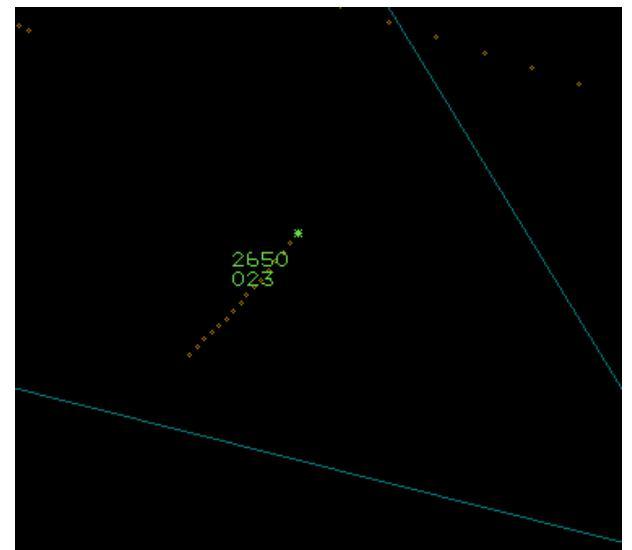
Figure 2 -1148:38

The GA8 continued on track, until in the vicinity of the glider's thermalling, still indicating FL023, Figure 2. It was estimated that the two aircraft were at their closest at 1148:38, when the glider's GPS indicated that they were at around 3900ft AMSL.
