AIRPROX REPORT No 2025007

Date: 29 Jan 2025 Time: 1508Z Position: 5219N 00048W Location: Sywell Airfield

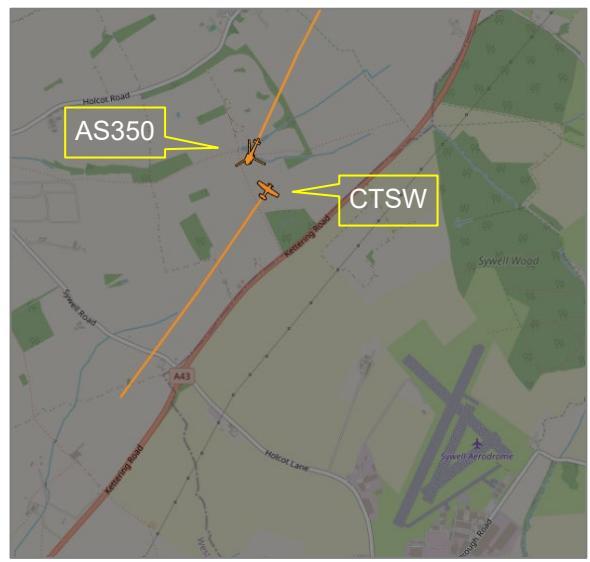
Figure 1: At 1507:35 CTSW at 1650ft. AS350 at 1875ft

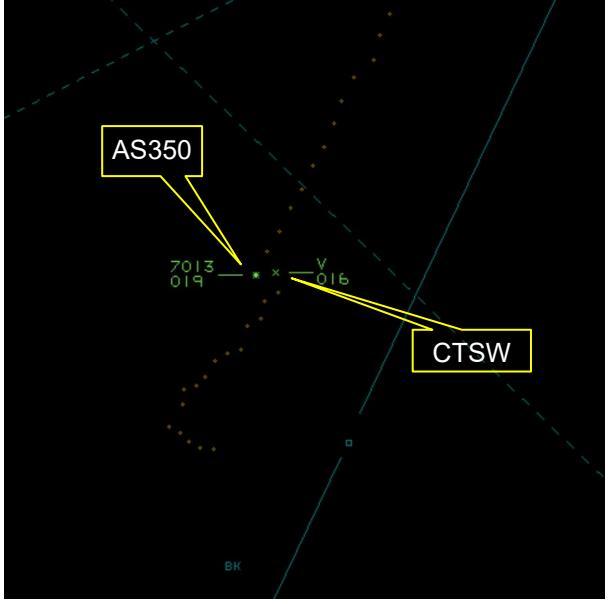
Figure 2: At CPA: 1507:39 300ft V/0.1NM H
