AIRPROX REPORT No 2025017

Date: 18 Feb 2025 Time: 1505Z Position: 5122N 00101W Location: 6.5NM WNW Blackbushe

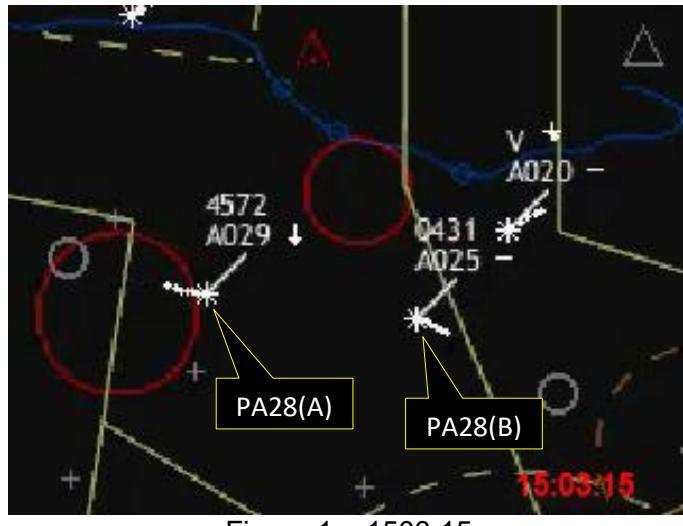
Figure 1 - 1503:15

The student pilot of [PA28(B)] contacted the Farnborough LARS West frequency at 1503:15: *"Farnborough Radar, Student* [PA28(B) C/S] *is south of Reading at two thousand feet, request Basic Service please"*.

Once the Farnborough LARS (LF-LARS) controller had established the correct callsign, the pilot of [PA28(B)] provided their details: "[...] *I am south of Reading at two thousand feet on QNH1020 request Basic Service*".

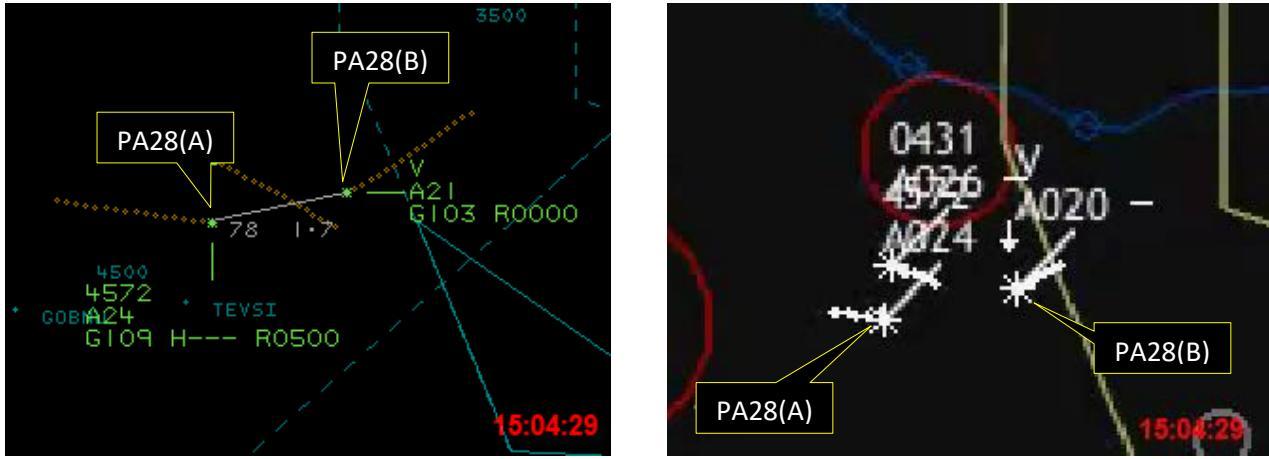
Figure 2 - NODE radar

At the time of that communication, finishing at 1504:29, [the pilot of PA28(A) (SSR 4572) was descending through 2400ft on a conflicting lateral track with [PA28(B)], maintaining 2000ft (SSR "V") (Figures 2 and 3).

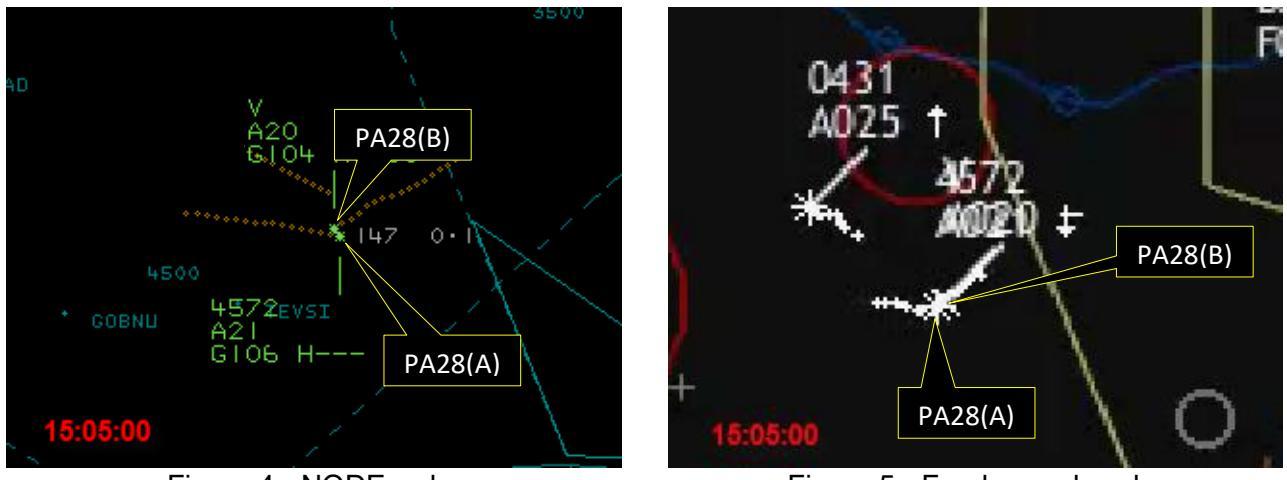
Figure 4 - NODE radar

[PA28(B)] was not identified by the LF-LARS controller whilst still displaying Mode A 7000 squawk (SSR "V") and continued to remain on the 7000 squawk. The LF-LARS controller continued with other tasks. The Closest Point of Approach (CPA) occurred at 1505:00 and was recorded on the NODE Multi-Track Radar as 0.1NM and 100ft (Figure 4 and 5).

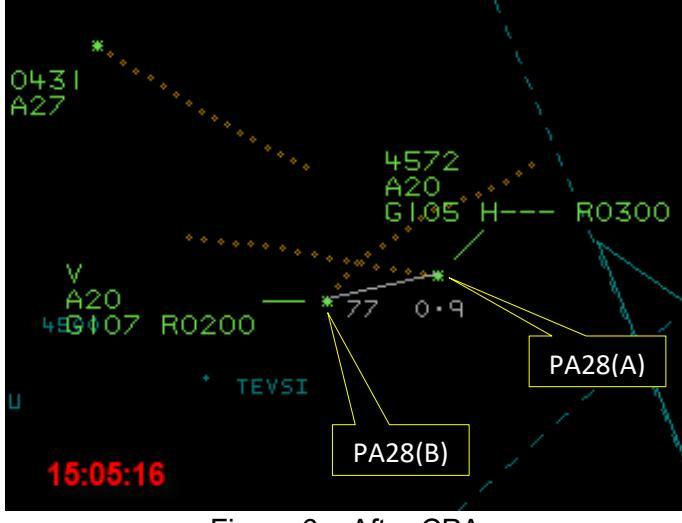
Figure 6 – After CPA

As the two aircraft passed the CPA, radar updates suggested neither pilot had performed an avoidance manoeuvre to deconflict (Figure 6). Neither pilot reported a confliction on the Farnborough frequency.
