AIRPROX REPORT No 2025018

Date: 22 Feb 2025 Time: ~1534Z Position: 5244N 00058W Location: 3NM WSW Melton Mowbray

PART A: SUMMARY OF INFORMATION REPORTED TO UKAB

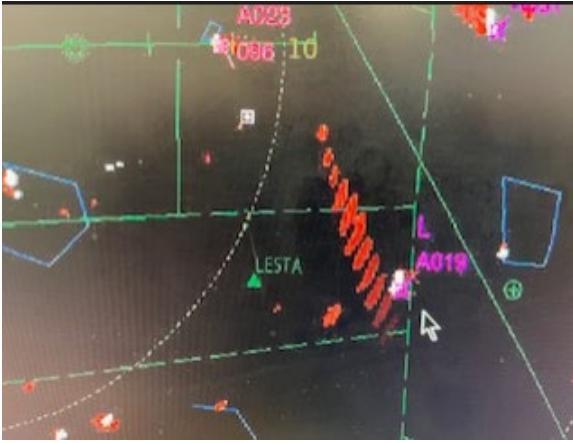
Figure 1 Time 1506:02

1506:02 RAD: "[Ikarus c/s] *pass your details*". [The Ikarus pilot] replied "[c/s] C42 microlight on a VFR flight from [departure to destination] via Melton Mowbray, 2 miles west of Melton Mowbray on a QNH of 1012". RAD: "[Ikarus c/s] roger, QNH correct, Basic Service squawk 4571". [The Ikarus pilot] read back "Basic Service, squawk 4571 [c/s]" (Figure 1).

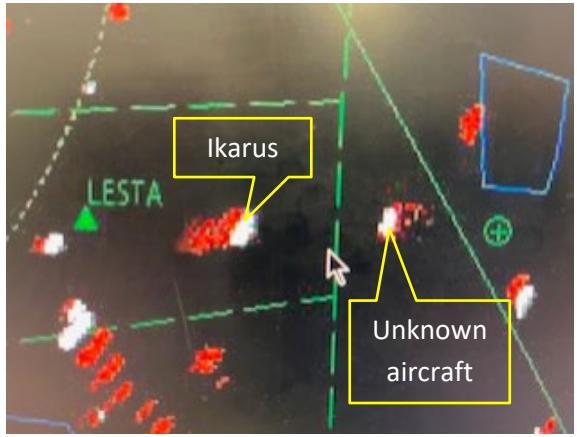
Figure 2 Time 1533:40

1533:40 The PSR contact believed to be [the Ikarus] had unknown traffic at 12 o'clock, 3NM opposite direction (Figure 2).

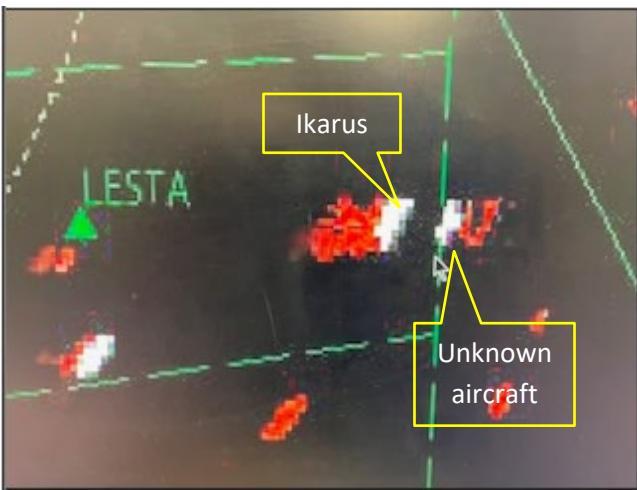
Figure 3 Time1534:19

1534:19 The closing distance was $\frac{1}{2}$ NM, still 12 o'clock opposite direction. After the merge, there was no change in the tracks of either contact (Figure 3).

East Midlands was able to provide information from its radar equipment and it was assessed that the CPA was at approximately 1534:19 with less than 0.4NM separation laterally (with the aircraft tracks still closing) and vertical separation unknown. The Ikarus pilot also supplied their track from their GPS device.
