AIRPROX REPORT No 2019191

Date: 09 Jul 2019 Time: 1245Z Position: 5124N 00321W Location: Cardiff Airport

PART A: SUMMARY OF INFORMATION REPORTED TO UKAB

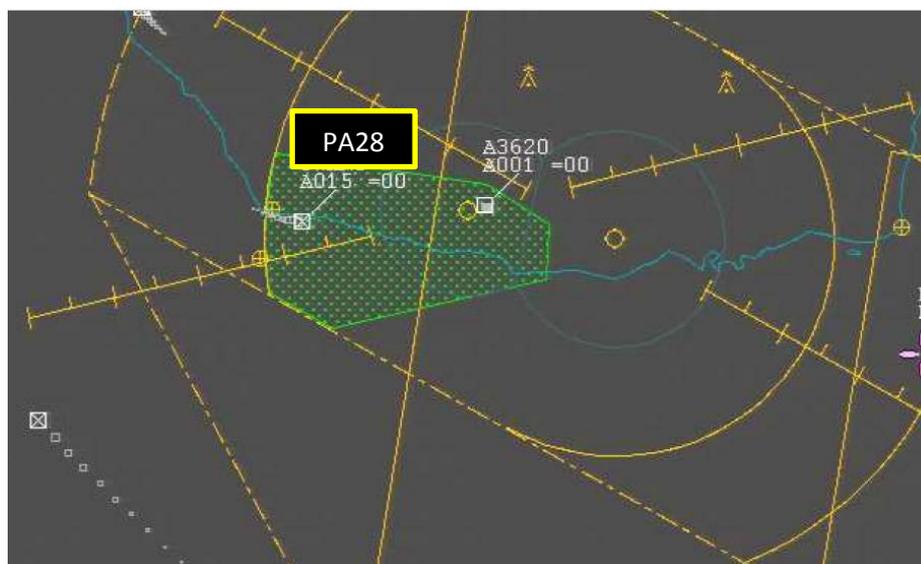
Figure 1 - 12:40:11.

- 12:40:12 B737 “[B737 C/S] request Taxi
ATCO 2 “ [B737 C/S] taxi holding point Alpha two
B737 “Holding Point Alpha [B737 C/S]
- 12:40:41 PA28 “[PA28 C/S] passing Nash Point
ATCO 3 “[PA28 C/S] Roger
- 12:40:51 ATCO3 Telephones ATCO 2
ATCO 2 “Cardiff Tower”
ATCO 3 “Request co-ordination, inbound to you, just reported passing Nash, [PA28 C/S], PA28 inbound to you.”
ATCO 2 “[PA28 C/S], yeah, co-ordinated
ATCO 3 “ Co-ordinated, I’ll give him to you South Abeam
ATCO 2 “Yeah Thanks, <ATCO 3s Name>
- 12:41:15 ATCO 2 telephones ATCO 1
ATCO 1 “Radar”
ATCO 2 “Tower, Checking [B737 C/S], EXMOR one Alpha
ATCO 1 “[B737 C/S] released
ATCO 2 “Released”

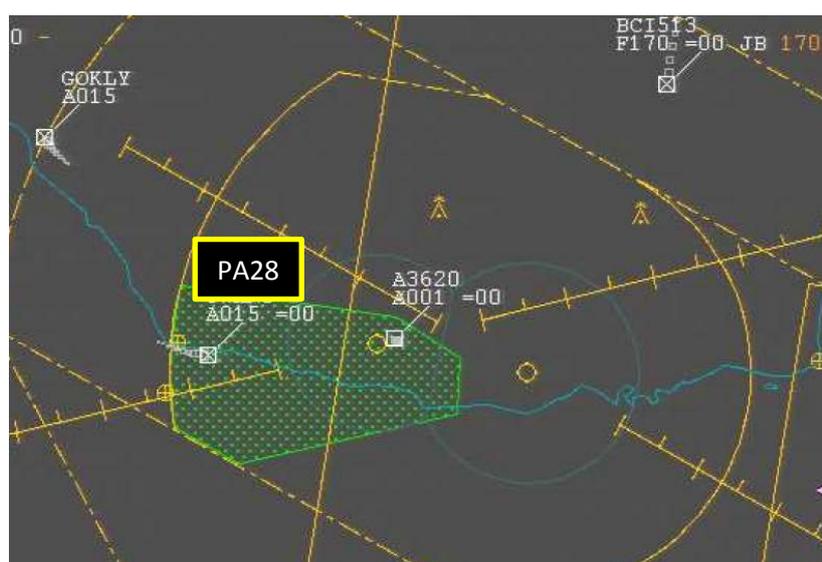
Figure 2 - 12:41:36.

- 12:41:36 ATCO 2 “[B737 C/S], Via Alpha one, Line up and Wait Three Zero
B737 “Via Alpha One line up and wait runway three zero, [B737 C/S].

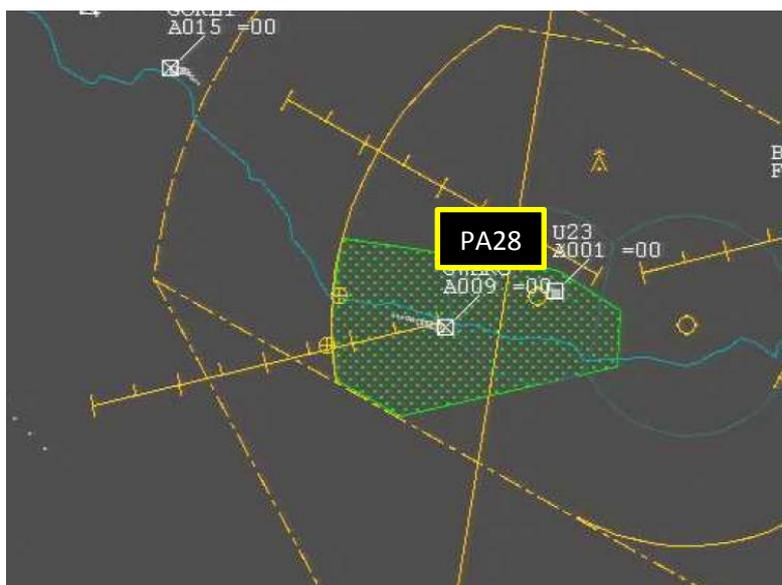
Figure 3- 12:42:29.

- 12:42:29 ATCO 2 telephones ATCO 3
 ATCO 3 "St Athan Tower"
 ATCO 2 "Cardiff, Departure Warning Boeing seven three seven"
 ATCO 3 "We are secure, can I give this guy a joining clearance to join downwind left hand runway three zero"
 ATCO 2 "Yep, [PA28 C/S] join downwind left-hand and you're secure"
 ATCO 3 "OK, Cheers"
- 12:42:29 B737 "[B737 C/S] ready for departure"
 ATCO 2 "[B737 C/S], runway three zero, cleared for take off, surface wind two eight zero degree, nine knots.
 B737 "Cleared for take off [B737 C/S]."
- 12:42:38 [PA28 C/S] abeam St. Athan airfield
 ATCO 3 "[PA28 C/S] roger"
- 12:42:50 ATCO 3 "[PA28 C/S] join downwind left-hand for runway three zero at Cardiff"
 PA28 "Join downwind left-hand runway 30, [PA28 C/S]"
 ATCO 3 "[PA28 C/S]"

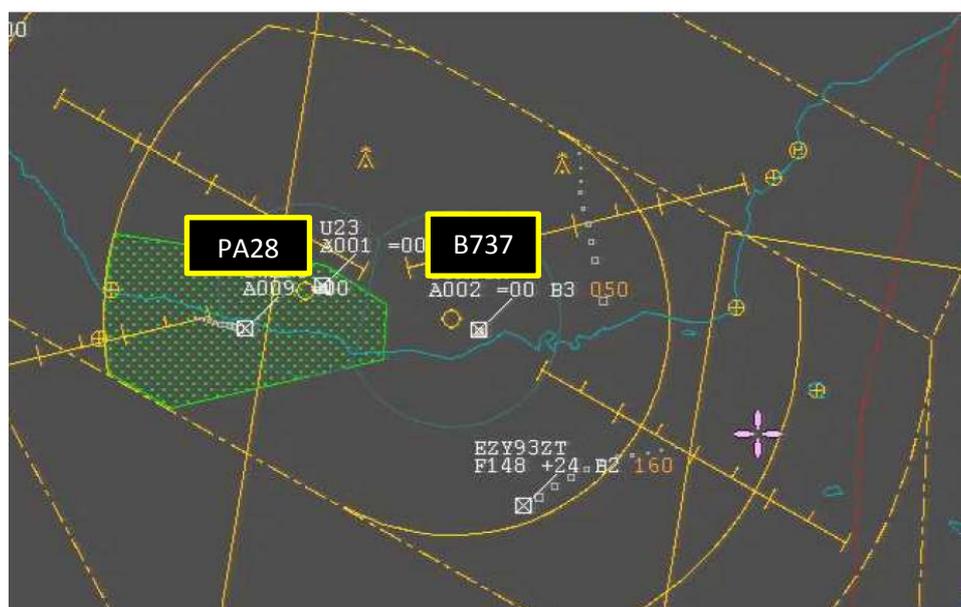
Figure 4 - 12:42:53.

12:43:34 PA28 “[PA28 C/S] request frequency change to Cardiff tower
 ATCO 3 “[PA28 C/S] roger, traffic just about to depart from runway three zero at Cardiff is a Boeing seven three seven, join downwind left-hand and contact Cardiff tower one three three decimal one.
 PA28 “Contact Cardiff One Three Three decimal one, roger the traffic [PA28 C/S]”

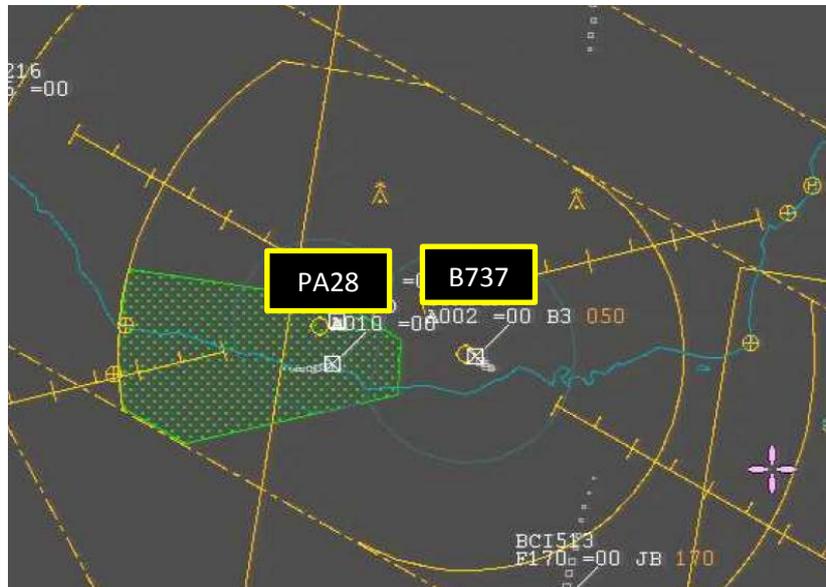
Figure 5 - 12:43:53.

12:44:01 ATCO 3 Telephones ATCO 2
 ATCO 2 “Cardiff Tower”
 ATCO 3 “ Just have a look, [PA28 C/S] I’ve just put him to you but can you <
 [PA28 C/S] contacts ATCO 2 on VHF>
 ATCO 2 “Yeah I’ll sort him out, I don’t know where he is going

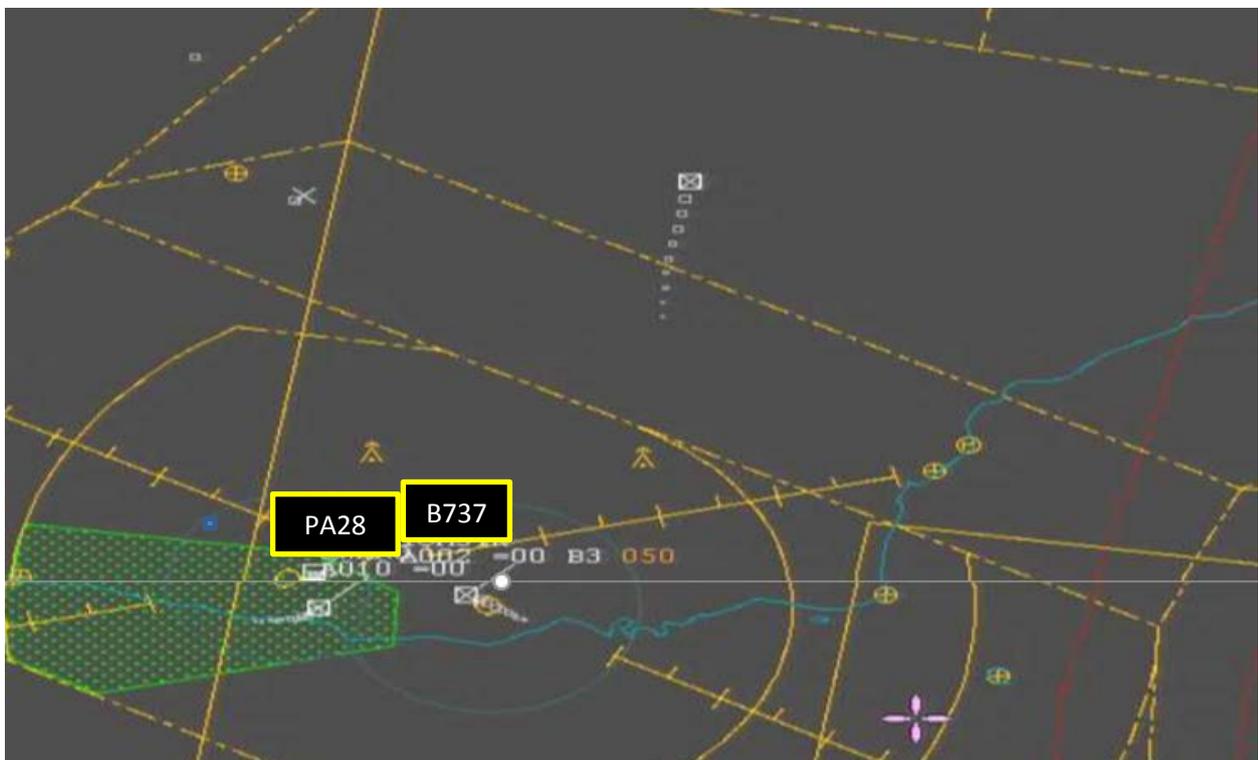
Figure 6 - 12:44:06.

- 12:44:07 (During the previous telephone call) PA28: "Cardiff Tower, [PA28 C/S], inbound, published VFR arrival via Nash Point, request rejoin.
12:44:11 ATCO 2 "[PA28 C/S], report downwind left-hand Runway Three Zero QFE One Zero One

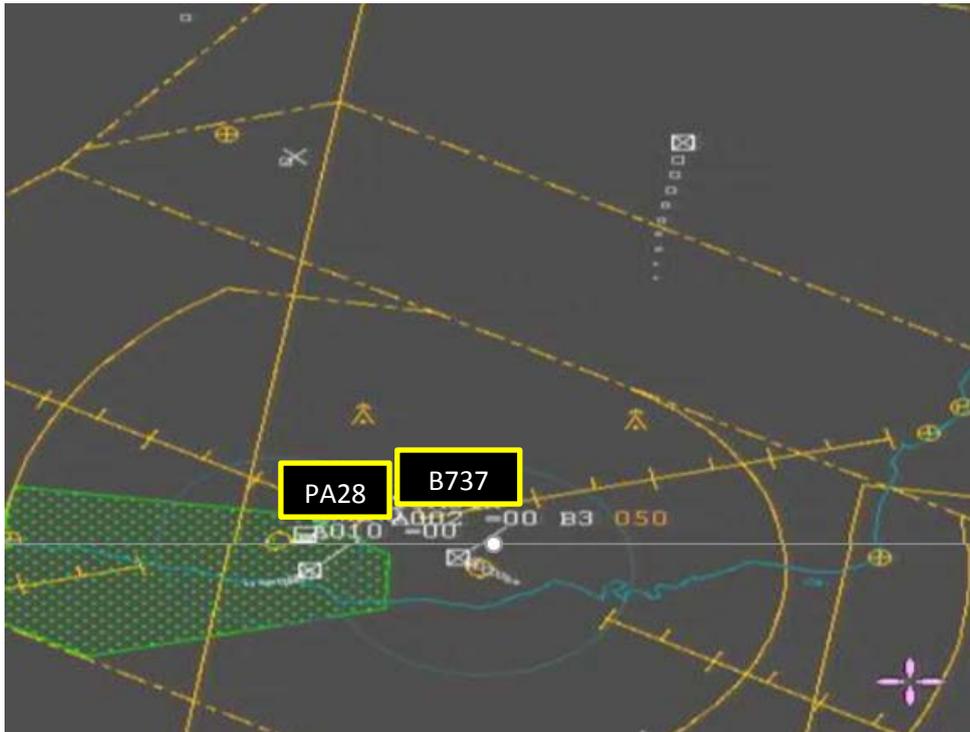
Figure 7 - 12:44:11.

- 12:44:21 PA28 "One Zero One Three, left-hand downwind and traffic in sight on the nose.

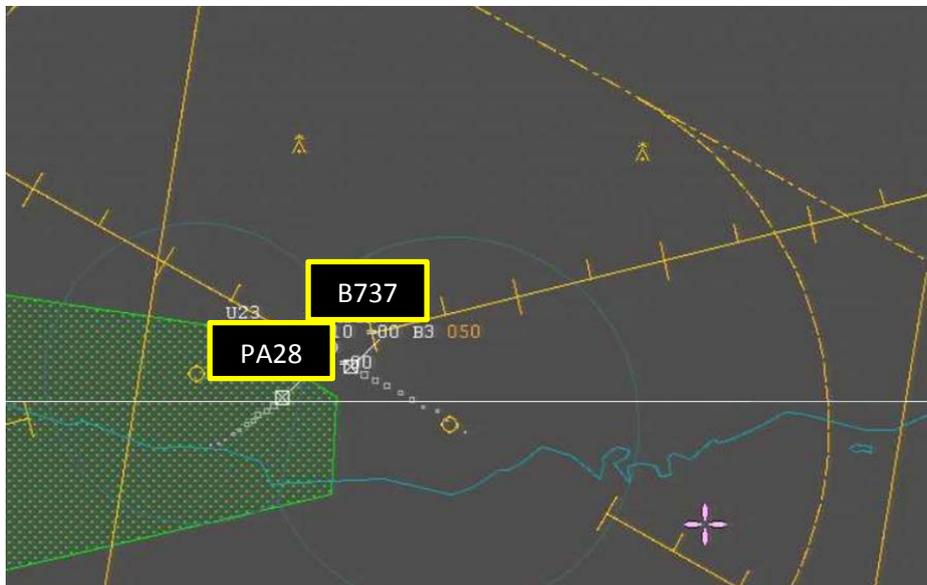
Figure 8 - 12:44:31.

- 12:44:29 ATCO 2 " [PA28 C/S], it shouldn't be on the nose, you should be joining the circuit at Cardiff downwind left-hand"
12:44:33 PA28 "Roger, downwind left-hand [PA28 C/S]"

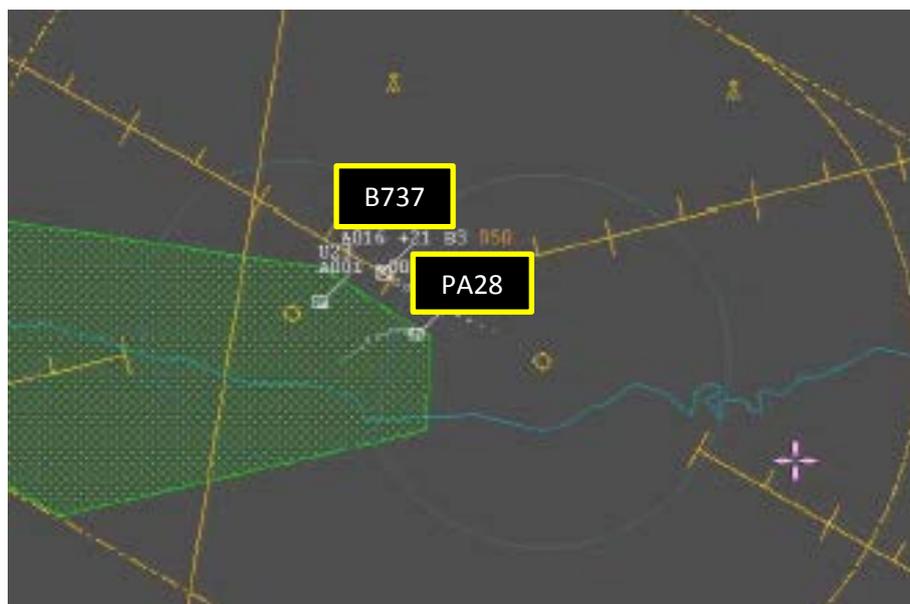
Figure 9 - 12:44:51

- 12:44:52 ATCO 2 “[B737 C/S] Contact Cardiff Radar One two five decimal eight five five.
B737 “Cardiff Radar one two five decimal eight five five, [B737 C/S]”
- 12:45:00 B737 “And Cardiff Tower [B737 C/S]”
ATCO 2 “Yes, Pass your message”
B737 “On the left-hand side we got a Traffic Advisory we will be reporting an Airprox just for your information.”

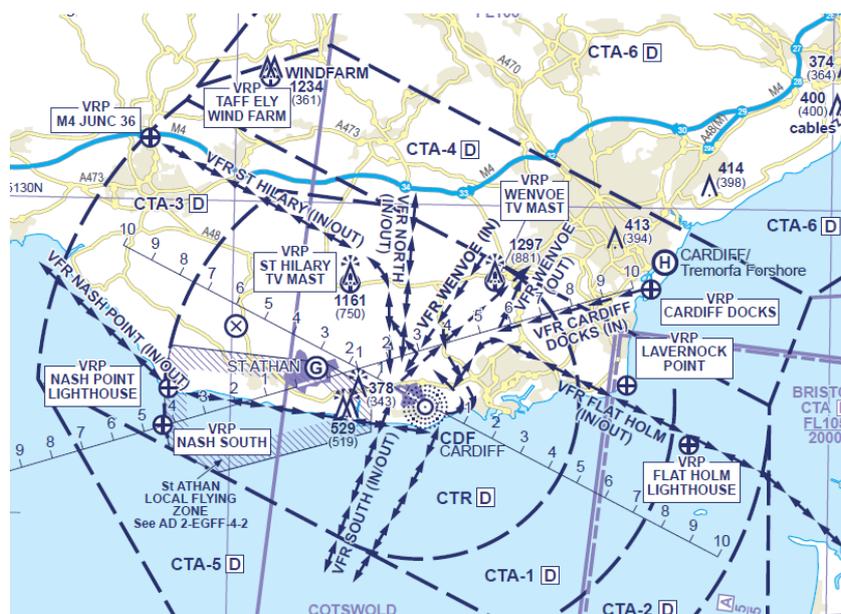
'A portion of Cardiff CTR is delegated to St Athan ATC during certain VMC weather criteria to enable St Athan to operate autonomously within the St Athan Local Flying Zone (LFZ), (Figure 10) provided: aircraft are to be in communication with and comply with instructions from St Athan ATC. All aircraft are to conduct their flights within the weather criteria specified for VFR flights within Class D Airspace.

Maximum Altitude 1700ft Cardiff QNH (1500ft St Athan QFE).

Figure 10. Cardiff Local Flying and Entry/Exit Points.⁵

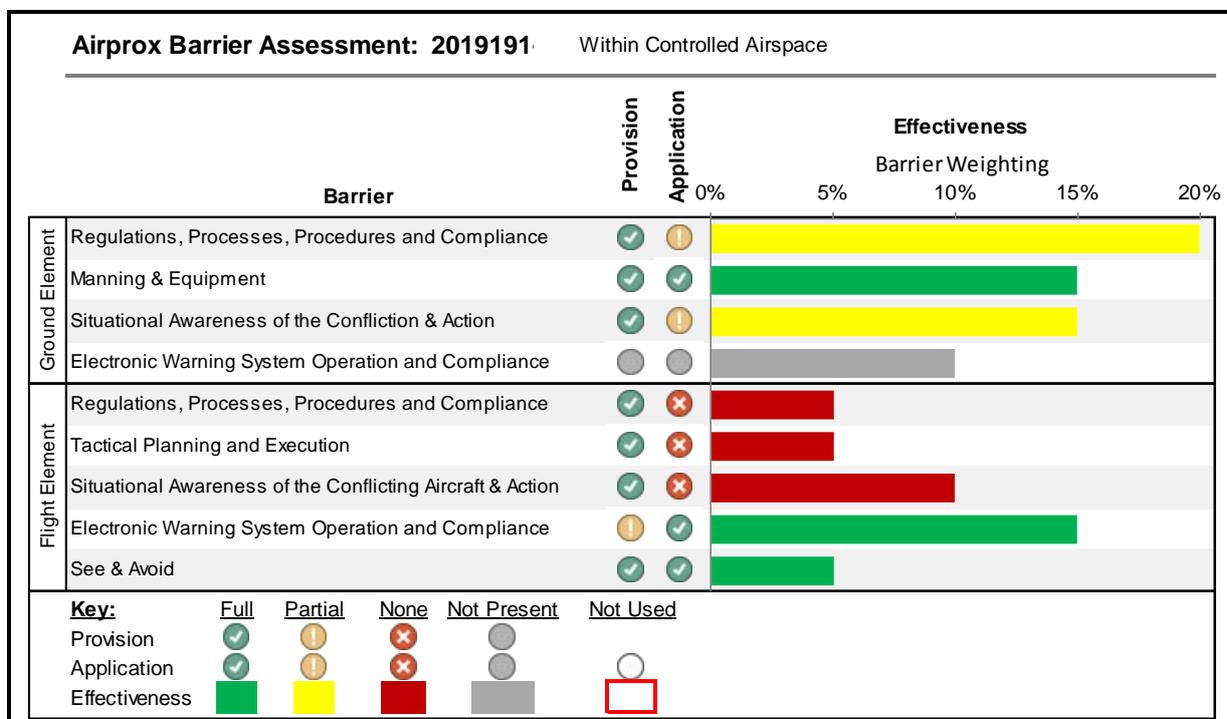
In assessing the effectiveness of the safety barriers associated with this incident, the Board concluded that the key factors had been that:

Regulations, Processes, Procedures and Compliance were assessed as **partially effective** because the Cardiff controller did not pass Traffic Information about the PA28 to the B737 pilot.

Situational Awareness of the Confliction and Action were assessed as **partially effective** because the Cardiff controller detected and resolved the conflict late, and also did not pass Traffic Information about the PA28 to the B737 pilot.

Regulations, Processes, Procedures and Compliance were assessed as **ineffective** because the PA28 pilot did not comply with his ATC clearance, as required within Class D airspace.

Tactical Planning and Execution was assessed as **ineffective** because the PA28 pilot was not aware of the correct VFR routeing from Nash point inbound to Cardiff airport to join a left-hand circuit to RW30.

Situational Awareness of the Conflicting Aircraft and Action were assessed as **ineffective** because the PA28 pilot, although being aware of the B737 departing, did not act upon the information. Also, the B737 pilot was not informed about the presence of the PA28.

Electronic Warning System Operation and Compliance were assessed as **partially available** because only the B737 was equipped with an electronic warning system.
