## AIRPROX REPORT No 2022062

Date: 30 Apr 2022 Time: 1229Z Position: 5159N 00103W Location: 2NM west of Buckingham

### PART A: SUMMARY OF INFORMATION REPORTED TO UKAB

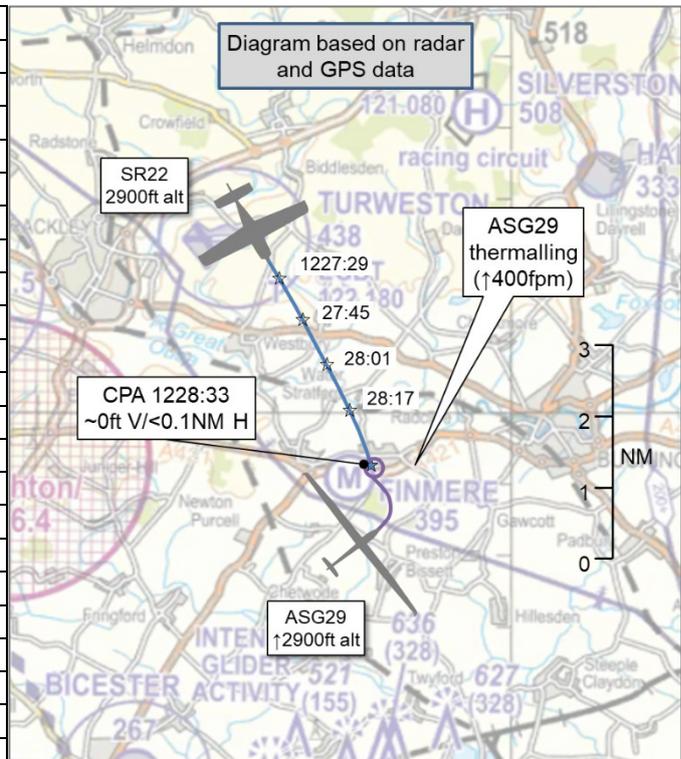
Recorded	Aircraft 1	Aircraft 2
Aircraft	SR22	ASG29
Operator	Civ FW	Civ Gld
Airspace	London FIR	London FIR
Class	G	G
Rules	VFR	VFR
Service	Listening Out	None
Provider	Turweston Radio	N/A
Altitude/FL	2900ft	2900ft <sup>1</sup>
Transponder	A, C, S+	Not fitted
<b>Reported</b>		
Colours	Grey, black	White
Lighting	Strobes, landing	Nil
Conditions	VMC	VMC
Visibility	>10km	NR
Altitude/FL	3000ft	3400ft
Altimeter	QNH (1029hPa)	QFE (NR hPa)
Heading	180°	NR
Speed	150kt	NR
ACAS/TAS	TAS	FLARM
Alert	None	Unknown
<b>Separation at CPA</b>		
Reported	200ft V/0m H	Not Seen
Recorded	~0ft V/<0.1NM H <sup>2</sup>

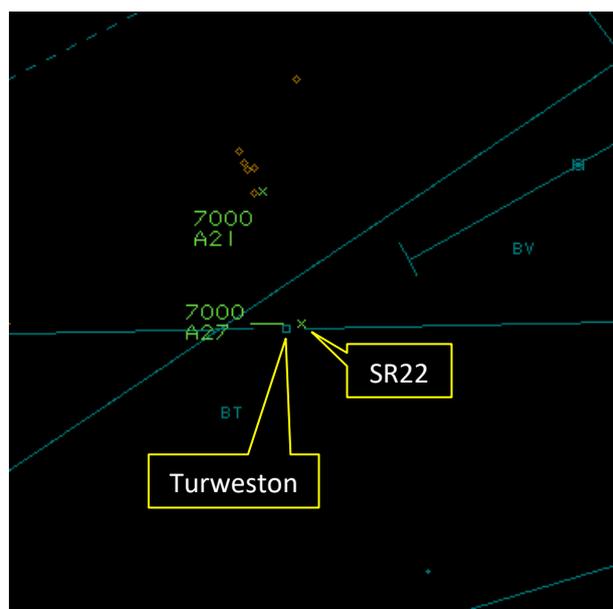
Figure 1 – 1227:13

An analysis of the NATS radar replay and GPS data for the ASG29 was undertaken. The SR22 was first detected by the NATS radars at 1227:13 in the overhead of Turweston aerodrome and at an altitude of 2700ft (see Figure 1). As the SR22 proceeded south-eastbound, the aircraft's Mode C readout stabilised at 2900ft (+/-100ft) until CPA. The ASG29 glider was not detected by the NATS radars, but GPS data from the aircraft showed that it was established in a thermal, making tight right-hand turns at the time the SR22 passed through the area. The radar position of the SR22 was compared with the GPS position of the ASG29 to determine the CPA.
