AIRPROX REPORT No 2022168

Date: 08 Aug 2022 Time: ~1358Z Position: 5402N 00030W Location: IVO Garton on the Wolds

PART A: SUMMARY OF INFORMATION REPORTED TO UKAB

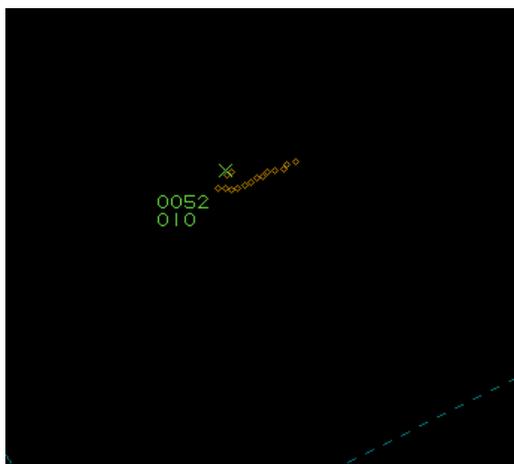
Figure 1:1349:40

An analysis of the NATS radar replay was undertaken. The EC135 could be seen squawking 0052 (listed as Police Air Support) and identified using Mode S data. The paraglider could not be seen on the radar. At 1349 (Figure 1) the EC135 could be seen orbiting as described in the pilot's report approximately 3NM south of Eddesfield and, at 1350:51, left the orbit on a southerly heading (Figure 2).
