**AIRPROX REPORT No 2022278**

Date: 13 Dec 2022 Time: 0849Z Position: 5129N 00007W Location: 1NM S London Eye VRP

**PART A: SUMMARY OF INFORMATION REPORTED TO UKAB**

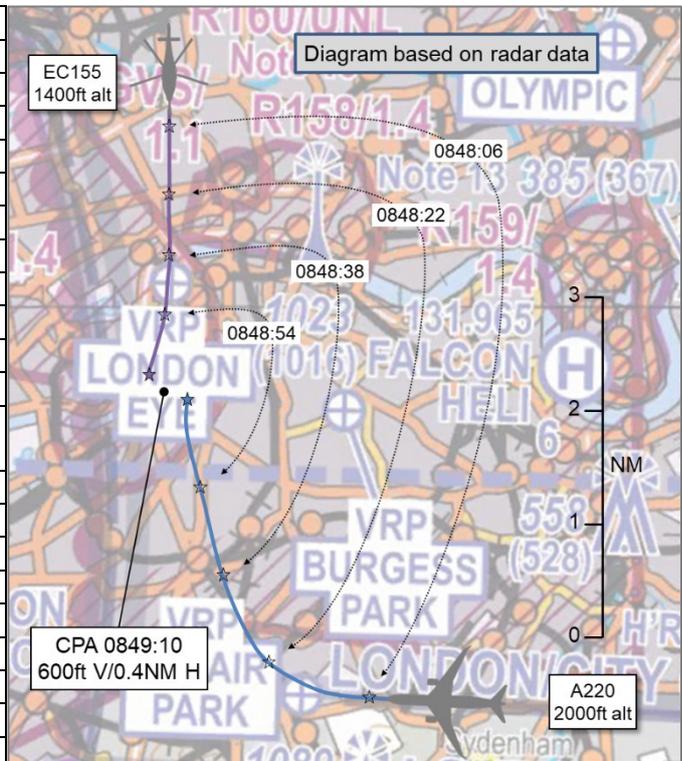
Recorded	Aircraft 1	Aircraft 2
Aircraft	A220	EC155
Operator	CAT	Civ Comm
Airspace	London City CTR	London City CTR
Class	D	D
Rules	IFR	VFR
Service	Radar Control	Radar Control
Provider	Thames Radar	Thames Radar
Altitude/FL	2000ft	1400ft
Transponder	A, C, S+	A, C, S
<b>Reported</b>		
Colours	White	Grey
Lighting	Landing, Strobe	Nav, Anti-col, Search
Conditions	VMC	VMC
Visibility	5-10km	>10km
Altitude/FL	2000ft	1300ft
Altimeter	QNH (NK hPa)	QNH (1009hPa)
Heading	NK	180°
Speed	160kt	145kt
ACAS/TAS	TCAS II	ACAS
Alert	RA	Information
<b>Separation at CPA</b>		
Reported	500ft V/200m H	1000ft V/3NM H
Recorded	600ft V/0.4NM H

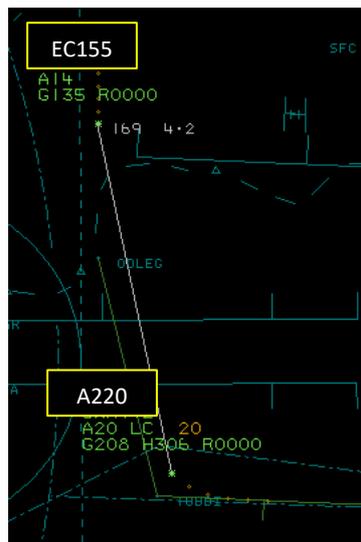
Figure 1.

At 0848:26 (Figure 1) the pilot of [the EC155] was passed Traffic Information on [the A220], the EC155 pilot replied, “*visual with that aircraft and visual with the landing site*”.

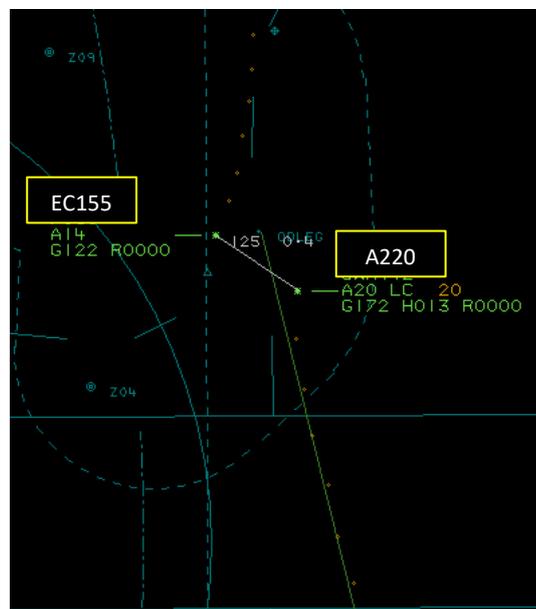
Figure 2

The closest point of approach between [A220] and [EC155] occurred at 0849:10 with 0.4NM and 600ft between the aircraft (Figure 2). High level STCA activated after the aircraft had passed each other at 0849:18 and de-activated 9 seconds later.

Closest Point of Approach occurred at 0849:10 and was recorded on Multi-Track Radar as 0.4NM and 600ft.

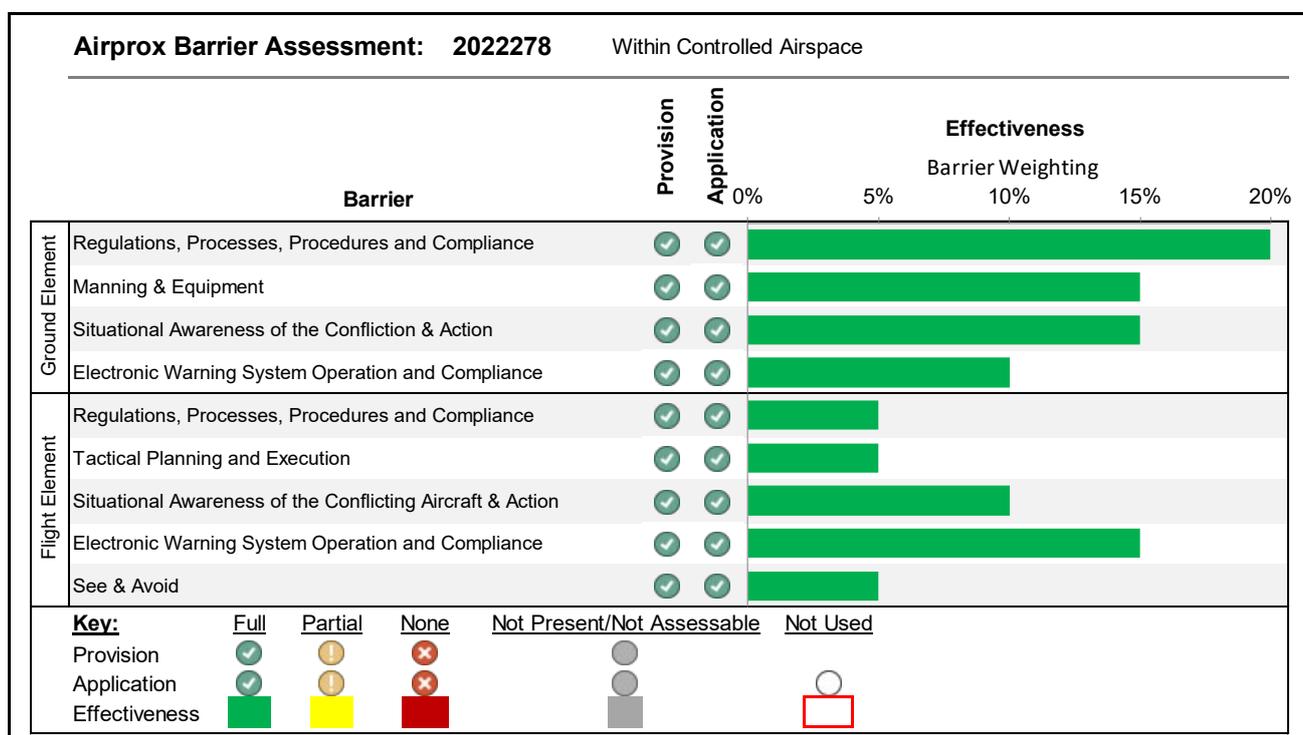
In assessing the effectiveness of the safety barriers associated with this incident, the Board concluded that all barriers had been effective.
