AIRPROX REPORT No 2016004

Date: 16 Jan 2016 Time: 1035Z Position: 5149N 00120W Location: 1.5nm south Oxford airport

PART A: SUMMARY OF INFORMATION REPORTED TO UKAB

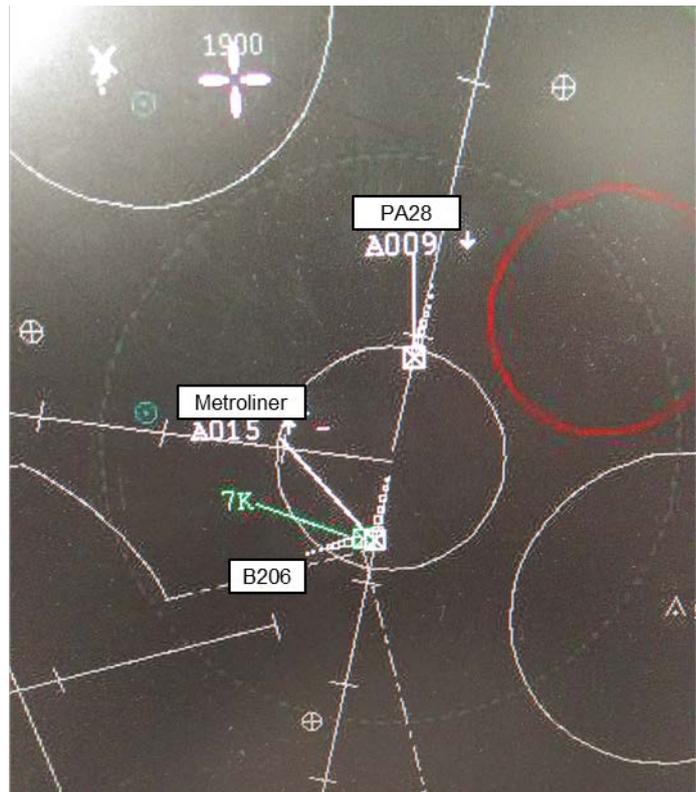
Screenshot of Oxford radar picture at CPA

Director commented that Oxford are quite used to aircraft passing west-abeam the Oxford ATZ without being in RTF contact and calling Brize for a CTR transit. Likewise, they were used to seeing 7000 squawks change to Brize squawks at or around the CTR boundary. He was completely perplexed as to why the helicopter pilot chose the routing he did after his reversal of track to enter the ATZ without clearance; Oxford aerodrome would have been clearly visible in his 11o'clock. Director stated that Tower estimated the point of conflict at altitude 1400ft with the Metroliner passing 100ft and 100m away, and straight in front of the helicopter. Almost immediately after the conflict, the helicopter pilot turned onto exactly the same track as the Metroliner and vacated the ATZ to the south.

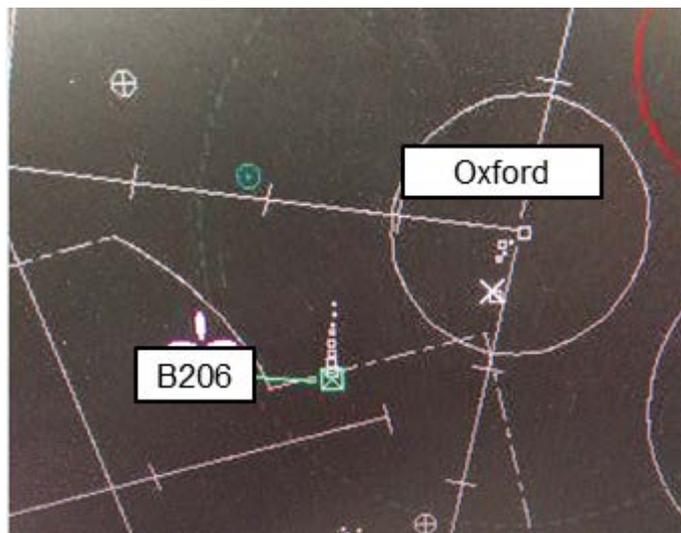
Figure 1

A clearance to join controlled airspace had been obtained by Oxford radar for a departing Metroliner, which was operating on a commercial IFR flight. The Radar controller had passed this clearance to the Tower controller and released the Metroliner for departure. As the Radar controller was monitoring the tower frequency he was aware of the likely time the Metroliner would be getting airborne. During this period an unknown aircraft was observed on Radar tracking southbound adjacent to, but away from the western side of the Oxford ATZ (Figure 1).

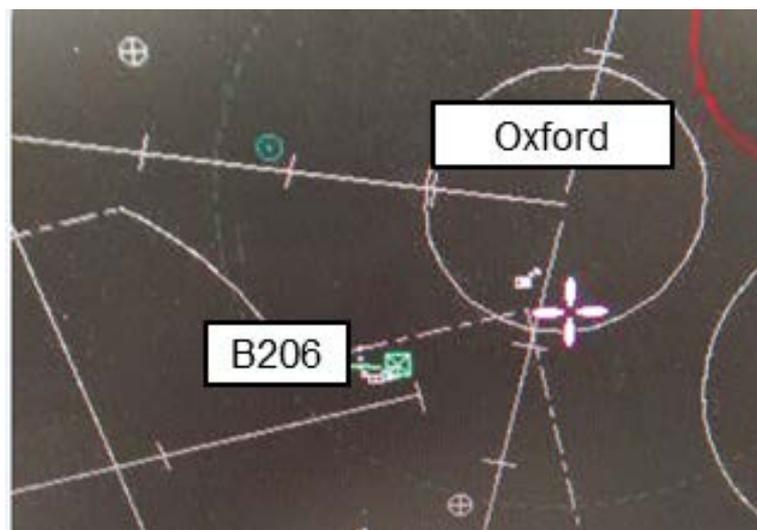
Figure 2

The Radar controller asked the Tower controller to see if he could see this traffic at 1030:04. After a few moments the Tower controller spotted the traffic and reported that it was a helicopter at about 1500ft. At 1032:02, whilst the Metroliner was backtracking for departure, the Tower controller passed Traffic Information about the unknown helicopter. The planned departure for the Metroliner was to turn right heading 315° after departure. The Metroliner was cleared for take-off at 1032:48. At 1033:41, the Radar controller phoned the Tower controller as the B206 had turned onto an easterly heading back towards the projected flight path of the Metroliner (Figure 2).

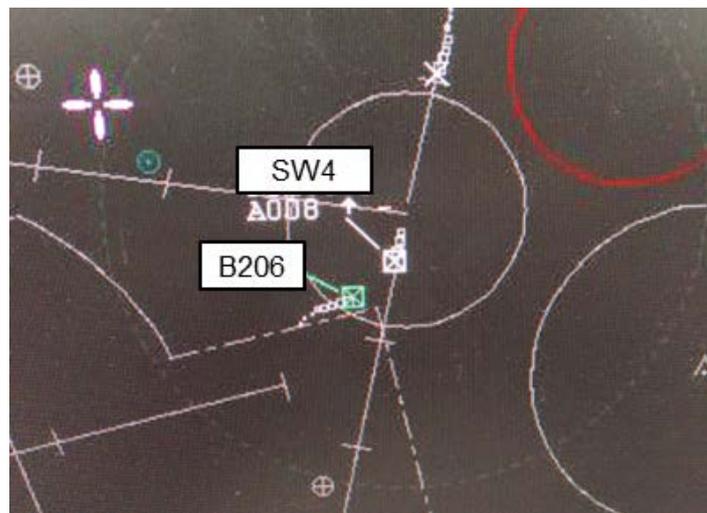
Figure 3

At 1034:24, approximately the time of Figure 3, as the B206 continued to track towards the Metroliner, the Tower controller passed further Traffic Information. The Metroliner was transferred to the Radar controller at 1034:40.

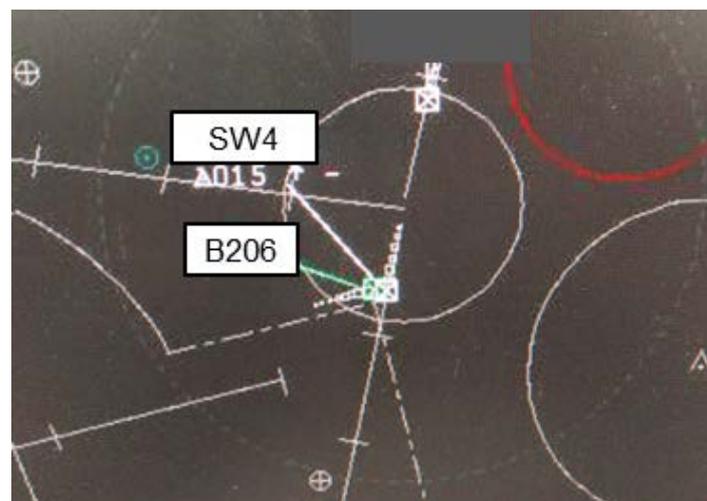
The Metroliner first called the Radar controller at 1035:32. The Radar controller advised that the Metroliner was now clear of the traffic and issued an instruction to turn to the right. Figure 4 shows the Metroliner and B206 at approximately CPA, as the B206 appears to be tracking just behind the Metroliner. It was not possible to measure CPA on the Oxford radar screenshots.
