**AIRPROX REPORT No 2016030**

Date: 14 Mar 2016 Time: 0821Z Position: 5130N 00006E Location: London City Airport

**PART A: SUMMARY OF INFORMATION REPORTED TO UKAB**

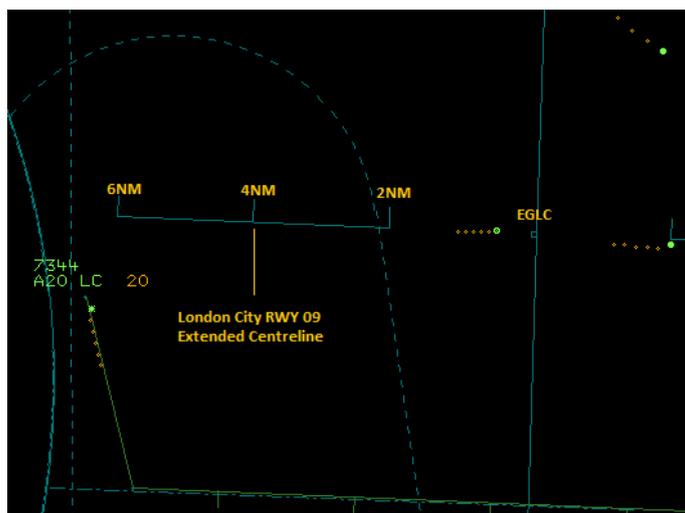
At 0817:21 (Figure 1), the City Tower controller gave the RJ1H clearance to line-up and wait on RW09. At this time, the inbound RJ85 was 6.6nm west-south-west of London City Airport on a right-hand base leg for the ILS approach to RW09 having been vectored by the City Director controller in accordance with standard Terminal Control London City RW09 arrival procedures.

Figure 1 – Swanwick MRT at 0817:21

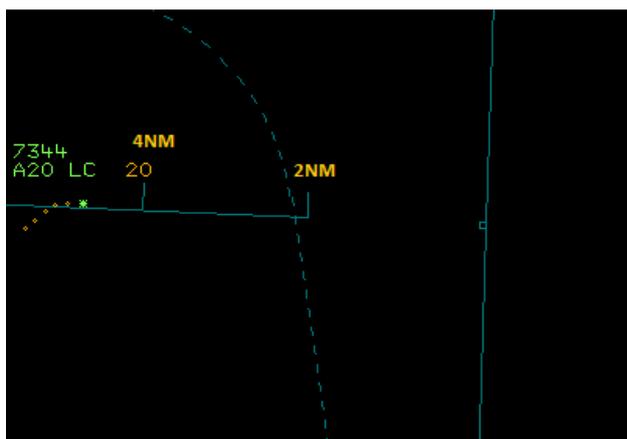
At 0818:15 (Figure 2), the RJ85 established on the final approach track for RW09 at 4.7nm.

At 0818:20 the RJ85 (at 4.6nm) was transferred by the City Director controller to the City Tower controller.

Figure 2 – Swanwick MRT at 0818:15

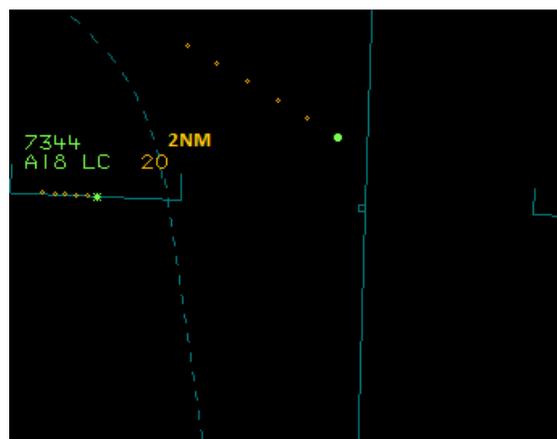
Figure 3 – Swanwick MRT at 0819:02

At 0819:02 (Figure 3), the City Tower controller issued take-off clearance to the RJ1H. According to the recorded surveillance data, at 0819:26 (Figure 4), the RJ85 initiated a climb at approximately 2.3nm final with the data-block showing a rate of climb of 400FPM.

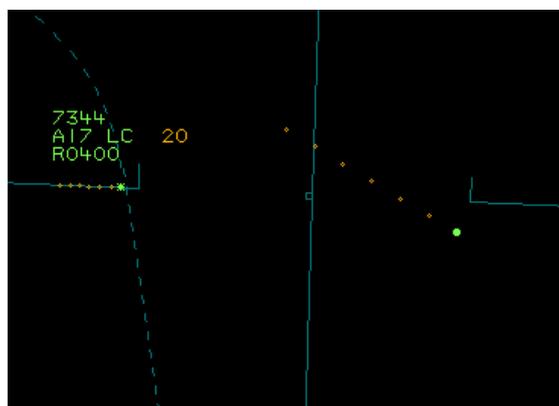
Figure 4 – Swanwick MRT at 0819:26

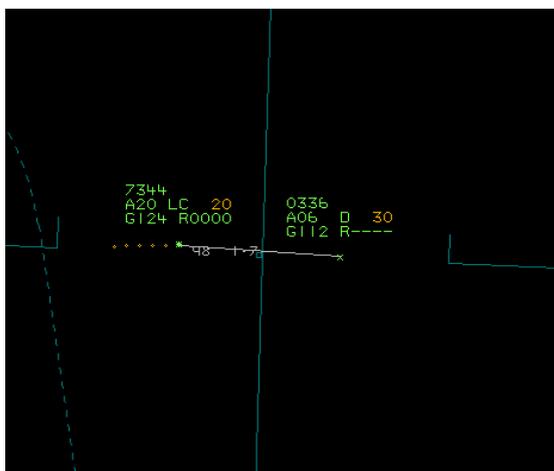
At 0820:10 (Figure 5), the departing RJ1H’s SSR return appears on the area radar recording for the first time. At this point, the RJ85 had levelled off at 2000ft and was displaying a groundspeed of 124kt with the lateral distance between the two aircraft being 1.7nm.

Figure 5 – Swanwick MRT at 0820:10

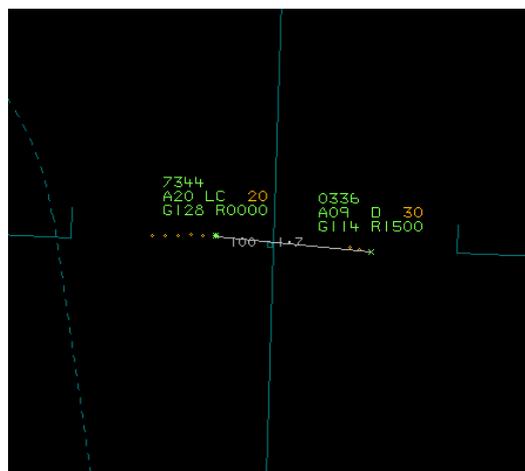
Figure 6 – Swanwick MRT at 0820:20

Ten seconds later, at 0820:20 (Figure 6), the City Tower controller instructed the RJ1H to “*make an early turn when able please, left heading of 360°*”. The RJ85 was displaying a groundspeed of 128kt and the lateral distance between the two aircraft was still 1.7nm.

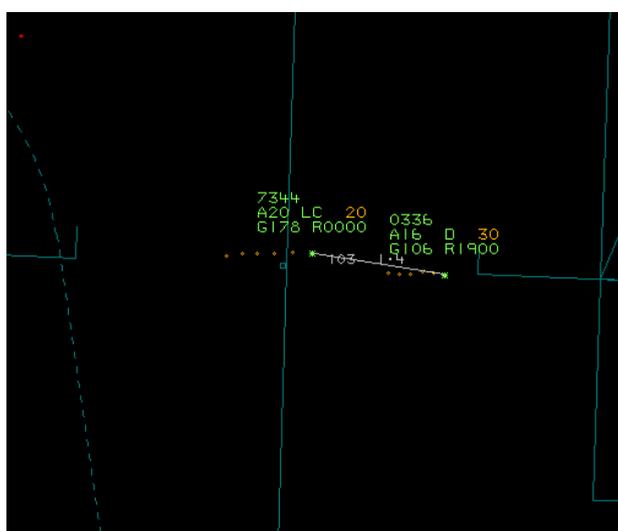
At 0820:39 (Figure 7), the City Tower controller provided updated traffic information to the RJ85 in respect of the departing RJ1H’s allocated heading of 360°. After the traffic information was acknowledged, the pilot of the RJ85 then enquired whether the City Tower controller wanted him to turn; however, this second call was not acknowledged. The RJ85 was now displaying a groundspeed of 178kt versus the RJ1H’s groundspeed of 106kt. The lateral distance between the two aircraft had reduced to 1.4nm.

Figure 7 – Swanwick MRT at 0820:39

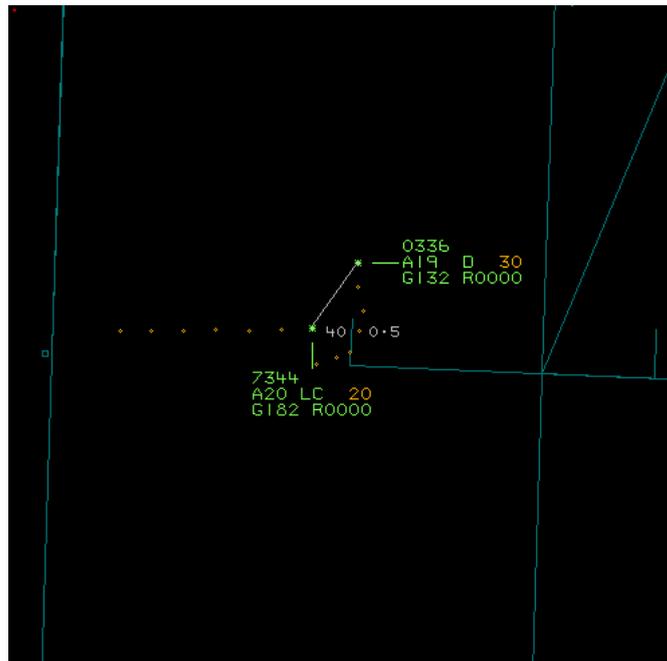
At 0821:04, the RJ1H reported a TCAS RA. CPA occurred very shortly afterwards at 0821:06 (Figure 8), with a lateral distance of 0.5nm and a vertical distance of 100ft.

Figure 8 – Swanwick MRT at 0821:06 (CPA)

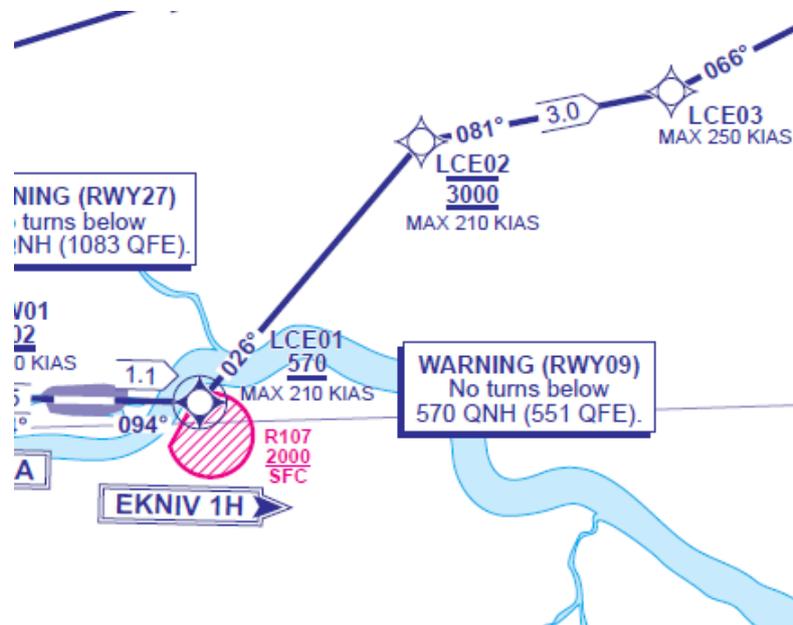
The departing RJ1H was cleared to fly the EKNIV1H RNAV Standard Instrument Departure (Figure 9) from RW09. The initial part of the SID involves climbing straight ahead to 1.1DME followed by a left turn onto a track of 026°.

Figure 9 – Extract from RNAV1 SID Chart (UK AIP AD-2-EGLC-6-4)

The published Missed Approach Procedure for RW09 at London City is based on a 2.5% climb gradient, straight ahead to 2000ft to I-LST DME 5 (LON DME 24.8), then turn left to NDB(L) LCY at 2000ft, or as directed.
