AIRPROX REPORT No 2016132

Date: 05 Jul 2016 Time: 1427Z Position: 5148N 00255W Location: IVO Abergavenny

PART A: SUMMARY OF INFORMATION REPORTED TO UKAB

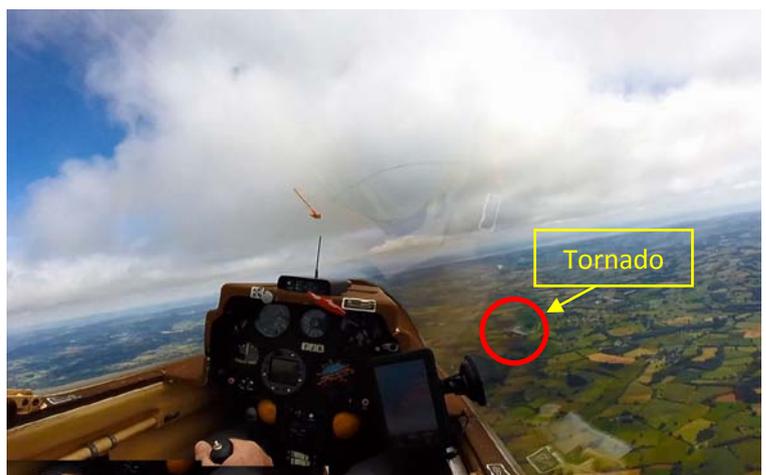
recorded the incident and the Board were able to watch the video of the moment that the Tornado passed in front of it (see the still-frame image taken just before CPA). Although the Board recognised that camera focal length can sometimes be misleading in perception of separation, the Board agreed that as they crossed, the two aircraft appeared to be much closer than the Tornado pilot had reported and this led them to believe that he may in fact have seen another glider, not the Airprox glider.

This led the Board on to determining the cause of the Airprox, which was quickly agreed to have been a possible non-sighting by the Tornado pilot and a late sighting by the glider pilot. However, the Board debated the risk for some time as they repeatedly ran through the glider pilot's video recording. Some members maintained that this incident was a Category C (no risk of collision) because of the distance that the Tornado had passed ahead of the glider. Others were concerned that, even for a fast-jet at 350kts, the crossing rate of the Tornado across the nose of the glider indicated that it was much closer than a 'no risk of collision' situation. In the end, after much discussion, the Board agreed on risk Category B, safety had been much reduced below the norm.

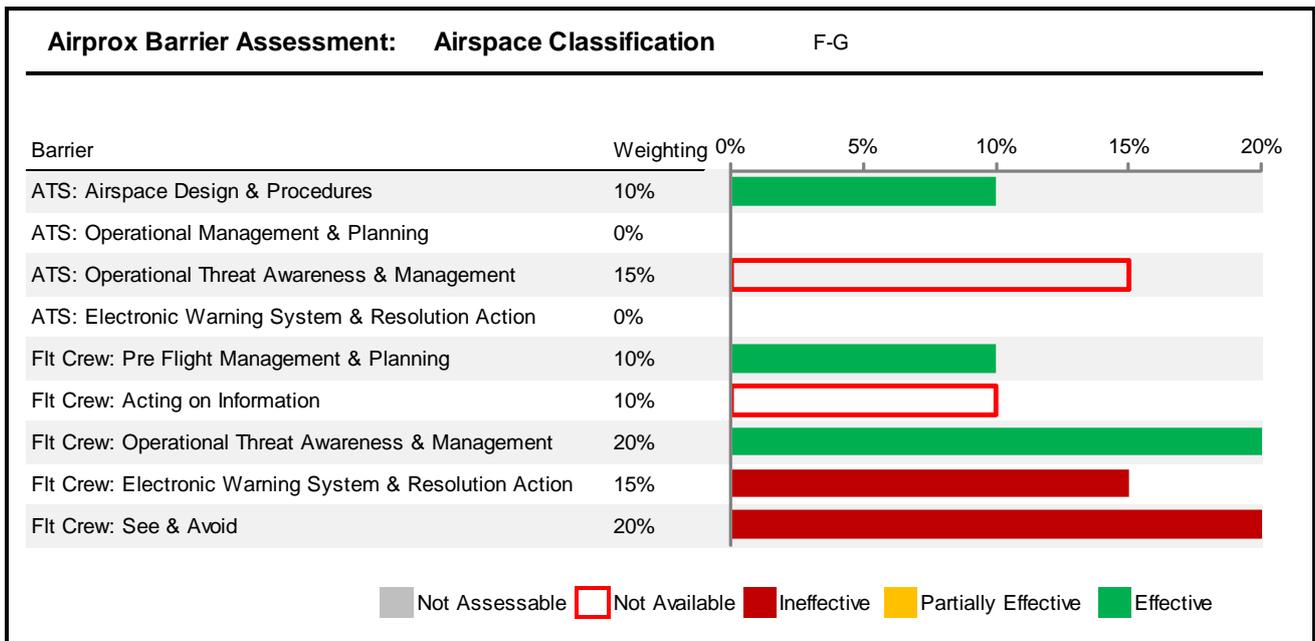
Barrier Assessment:

In looking at the barriers that were relevant to this Airprox, the Board agreed that ATS barriers were all not available because neither pilot was receiving a service at the time (although the Tornado had been given generic Traffic Information on possible gliders that were no longer deemed to be a threat prior to the Airprox). Members noted that the two aircraft were operating with different CWS that were not compatible with each other (FLARM and TCAS), and the Board were disappointed that this should be the case because this rendered each CWS ineffective – installation of cooperative systems was vital in this regard: either SSR or an SSR-compatible CWS in the glider (such as PilotAware³ for example); or a FLARM-compatible CWS in the Tornado (such as PilotAware³ for example). Finally the Board thought that see-and-avoid had also been ineffective because the Tornado pilot probably didn't see this glider, or at least perceived it to be further away than it was, and the glider pilot saw the Tornado too late to take any action.

Modern safety management processes employ the concept of safety barriers that prevent contributory factors or human errors from developing into accidents. Based on work by EASA, CAA, MAA and UKAB, the following table depicts the barriers associated with preventing mid-air-collisions. The length of each bar represents the barrier's weighting or importance (out of a total of 100%) for the type of airspace in which the Airprox occurred (i.e. Controlled Airspace or Uncontrolled Airspace).⁴ The colour of each bar represents the Board's assessment of the effectiveness of the associated barrier in this incident (either Fully Effective, Partially Effective, Ineffective, Not Available, or Not Assessable). The chart thus illustrates which barriers were effective and how important they were in contributing to collision avoidance in this incident.
