**AIRPROX REPORT No 2016233**

Date: 12 Nov 2016 Time: 1539Z Position: 5255N 00239W Location: Tilstock

**PART A: SUMMARY OF INFORMATION REPORTED TO UKAB**

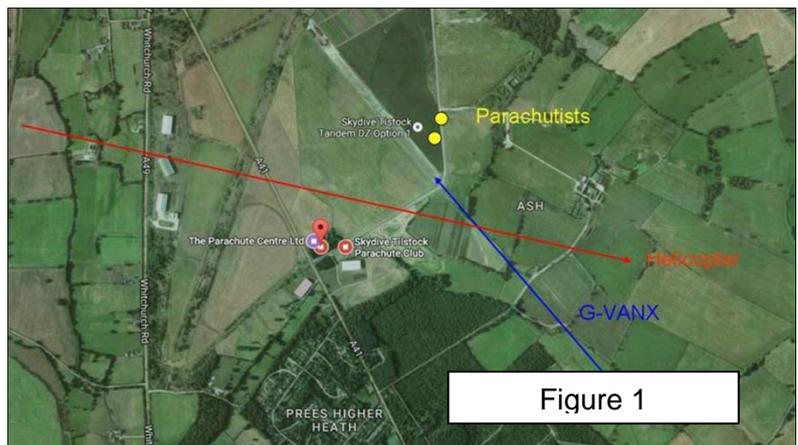
**THE AIRVAN PILOT** reports that he had just dropped 7 parachutists and was on final approach to land at Tilstock RW32 when he saw a helicopter on a relative bearing of 20° to his left, about 400m away and 200ft above, heading towards him. At the same time, the Tilstock A/G operator warned him about the potential conflict. At that time there were parachutists about to land on the Tilstock parachute landing area, which is adjacent to RW32. When he saw the helicopter he was at about 400ft AGL, 1nm final, and had all his lights on. He continued his approach and the helicopter overflew him. He reported that it did not take any evasive action and appeared to be unaware of the Airvan, or the parachutists in the air. He also commented that the helicopter appeared to be within the Tilstock 1.5nm radius 'ATZ'. The event was witnessed by some observers on the ground, one of whom filmed it on his mobile phone. Figure 1 is a diagram given by the Airvan pilot describing the relative positioning of the two aircraft as he perceived it.

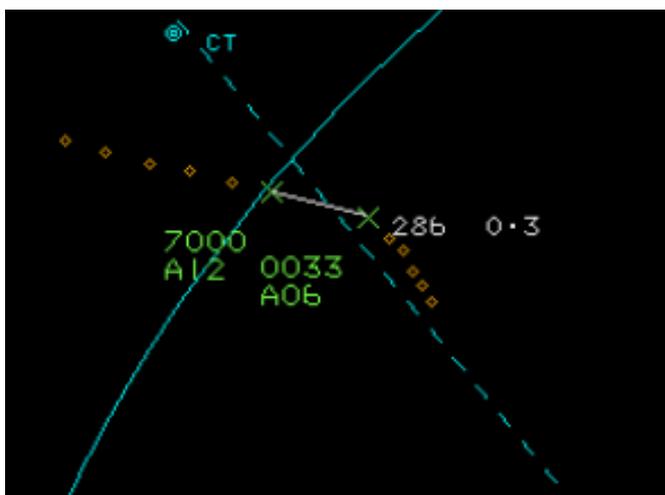
Figure 2: 1539:50

Figure 2 is a radar screen shot taken from the NATS area radar at 1539:50, the helicopter is squawking 7000 and the Airvan on final approach is squawking 0033. The area radar does not have the para-drop circle marked on the map; Tilstock is EGCT. Figure 3 taken at 1539:55 shows the helicopter crossing over the top of the Airvan, 600ft above and 0.1nm laterally.

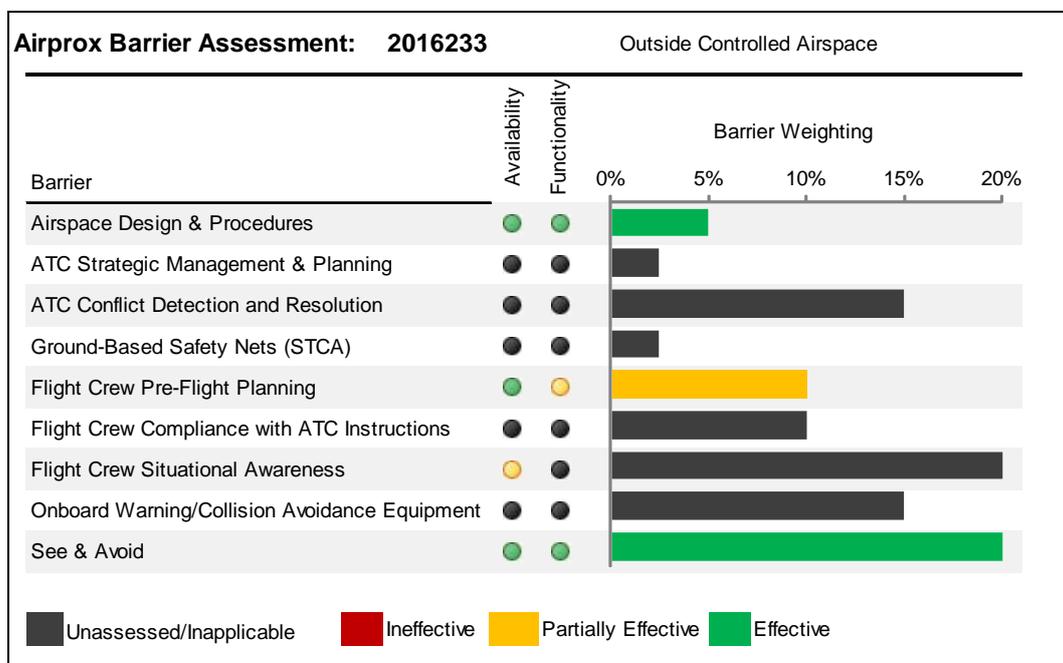
- **Flight crew pre-flight planning** was assessed as only **partially effective** at best because the helicopter pilot had not given the parachute dropping site a wider berth, which indicated that his flight planning may not have been particularly comprehensive.
- **See and Avoid** was considered to have been **effective** because the Airvan pilot had seen the helicopter in time to assess that no action was necessary.

Modern safety management processes employ the concept of safety barriers that prevent contributory factors or human errors from developing into accidents. Based on work by EASA, CAA, MAA and UKAB, the following table depicts the barriers associated with preventing mid-air-collisions. The length of each bar represents the barrier's weighting or importance (out of a total of 100%) for the type of airspace in which the Airprox occurred (i.e. Controlled Airspace or Uncontrolled Airspace).<sup>5</sup> The colour of each bar represents the Board's assessment of the effectiveness of the associated barrier in this incident (either Fully Effective, Partially Effective, Ineffective, or Unassessable/Absent). The chart thus illustrates which barriers were effective and how important they were in contributing to collision avoidance in this incident.

Without the helicopter pilot's report, assessing the effectiveness of the safety barriers associated with this incident was somewhat problematic and the Board concluded that many of the potential barriers to Airprox were either not applicable or not assessable for this incident. What was known was that the Airvan pilot was not in receipt of an ATS and did not have any onboard collision avoidance system, whether this was also true for the helicopter pilot could not be known. Of the remaining barriers, the key factors were assessed as follows:
