# **AIRPROX REPORT No 2016250**

Date: 29 Nov 2016 Time: 1433Z Position: 5313N 00009W Location: 2nm NW Horncastle

An Airprox was reported when a Chipmunk and a Helicopter flew into proximity at 1433 on Tuesday 29th November 2016. Both pilots were operating under VFR in VMC, the Chipmunk pilot in receipt of a Traffic Service from Coningsby. The EC145 pilot did not submit a report.

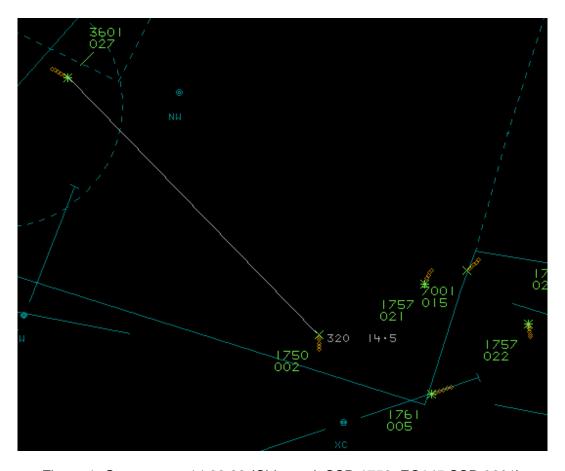
Figure 1: Geometry at 14:28:22 (Chipmunk SSR 1750; EC145 SSR 3601)

At 14:28:22 (Figure 1), the Coningsby Deps/LARS controller, who already had the Chipmunk on frequency, instructed the Coningsby Tower controller that a departing formation of Typhoon were released.

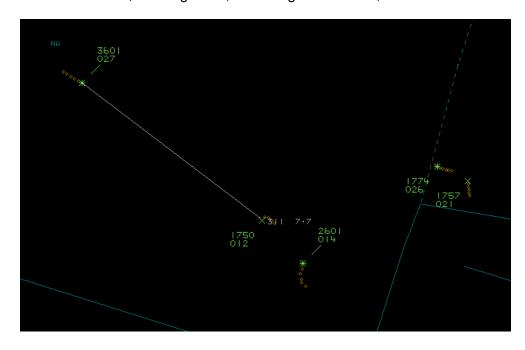
Figure 2: Geometry at 14:30:48 (Chipmunk SSR 1750; EC145 SSR 3601)

At 14:30:48 (Figure 2), the Coningsby Deps/LARS controller passed Traffic Information (TI) to the Chipmunk on traffic 2nm SE, tracking north, indicating similar level, believed to be a Tutor.

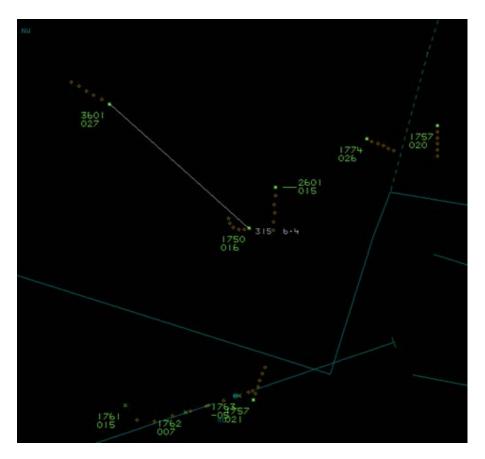
Figure 3: Geometry at 14:31:48 (Chipmunk 1750; EC145 3601; lead Typhoon 1761)

At 14:31:48 (Figure 3), the departing formation of Typhoons checked in on frequency with Coningsby Deps/Zone. Multiple transmissions between the formation and the Deps/LARS controller followed over the next 70 seconds.

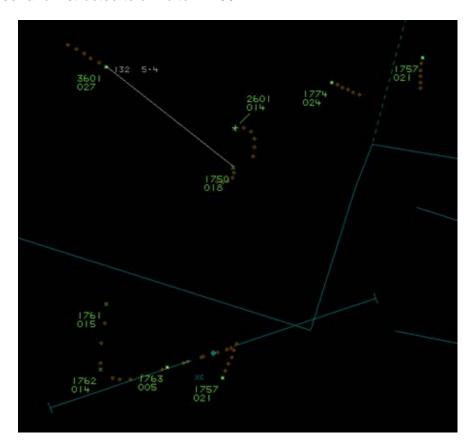
Figure 4: Geometry at 14:32:13 (Chipmunk 1750; EC145 3601; lead Typhoon 1761)

At 14:32:13 (Figure 4), the departing formation of Typhoons were informed that they were clear of a MATZ crosser and instructed to climb to FL150.

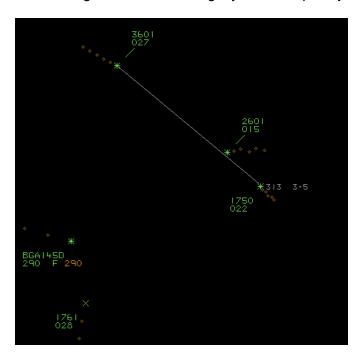
Figure 5: Geometry at 14:32:45 (Chipmunk 1750; EC145 3601; lead Typhoon 1761)

At 14:32:45 (Figure 5), TI was passed to the Typhoons on traffic in the 12 o'clock, 4nm, manoeuvring, indicating similar level. No TI was passed to the Chipmunk. At this time, Coningsby Approach began taking a handover, on behalf of Coningsby Deps/LARS, to transfer control of the EC145 from Waddington Zone to Coningsby Zone frequency.

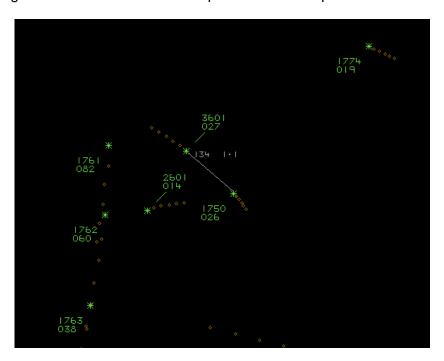
Figure 6: Geometry at 14:33:30 (Chipmunk 1750; EC145 3601; lead Typhoon 1761)

At 14:33:30 (Figure 6), Coningsby Deps/LARS released a Basic Service (BS) transit to Humberside. There was still no TI passed to the Chipmunk. The Coningsby Approach controller did not ask during the handover if TI on the Chipmunk had been passed to the EC145.

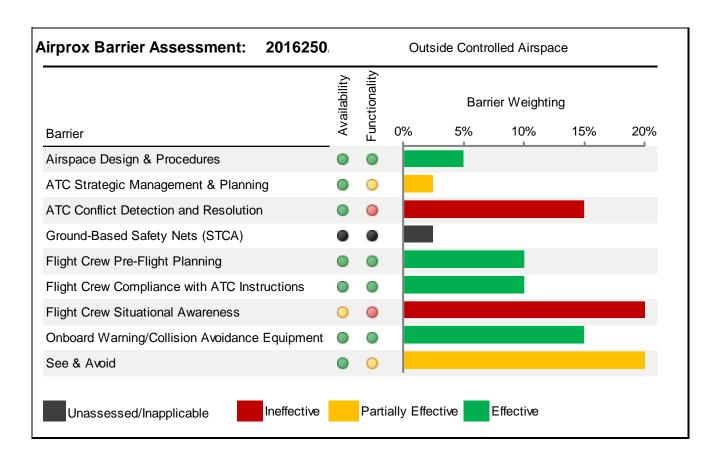
ATC Strategic Manning and Planning was considered to be only partially effective because Coningsby had reduced the number of controllers on console which resulted in bandboxed

operations and the high workload of the controller. This was exacerbated by the Supervisor not identifying the controller workload through distraction by other tasks.

**ATC Conflict Detection and Resolution** was considered to be **ineffective** because the controller did not reduce the Traffic Service and did not pass TI to the Chipmunk through not identifying the confliction.

Flight Crew Situational Awareness was also considered to be ineffective because although the Chipmunk was generically aware of the traffic in the area, he had not had specific Traffic Information on the EC145. The EC145 pilot was on a Basic Service with Waddington but had not been informed of the Chipmunk in his area.

**See and Avoid** was considered to be only **partially effective** because the Chipmunk pilot saw the EC145 late and the EC145 pilot probably did not see the Chipmunk.
