AIRPROX REPORT No 2017028

Date: 01 Mar 2017 Time: 1016Z Position: 5311N 00007W Location: 5nm N Coningsby

PART A: SUMMARY OF INFORMATION REPORTED TO UKAB

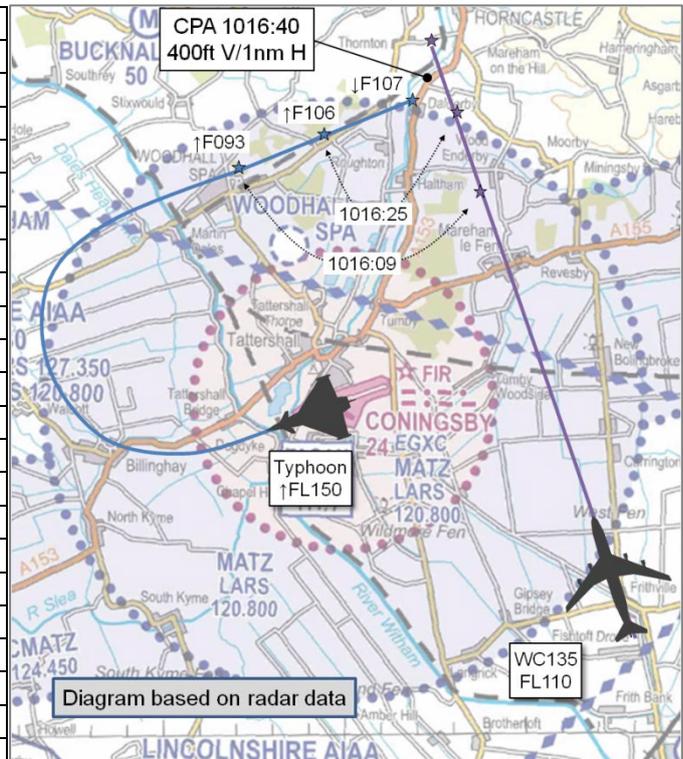
Recorded	Aircraft 1	Aircraft 2
Aircraft	Typhoon	WC135
Operator	HQ Air (Ops)	Foreign Mil
Airspace	London FIR	London FIR
Class	G	G
Rules	VFR	VFR
Service	Traffic	Traffic
Provider	Coningsby	Swanwick
Altitude/FL	FL107	FL111
Transponder	A, C, S	A, C, S
Reported		
Colours	Grey	
Lighting	Nav, Strobes	
Conditions	VMC	VMC
Visibility	>10km	
Altitude/FL	FL105	FL110
Altimeter	1013hPa	1013hPa
Heading	069°	020°
Speed	305kt	300kt
ACAS/TAS	Not fitted	TCAS II
Alert	N/A	RA
Separation		
Reported	500ft V/1nm H	0ft V/0.5nm H
Recorded	400ft V/1nm H

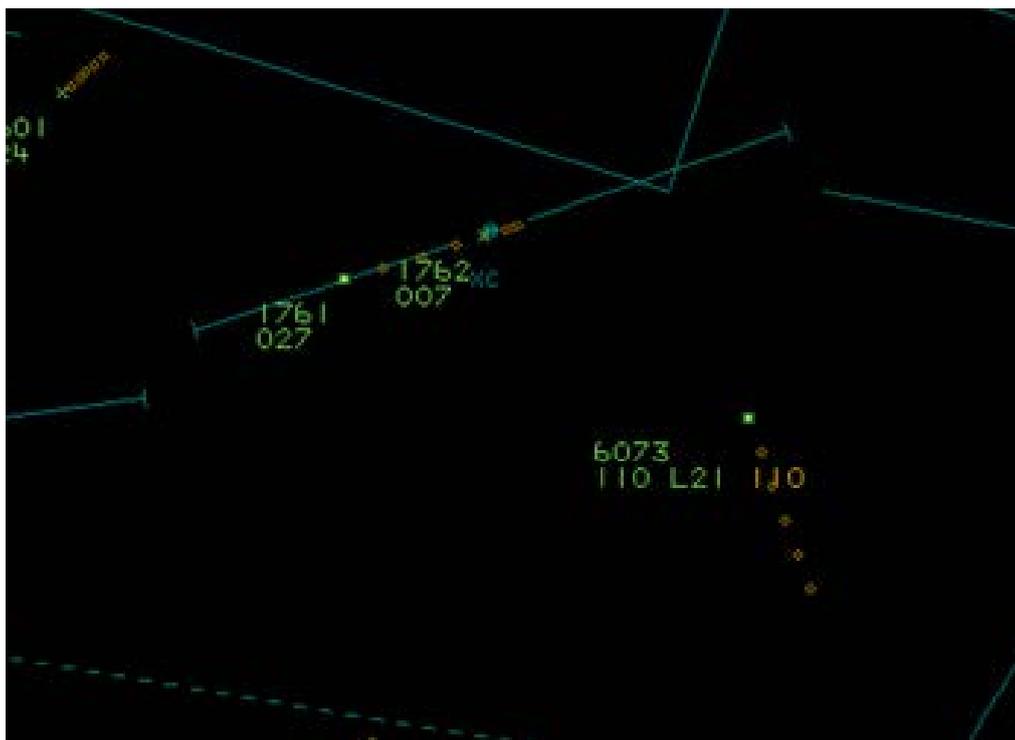
Figure 1: Geometry at 10:14:48 (Typhoon 1761; WC135 6073)

At 10:14:48 (Figure 1), the formation of Typhoons checked in with Coningsby Departures, requesting SID East, FL150 and TS. The Coningsby Departures Controller identified the formation, issued the climb and agreed TS before immediately calling Hotspur on landline to handover a different formation.

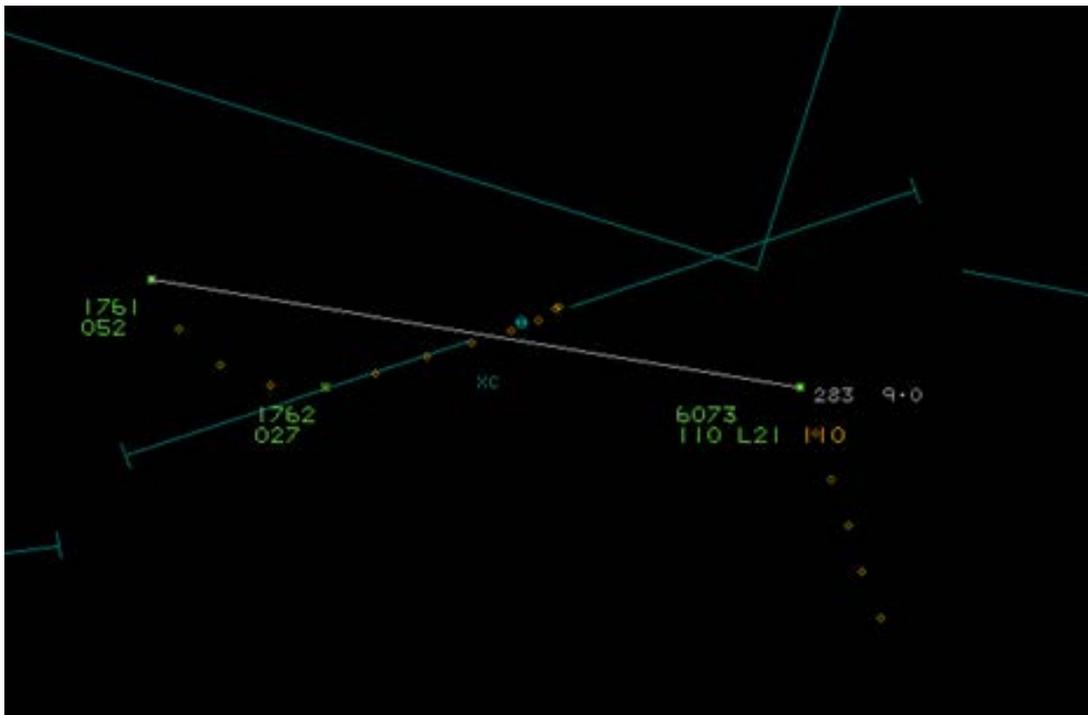
Figure 2: Geometry at 10:15:02 (Typhoon 1761; WC135 6073)

At 10:15:15 (Figure 2), the Swanwick East Tac Left passed TI to the WC135 as traffic west, approximately 5nm, indicating FL50 climbing, routing northbound.

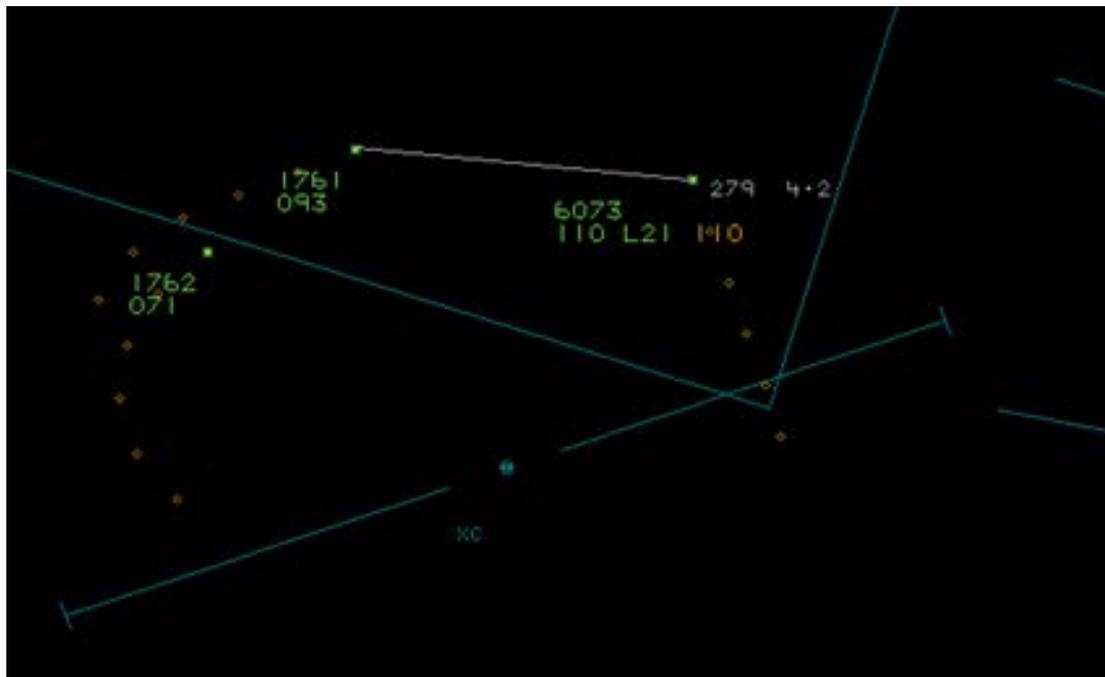
Figure 3: Geometry at 10:16:15 (Typhoon 1761; WC135 6073)

At 10:16:15: (Figure 3), the Coningsby Departures controller requested the level passing of each Typhoon in order to verify mode C. No TI was passed on the conflicting traffic. At 10:16:21, the Swanwick East Tac Left updated TI to the KC135 as traffic west, 2nm, indicating FL100 climbing.

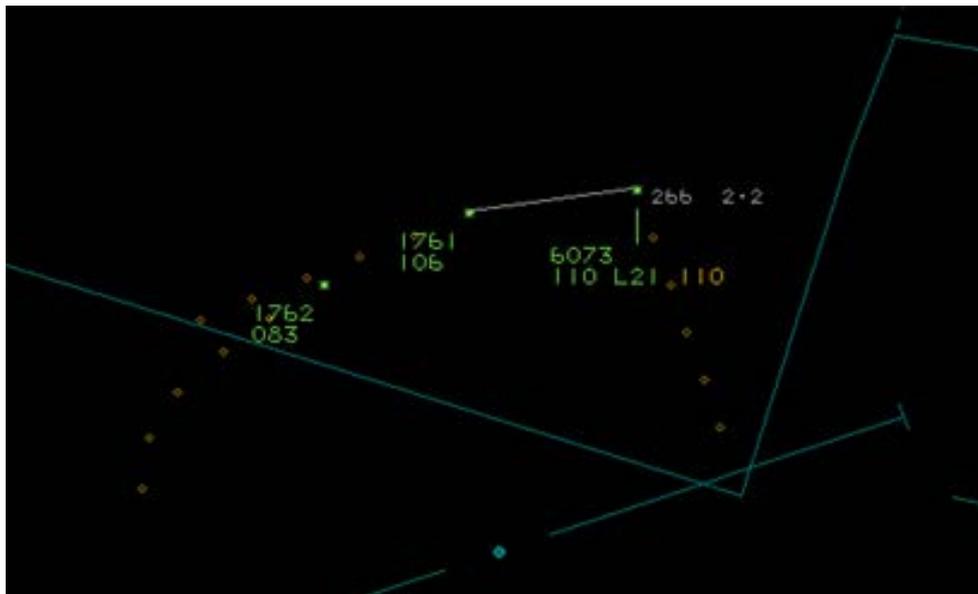
Figure 4: Geometry at 10:16:28 (Typhoon 1761; WC135 6073)

At 10:16:28 (Figure 4), the Typhoon formation was instructed to change squawk in preparation for handover to the next agency. The lead Typhoon responded that they were just passing behind 'heavy traffic' [meaning a large aircraft].

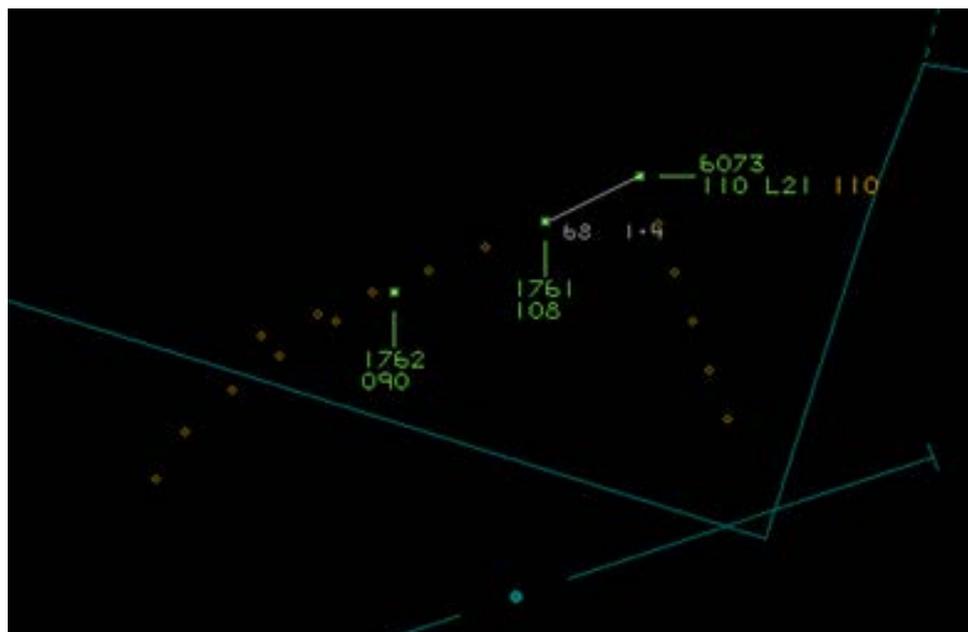
Figure 5: Geometry at 10:16:39 (Typhoon 1761; WC135 6073)

At 10:16:39 (Figure 5), the Coningsby Departures controller passed TI to the Typhoons on traffic left, 11 o'clock, 1nm, tracking north, no factor. This was the traffic the Typhoons had already stated they were passing behind, achieving a CPA of 1nm.
