AIRPROX REPORT No 2017086

Date: 10 May 2017 Time: 1208Z Position: 5201N 00316W Location: ivo Bronllys, Brecon

PART A: SUMMARY OF INFORMATION REPORTED TO UKAB

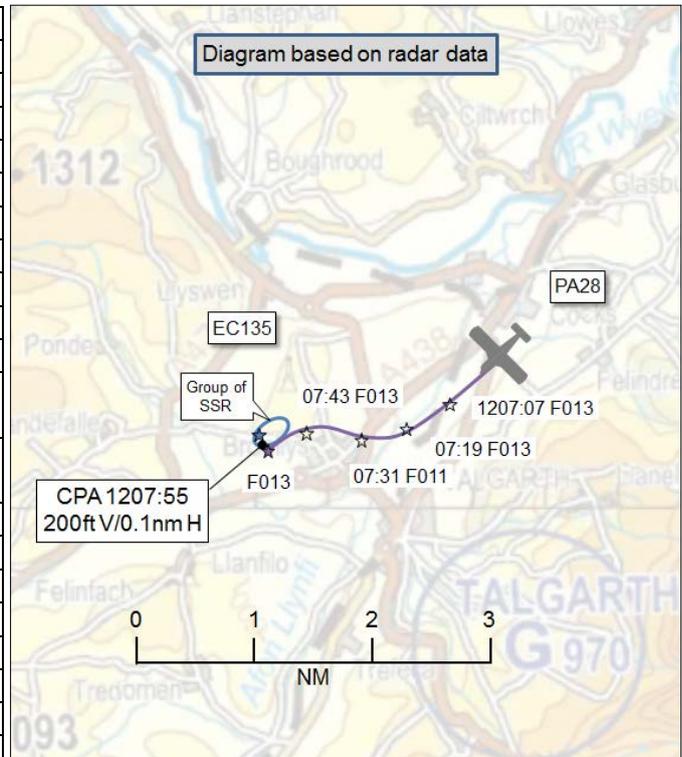
Recorded	Aircraft 1	Aircraft 2
Aircraft	EC135	PA28
Operator	Civ Comm	Civ Trg
Airspace	London FIR	London FIR
Class	G	G
Rules	VFR	VFR
Service	None	Basic
Provider	(London)	Shobden
Altitude/FL	NK	FL013
Transponder	A, C, S	A, C
Reported		
Colours	Yellow, black, day-glo	White, blue, yellow
Lighting	Strobes, HISL, landing lamps	Strobes, nav
Conditions	VMC	VMC
Visibility	>25km	30km
Altitude/FL	115ft	600ft
Altimeter	Rad Alt	agl (1009hPa)
Heading	240°	290°
Speed	10kt	115kt
ACAS/TAS	TCAS I	Not fitted
Alert	TA	N/A
Separation		
Reported	400ft V/0.5nm H	500ft V/500m H
Recorded	200ft V/0.2nm H

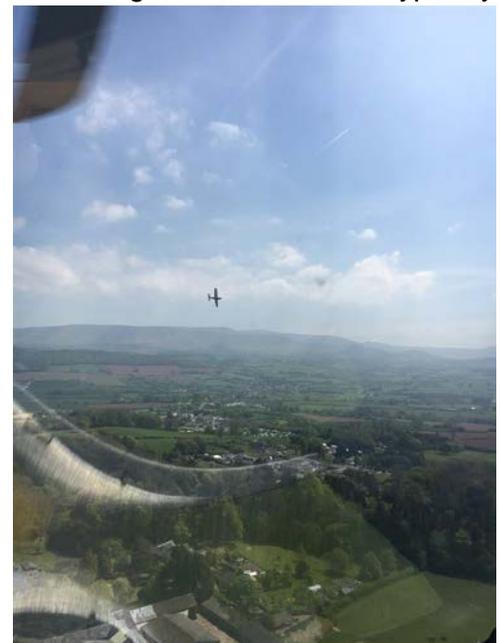
Photograph taken from the EC135

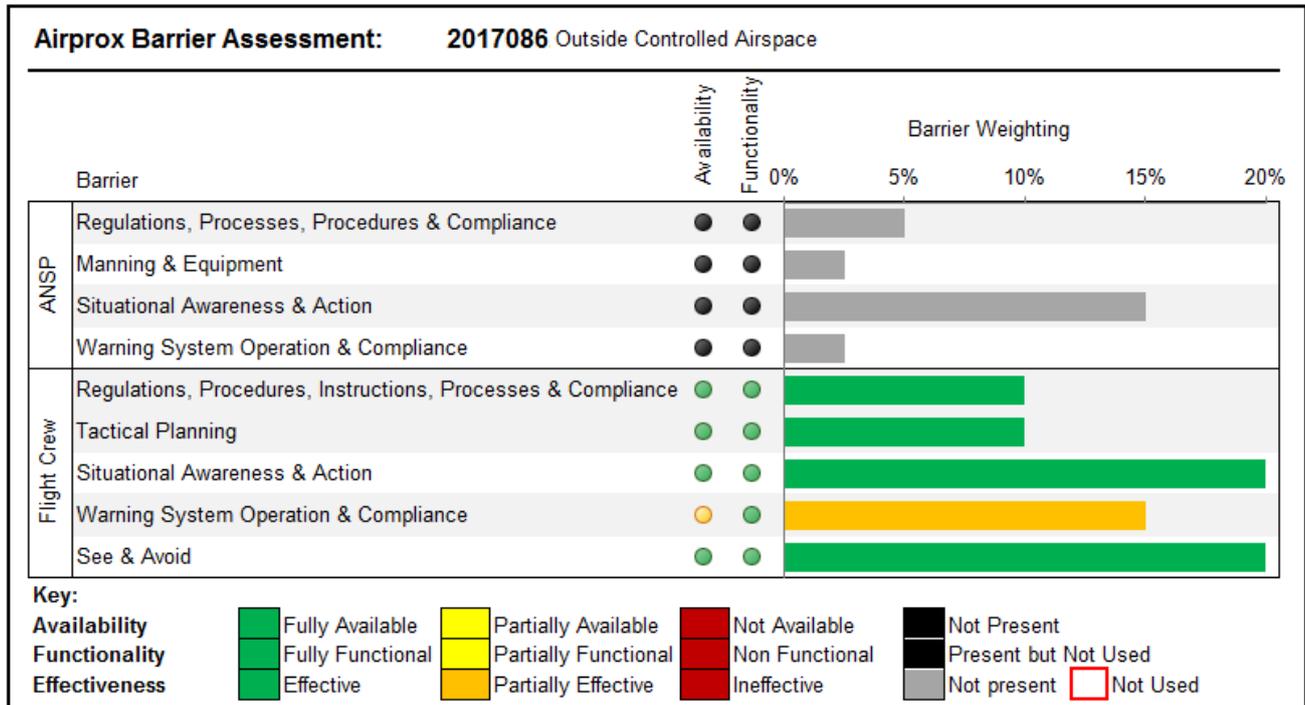
Warning System Operation and Compliance were assessed as **partially effective** because only the EC135 was equipped with a TAS/TCAS. Had the PA28 been similarly equipped then it is likely that the PA28 pilot would have become aware of the EC135 at an earlier juncture and would probably have abandoned the PFL before the aircraft came into proximity.
