AIRPROX REPORT No 2017109

Date: 31 May 2017 Time: 1446Z Position: 5111N 00144W Location: 4nm N Boscombe airfield

PART A: SUMMARY OF INFORMATION REPORTED TO UKAB

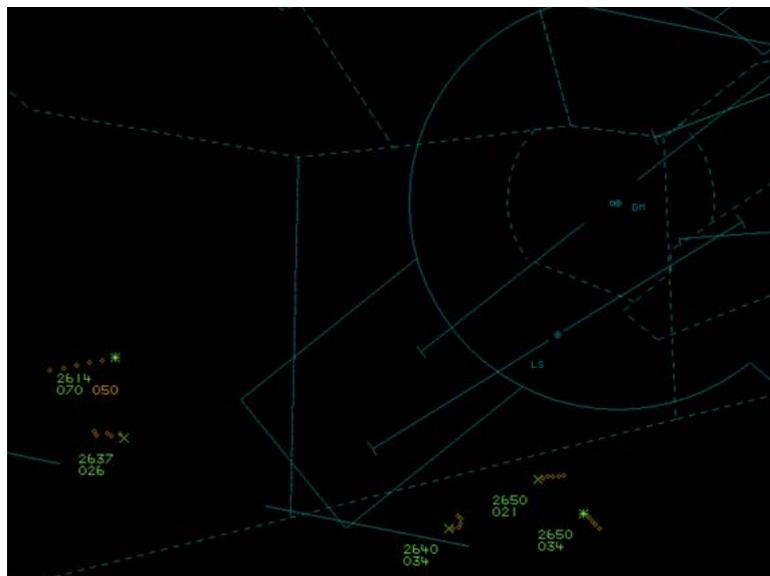
Figure 1: Geometry at 14:42:57 (BAe146 2614; C208 not seen).

At 14:42:57 (Figure 1), the Boscombe Director instructed the BAe146 pilot to descend to height 2000ft QFE 1008 while being vectored for a PAR approach to RW23RH.

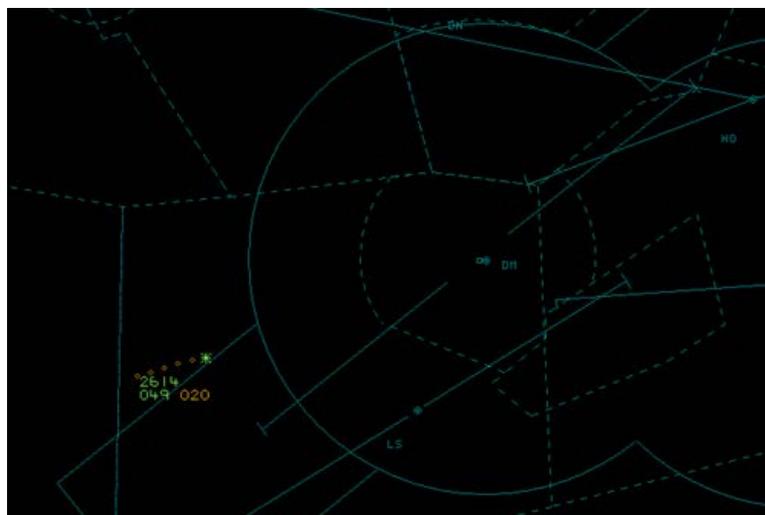
Figure 2: Geometry at 14:44:21 (BAe146 2614; C208 not seen).

At 14:44:21 (Figure 2), the Boscombe Director instructed the BAe146 pilot to turn left onto heading 050° in order to position downwind. From the screenshots, it is not certain what the location of the C208 was at this time.

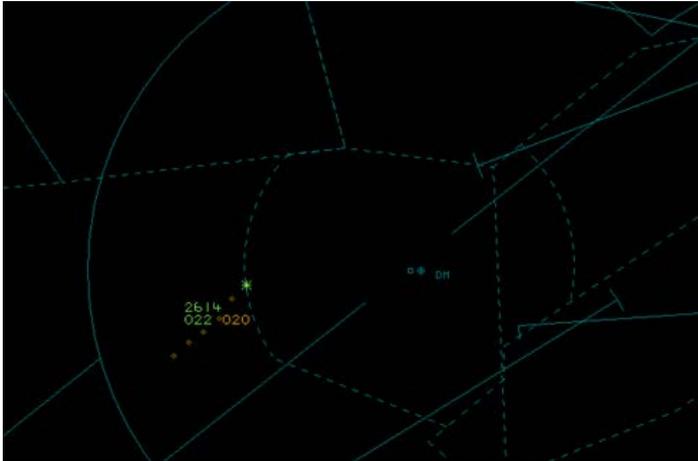
Figure 3: Geometry at 14:45:12

At 14:45:12 (Figure 3), the Boscombe Director passed Traffic Information to the BAe146 pilot on the C208 as left, 11 o'clock, 4nm, manoeuvring, indicating 700ft below, Netheravon para-dropper. The BAe146 pilot responded that he was looking but that there was nothing on TCAS.

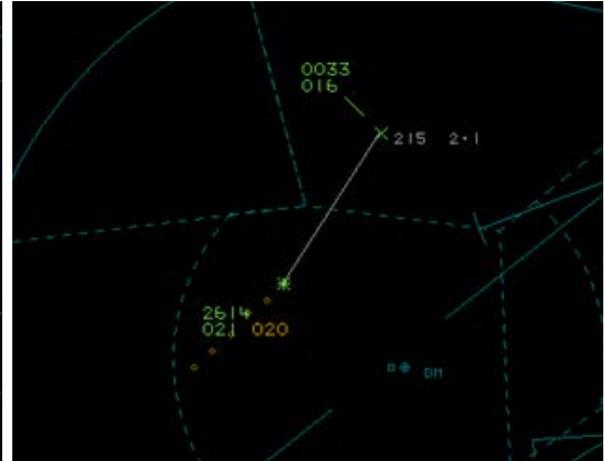
Figure 4: Geometry at 14:45:37

(BAe146 2614; C208 0033).

At 14:45:37 (Figure 4), the Boscombe Director updated the Traffic Information as 12 o'clock, 2nm, manoeuvring, indicating 300ft below. The BAe146 pilot acknowledged the Traffic Information.

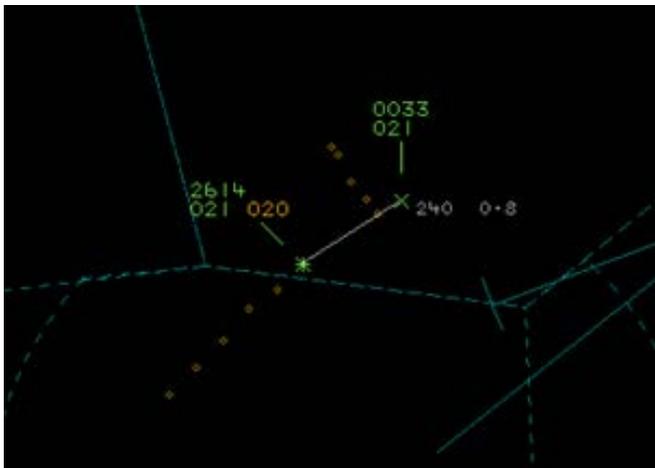
Figure 5: Geometry at 14:45:57

At 14:45:57 (Figure 5), the Boscombe Director updated the Traffic Information again, as right, 1 o'clock, 1nm, indicating similar level. The BAe146 pilot responded that the traffic had climbed across their aircraft, passing through their level.

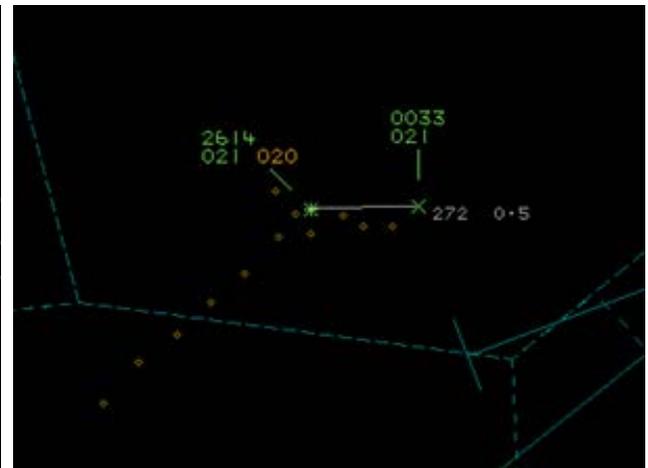
Figure 6: Geometry at 14:46:06

(BAe146 2614; C208 0033)

At 14:46:06 (Figure 6), the 2 aircraft passed at their CPA of approximately 0.5nm laterally and same height vertically, as the C208 pilot turned back onto a northwesterly track and continued climb.

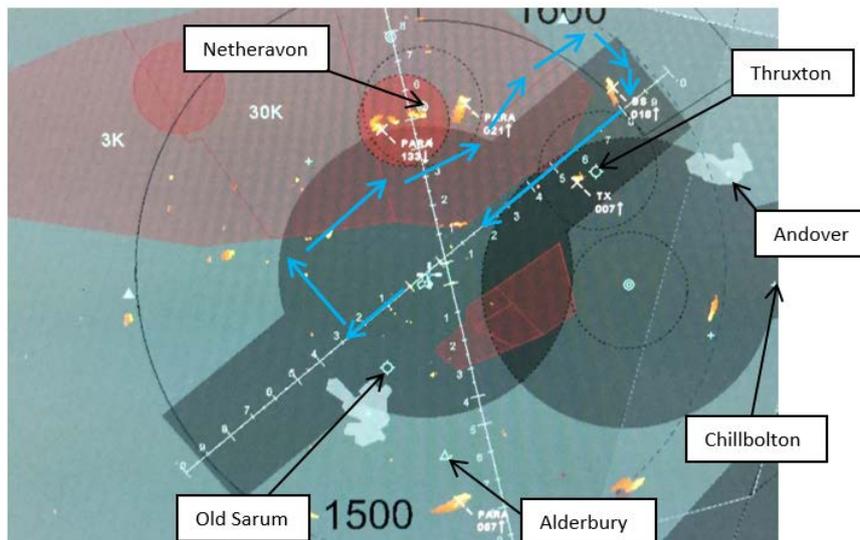
Figure 7: Boscombe Down RTC.

The Boscombe Down Radar Training Circuit (RTC) (Figure 7) is normally flown at height 2000ft QFE to the north of the aerodrome due to the proximity of other aerodromes, and associated high traffic density, to the south. It is a complex piece of airspace, requiring caution not to conflict with other inbound instrument traffic.

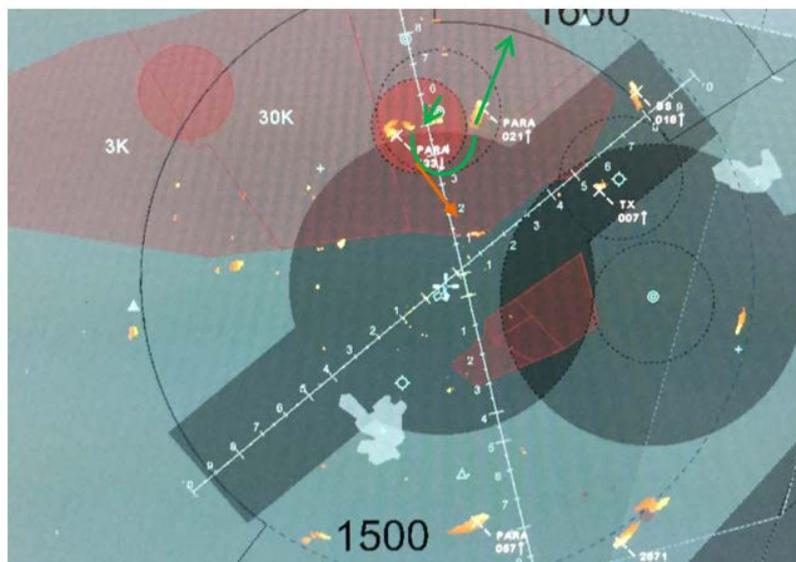
Figure 8: Netheravon Paradrropping Profiles.

A standard profile for para-dropping at Netheravon (Figure 8) when operating from RW22 is a climb out in the left-hand turn, remaining within the lateral confines of the ATZ, which is displaced from the drop zone, until tracking north-northeast (green arrows). There are no height restrictions imposed and it is deemed safe for Boscombe Down traffic to overfly the Netheravon ATZ avoiding the drop zone. Sorties are notified to Boscombe Zone on Box 2, on which the C208 pilot was listening out, though no ATS is provided. On this occasion, the C208 pilot flew further southeast (orange arrow) than expected before turning back northbound.

The Board agreed that there was a considerable degree of ambiguity about the operation of parachute aircraft from Netheravon within the associated LoA. Apart from the communication procedures, there were no other formal agreements about the routing of the parachute aircraft, and Boscombe ATC seemed just to expect the aircraft not to enter their airspace. Accordingly, the Board resolved to make a recommendation that Boscombe Down and Netheravon agree a robust LoA concerning parachuting ops from Netheravon.

<u>Cause:</u>	The BAe146 pilot was concerned by the proximity of the C208.
<u>Degree of Risk:</u>	C.
<u>Recommendation:</u>	HQ Air Command and Netheravon agree a robust LoA with respect to parachuting operations from Netheravon and the implications for Boscombe Down operations.

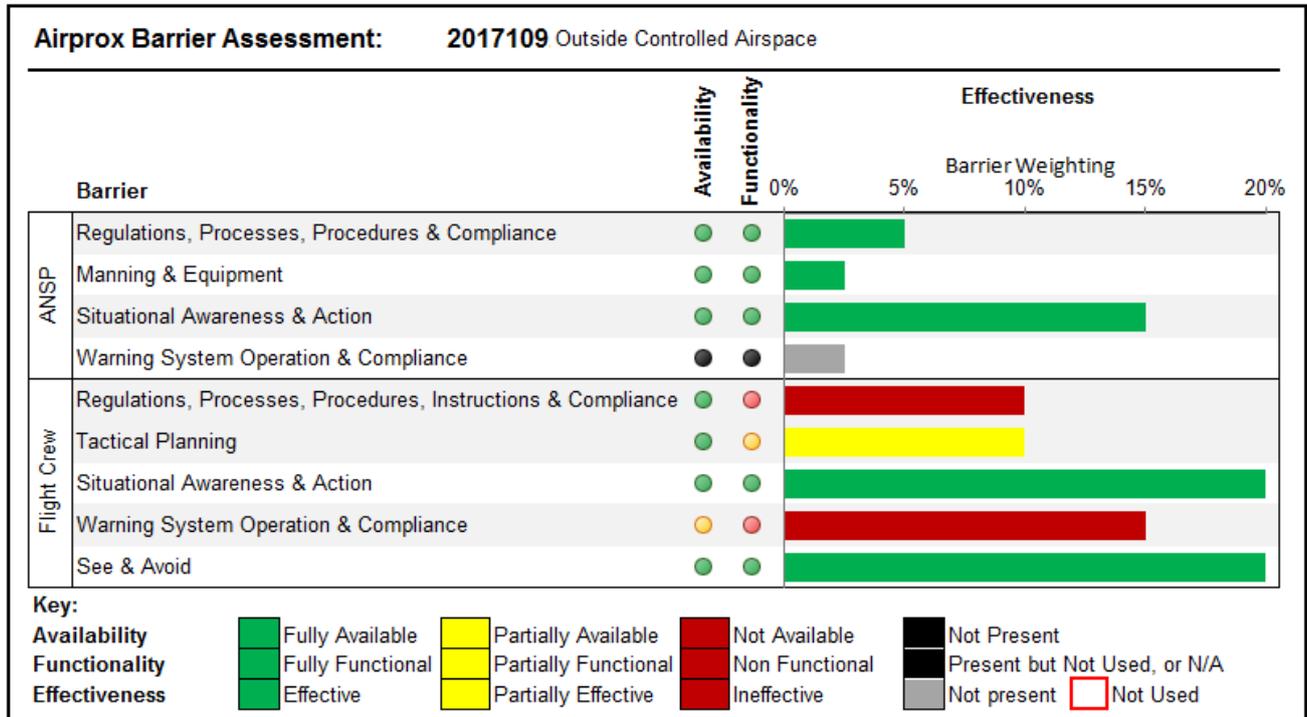
In assessing the effectiveness of the safety barriers associated with this incident, the Board concluded that the key factors had been that:

Regulations, Processes, Procedures and Compliance were assessed as **ineffective** because there was ambiguity within the LoA about para-dropping aircraft routing and the expectation by Boscombe ATC that the C208 pilot would remain outside their airspace. Additionally Boscombe Zone was unable to contact the C208 pilot who was required to listen out on their frequency.

Tactical Planning was assessed as **partially effective** because the C208 either did not plan to remain clear of Boscombe's airspace, or was unaware of the requirement to climb within the Netheravon ATZ.

Warning System Operation and Compliance were assessed as **partially available** because only the BAe146 was equipped with an electronic system. Overall, the barrier was assessed as **ineffective** because the warning system did not alert.
