**AIRPROX REPORT No 2017155**

Date: 06 Jul 2017 Time: 1108Z Position: 5138N 00047W Location: Wycombe Air Park

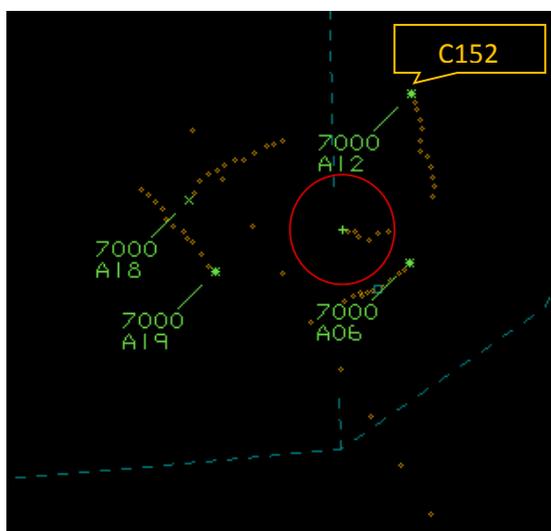
Figure 1 - 1101:58  
(primary-only radar contacts outlined in red)

At 1101:58 the C152 was observed on the radar replay to be crosswind. At this point, a primary-only radar contact was observed inside the visual circuit just to the north/north west of the Airfield (Figure 1). This primary-only radar contact faded in and out of radar cover and it was not possible to continuously track the aircraft on radar. However, it was established from the R/T recording that glider operations and helicopter activity were taking place to the north of RW06 at this time.

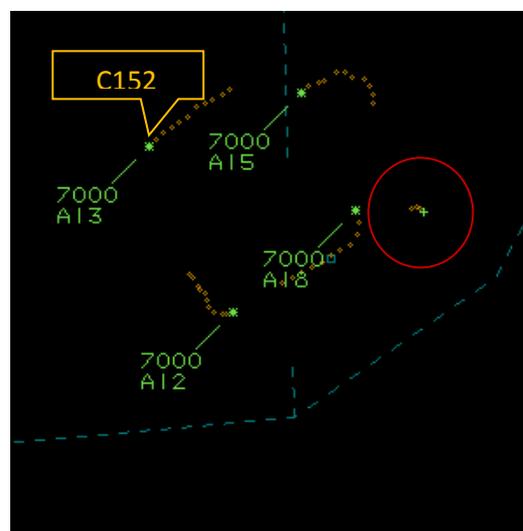
Figure 2 - 1103:39

At 1103:39, another primary-only radar contact appeared upwind of the climb out lane for RW06 (Figure 2). This radar contact faded from radar cover almost immediately.

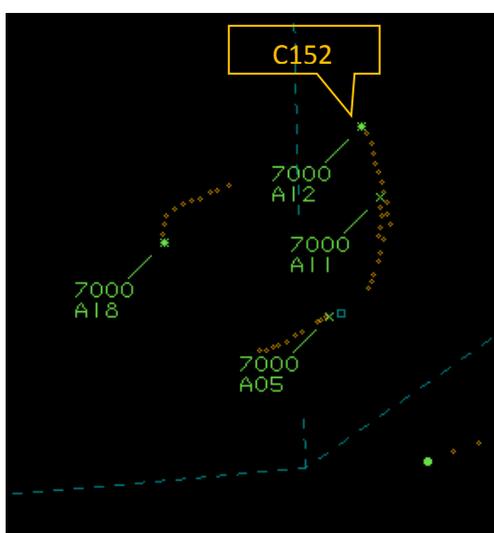
Figure 3 - 1108:00

The Airprox reportedly occurred at 1108:00 when the C152 was crosswind (Figure 3). At this time there were no primary-only radar contacts displayed on the radar replay.

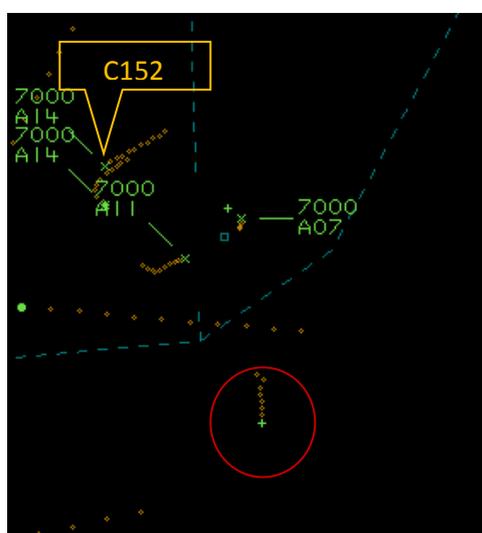
Figure 4 - 1109:57

At 1109:57 a primary-only radar contact displayed on radar replay to the south of Wycombe tracking south and eventually faded from radar cover to the west of White Waltham (Figure 4). Attempts were made by Wycombe ATC to trace the aircraft but these attempts were unsuccessful and it was not possible to confirm the identity of the reported conflicting aircraft at the time.

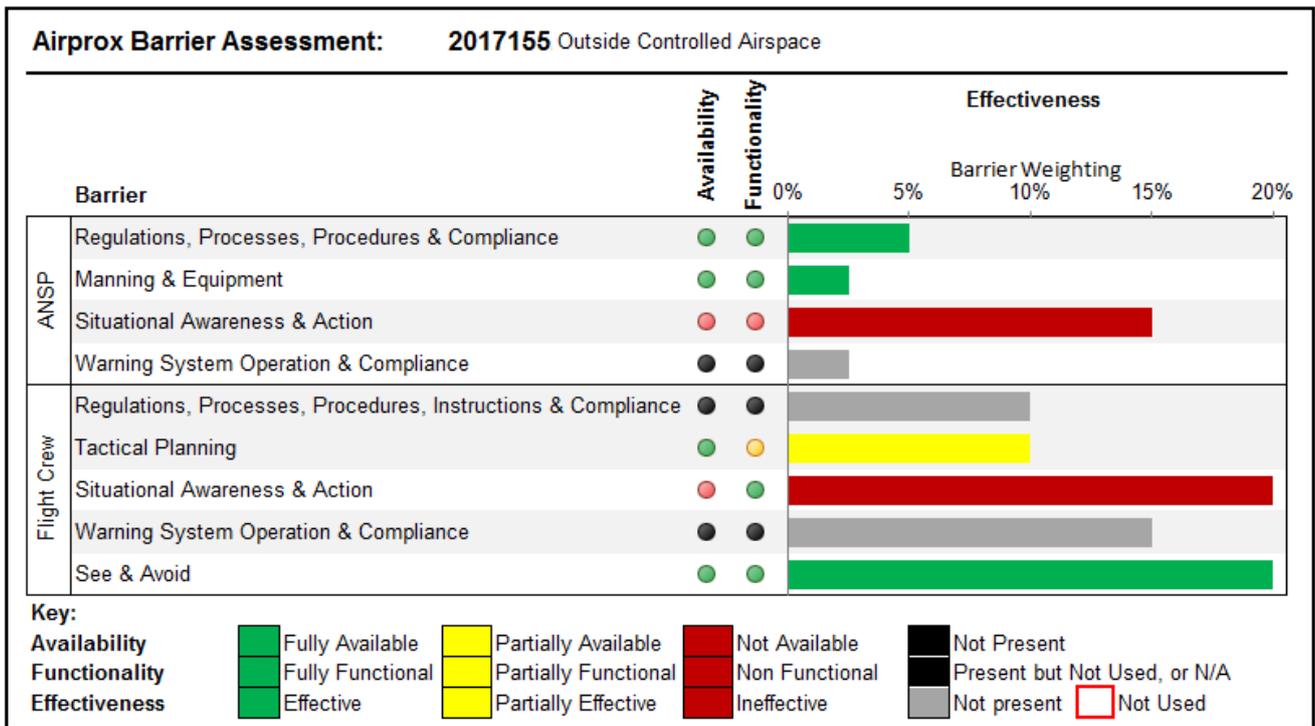
**Situational Awareness & Action** was assessed as ineffective because Wycombe ATC were not speaking to the Chilton pilot and therefore had no knowledge that he was there.

**Regulations, Processes, Procedures, Instructions & Compliance** were unable to be assessed because it was not known whether the Chilton pilot was inside, or outside the Wycombe ATZ.

**Tactical Planning** was assessed as partially effective because the Chilton pilot could have given Wycombe ATC a call to let them know he was transiting close by if he had a radio, and could have planned to avoid the ATZ by a greater margin.

**Situational Awareness & Action** was assessed as ineffective because the C152 pilot did not know the Chilton pilot was in the vicinity, and if the Chilton pilot was aware of the C152 as he stated he did not take sufficient action to avoid it.

**Warning System Operation and Compliance** was assessed as not present because the C152 was not fitted with a CWS and the Chilton was not transponder equipped.

**See and Avoid** was assessed as fully effective because both pilots saw each other with enough time to take action, (or decide that no action was necessary).

See overleaf for the Safety Barrier Assessment depiction.
