AIRPROX REPORT No 2017166

Date: 12 Jul 2017 Time: 1200Z Position: 5558N 00315W Location: Edinburgh

PART A: SUMMARY OF INFORMATION REPORTED TO UKAB

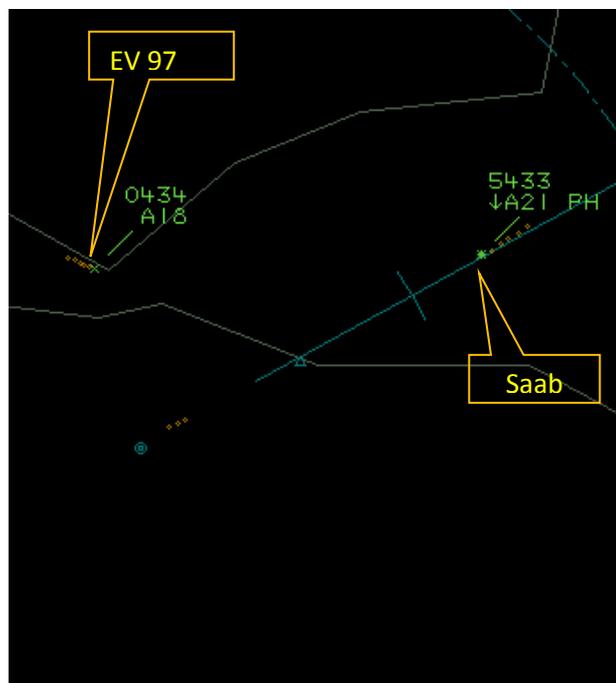
Figure 1 - 1216:10

At 1209:10, the EV97 pilot checked in on the AIR frequency and the AIR controller instructed him to report at the bridges. The pilot provided an accurate read back. At 1216:10, he reported at the bridges and was displayed on the radar replay proceeding eastbound along the Forth (Figure 1). The AIR controller instructed the EV97 to continue towards the airfield with a clearance limit of the northern aerodrome boundary. The controller advised that there was an SF34 on 6 mile final for RW24 and requested that the EV97 pilot report that traffic in sight. The EV97 pilot responded and said he would keep visual. The controller responded with a request to confirm when traffic was in sight and advised that it was now 5nm final. The EV97 pilot replied that he would report traffic in sight. At this time the radar replay displayed a steady stream of inbound IFR aircraft for RW24, with the SF34 No1 and the A320, who subsequently reported the Airprox, No2 for the approach.

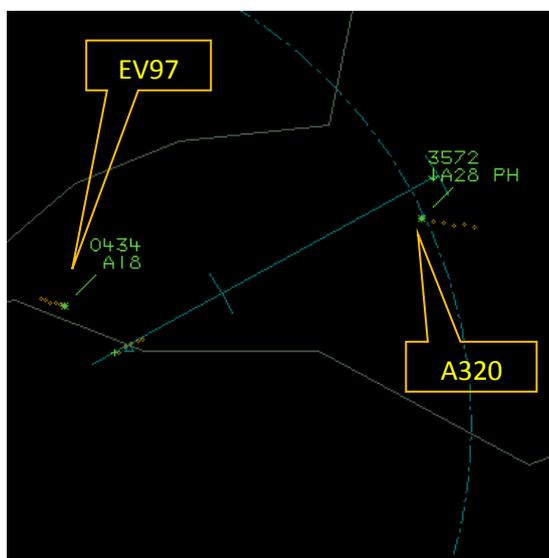
Figure 2 - 1217:40

At 1217:40, the radar replay displayed the EV97 slightly north of the final approach track at 2.5nm still tracking eastbound (Figure 2). The AIR controller advised the EV97 pilot that there was an A320 just turning onto an 8 mile final, (unfortunately there is a gap in the R/T recording and the response from the pilot is not captured). The Edinburgh unit investigation report states that the controller went on to say “for RW24” and the EV97 pilot responded with “roger that”.

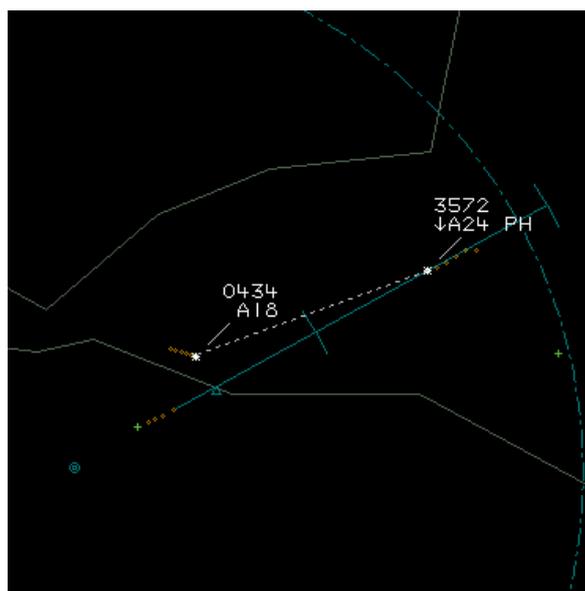
Figure 3 - 1218:20

At 1218:00, the AIR controller instructed the EV97 to track south easterly to clear the extended centreline. The pilot acknowledged the instruction. At 1218:20, the A320 pilot checked in with the AIR controller at 8nm final and the controller instructed him to continue approach RW24, advised that they were just becoming No1, and passed Traffic Information as ‘right to left about a 3 mile final, a microlight, not above altitude 2000ft VFR’. The A320 pilot acknowledged the Traffic Information. At this time the EV97 was displayed on the radar replay north abeam the final approach track at 3nm and still tracking eastbound (Figure 3).

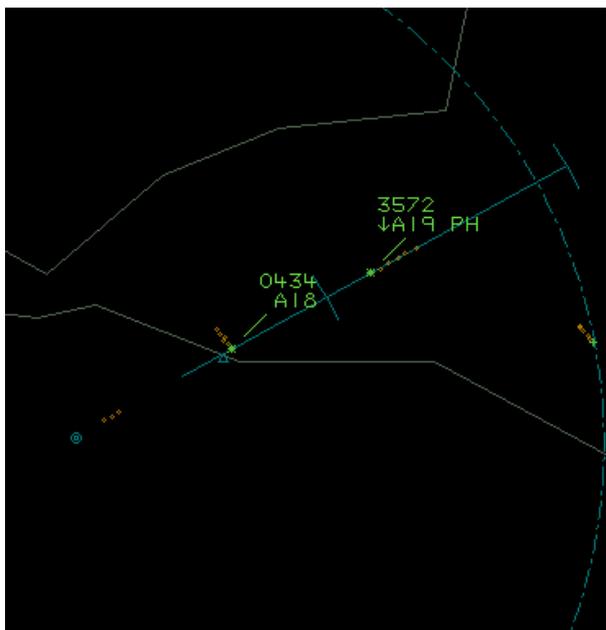
Figure 4 - 1218:52

At 1218:52, the EV97 crossed the final approach track at 3nm final, with the A320 at 6nm final. The A320 altitude indicated 1900ft and the EV97, 1800ft (Figure 4).

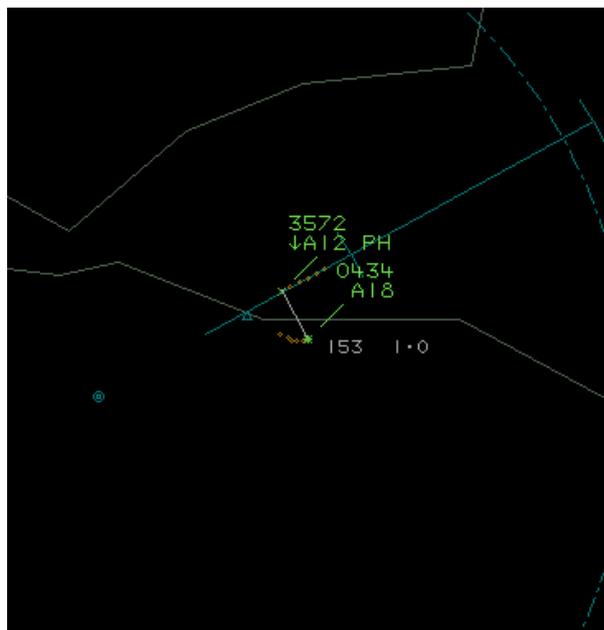
Figure 5 - 1219:44

At 1219:02, the EV97 pilot reported that he had cleared the final approach track and the controller responded with an instruction to route direct to Musselburgh. The EV97 pilot did not respond but was observed on the radar replay to turn to the east. CPA occurred at 1219:44 (Figure 5), where there was 1nm laterally and 600ft vertically between the two aircraft.

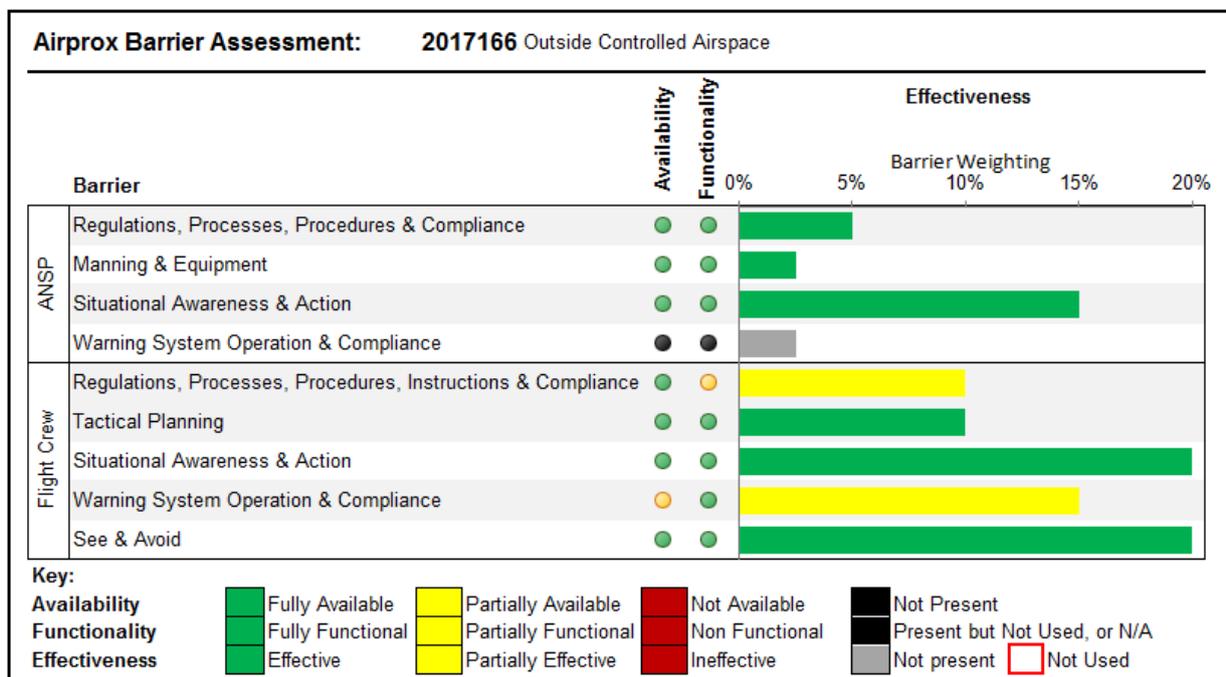
In assessing the effectiveness of the safety barriers associated with this incident, the Board concluded that the key factors had been that:

Regulations, Processes, Procedures & Compliance was assessed as **fully effective**; all the appropriate procedures were adhered to.

Regulations, Processes, Procedures, Instructions & Compliance was assessed as **partially effective** because the EV97 pilot only partially complied with ATC instructions.

Warning System Operation and Compliance was assessed as **partially effective** because the EV97 did not have a CWS.

See and Avoid was assessed as **fully effective** because the A320 pilot had seen the EV97 in enough time to judge that a go-around was not required.
