**AIRPROX REPORT No 2017252**

Date: 20 Oct 2017 Time: 1023Z Position: 5417N 00122W Location: Topcliffe

**PART A: SUMMARY OF INFORMATION REPORTED TO UKAB**

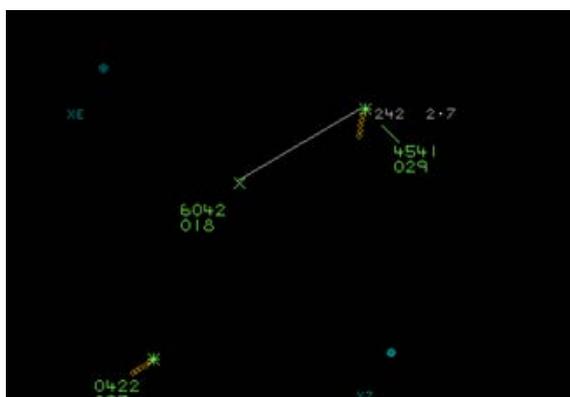
Figure 1: Geometry at 10:22:46

Figures 1-6 show the positions of the Hawk formation and Tutor at relevant times in the lead up to and during the Airprox. The screen shots are taken from a replay using a NATS radar, which is not used by Leeming or Linton-on-Ouse ATC and therefore is not representative of the picture available to any of the controllers involved. Figure 1 is the first instance the Hawk formation showed on radar replay, though it was visible to the Leeming Approach Controller on climb out.

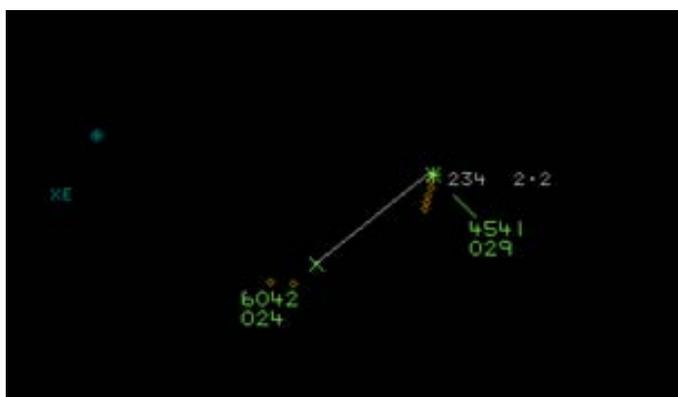
Figure 2: Geometry at 10:22:52

(Hawk squawking 6042, Tutor squawking 4541)

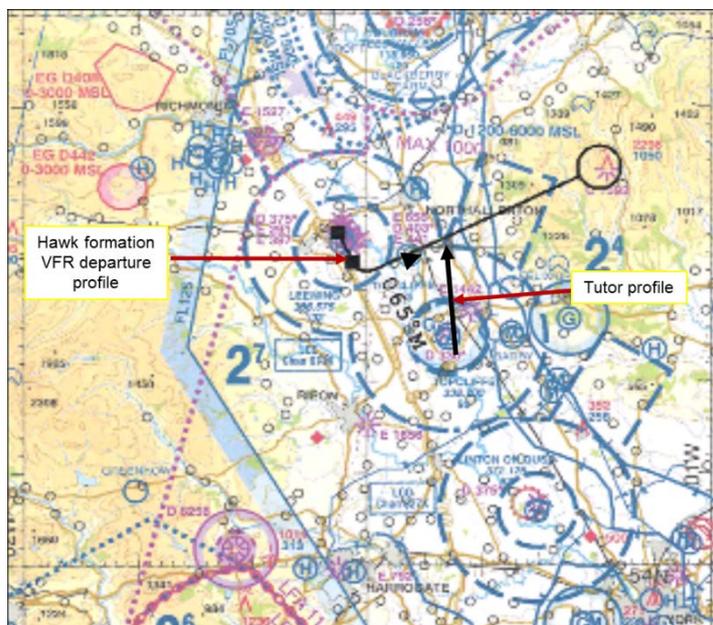
Figure 8: Hawk and Tutor profiles depicted on map (as determined in the OSI)

A comprehensive Occurrence Safety Investigation (OSI) took place with collaboration between RAF Leeming and RAF Linton-on-Ouse. Recommendations were made, including the introduction of mandatory call for release in Leeming ATC when the Topcliffe MATZ is active, publicising the benefits of traffic-specific call for release, and a review of the local airspace management procedures between Leeming and Linton ATC.

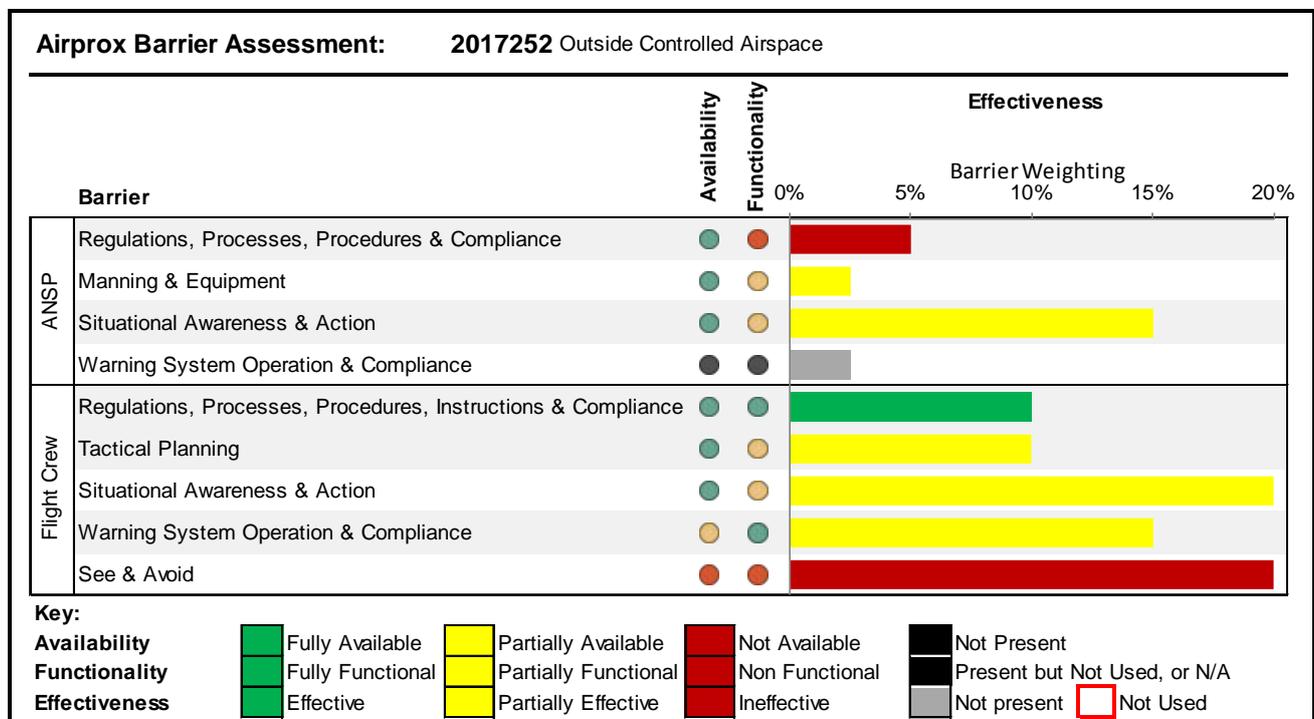
In assessing the effectiveness of the safety barriers associated with this incident, the Board concluded that the key factors had been that:

**Regulations, Processes, Procedures and Compliance** were assessed as **ineffective** because ATC released the Hawk into conflict.

**Manning and Equipment** were assessed as **partially effective** because the Approach controller was overtasked by the Supervisor, who was trying to protect the Director.

**Situational Awareness and Action** were assessed as **partially effective** because the Approach controller did not realise that the 'call for release' restriction was put in place against the Tutor.

**Tactical Planning** was assessed as **partially effective** because the Hawk pilot had planned for a VFR departure, but couldn't maintain VMC.

**Situational Awareness and Action** were assessed as **partially effective** because the Hawk pilot was given Traffic Information on the Tutor at 4nm but continued towards it.

**Warning System Operation and Compliance** were assessed as **partially effective**; only the Tutor was fitted with TAS, the Hawk did not have any CWS.

**See and Avoid** were assessed as **ineffective**, both pilots were in cloud and neither saw the other aircraft.
