**AIRPROX REPORT No 2017272**

Date: 01 Dec 2017 Time: 1058Z Position: 5348N 00150E Location: Below EGD323D

**PART A: SUMMARY OF INFORMATION REPORTED TO UKAB**

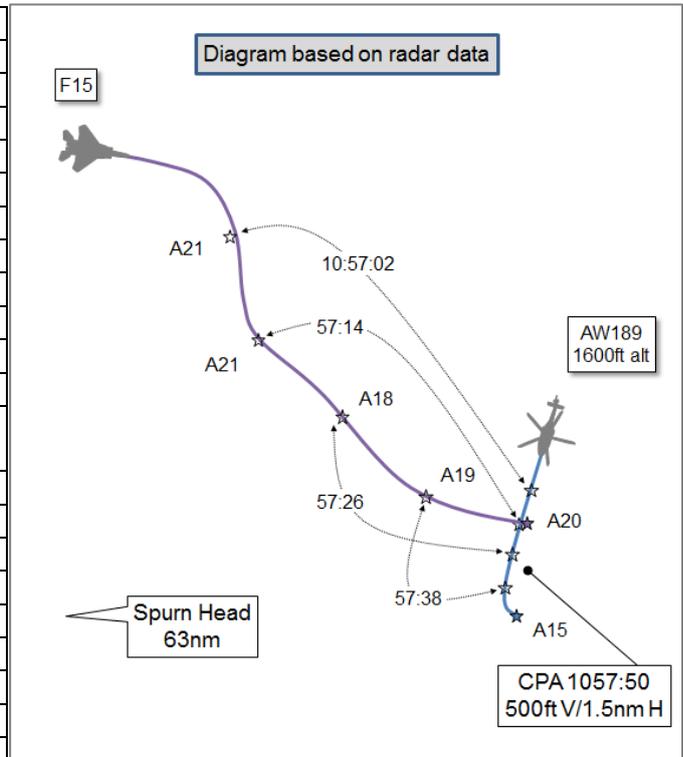
Recorded	Aircraft 1	Aircraft 2
Aircraft	AW189	F15
Operator	Civ Comm	Foreign Mil
Airspace	London FIR	London FIR
Class	G	G
Rules	IFR	VFR
Service	Deconfliction	None
Provider	Anglia Radar	N/A
Altitude/FL	1500ft	2000ft
Transponder	A, C, S	A, C, S
<b>Reported</b>		
Colours	Blue, white	Grey
Lighting	Strobes, nav, position	Anti-col, nav, position
Conditions	VMC	VMC
Visibility	>10km	>50nm
Altitude/FL	1500ft	1600ft
Altimeter	QNH (1015hPa)	Rad Alt
Heading	195°	110°
Speed	140kt	515kt
ACAS/TAS	TCAS II	Not fitted
Alert	TA	N/A
<b>Separation</b>		
Reported	0ft V/2nm H	100ft V/2nm H
Recorded	500ft V/1.5nm H

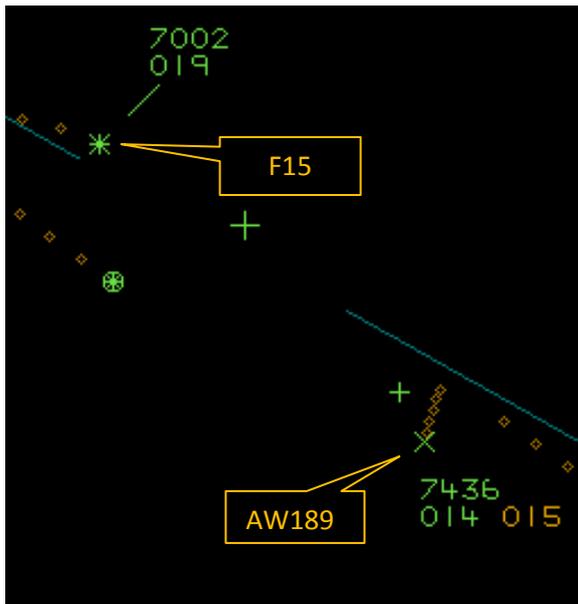
Figure 1 – 1056:50

At 1050:00, the AW189 was still not showing on the controller's radar display and the controller passed further generic Traffic Information to the AW189 pilot, advising that there was a military contact about 5nm southeast of Schooner, tracking northwest and indicating altitude 3500ft. The pilot responded that they were looking, they made a comment about the cloud base and then called visual with the military aircraft. At 1055:00, the controller instructed the AW189 pilot to squawk ident and went on to identify the aircraft and advise the pilot that they may receive late or no warning of the military traffic from low-level, due to them appearing and disappearing on the radar and that they would keep the pilot advised. At 1056:50, the controller passed Traffic Information to the AW189 pilot, advising that there was military traffic in their 4 o'clock position, 8nm distant, that it would be passing behind right to left, and was indicating 2000ft. The pilot responded that they were looking (Figure 1).

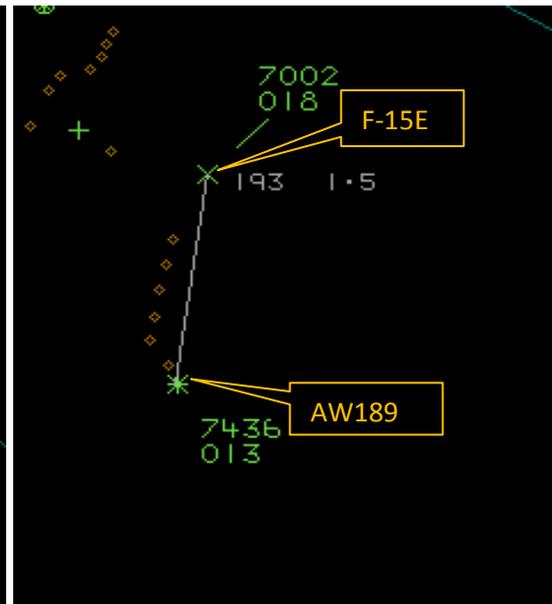
Figure 2 – 1057:52

At 1057:20, the controller passed an avoiding action left turn on to 090° and updated the position of the military traffic as being northwest of the AW189 by 5nm, the pilot acknowledged the avoiding action turn and the controller then updated the Traffic Information, advising that the traffic was now just north of the AW189 by 2nm and that it was passing behind right to left. The controller then instructed the pilot to turn right heading 180°. The pilot acknowledged the heading change and advised the controller that they were now visual with the traffic and that it was passing down their left-hand side at the same level, about 2nm away. The pilot advised the controller that they would be filing a report and the controller commented that the aircraft appeared to change track at the last minute. CPA occurred at 1057.52 over the Southern North Sea in Class G airspace with the aircraft separated by 1.5nm laterally and 500ft vertically (Figure 2).

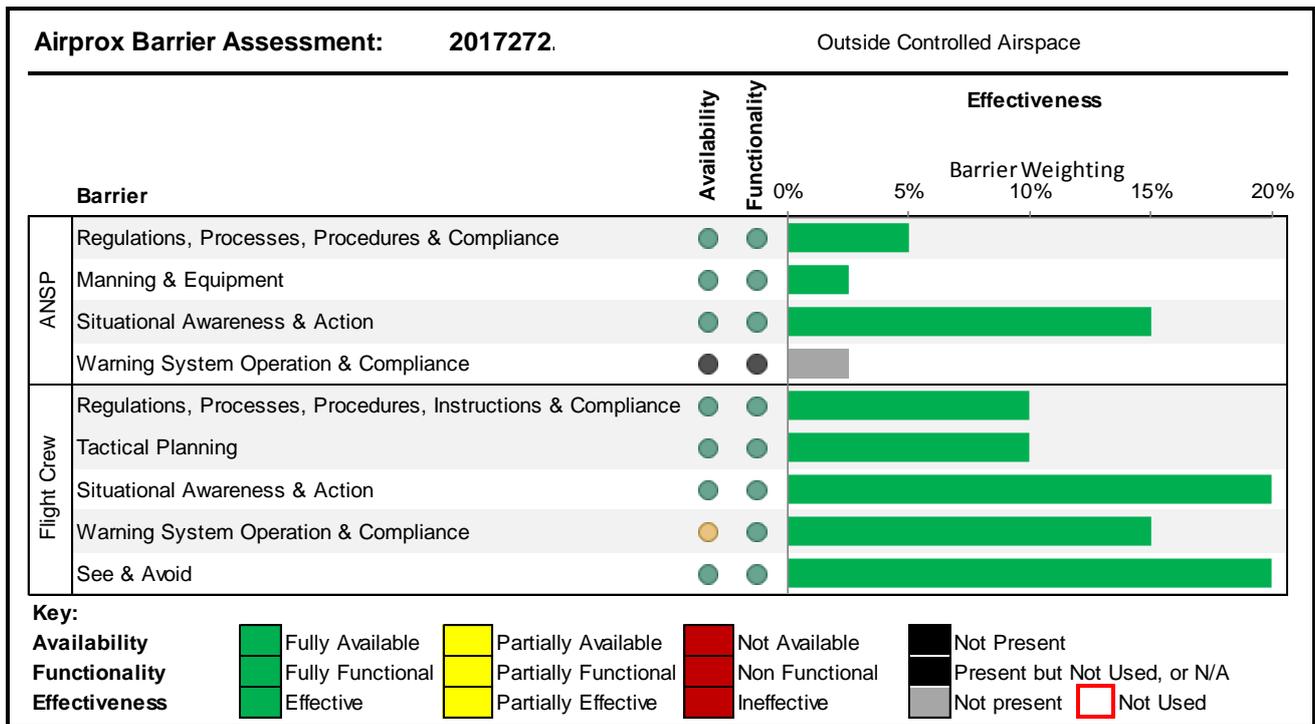
In assessing the effectiveness of the safety barriers associated with this incident, the Board concluded that the key factors had been that:

**Warning System Operation and Compliance** were assessed as **not used** because the Anglia Radar console was not configured with an automatic warning system.

**Warning System Operation and Compliance** were assessed as **effective** on the part of the AW189 but only **partially available** because the F15 was not fitted with a TAS or CWS.
