AIRPROX REPORT No 2017051

Date: 05 Apr 2017 Time: 1415Z Position: 5310N 00001E Location: NE Coningsby

PART A: SUMMARY OF INFORMATION REPORTED TO UKAB

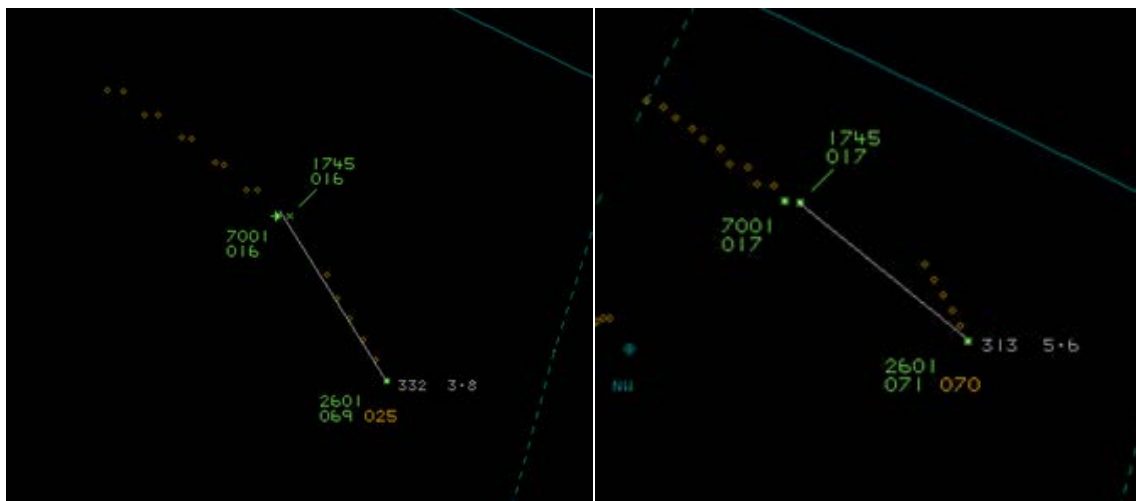
Figure 1: Geometry at 14:12:33

At 14:12:33 (Figure 1), the pair of Typhoons free-called Coningsby Approach, having pulled up from low-level. The lead aircraft had already selected the Coningsby 'recovery' squawk and the second aircraft had retained the low level squawk.

(Typhoons 1745/7001; King Air 2601)

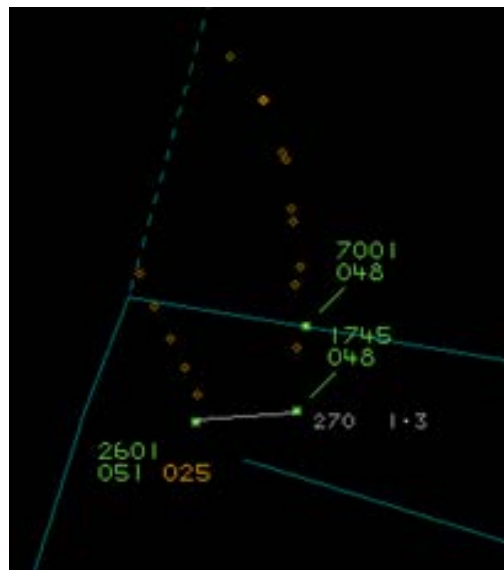
Figure 5: Geometry at 14:15:05

At 14:14:55 the Typhoons were instructed to climb to height 10,000ft, while the King Air reported responding to a TCAS RA (and right onto heading 210°). The King Air and Typhoons passed at CPA of 1.3nm at 14:15:05 (Figure 5).

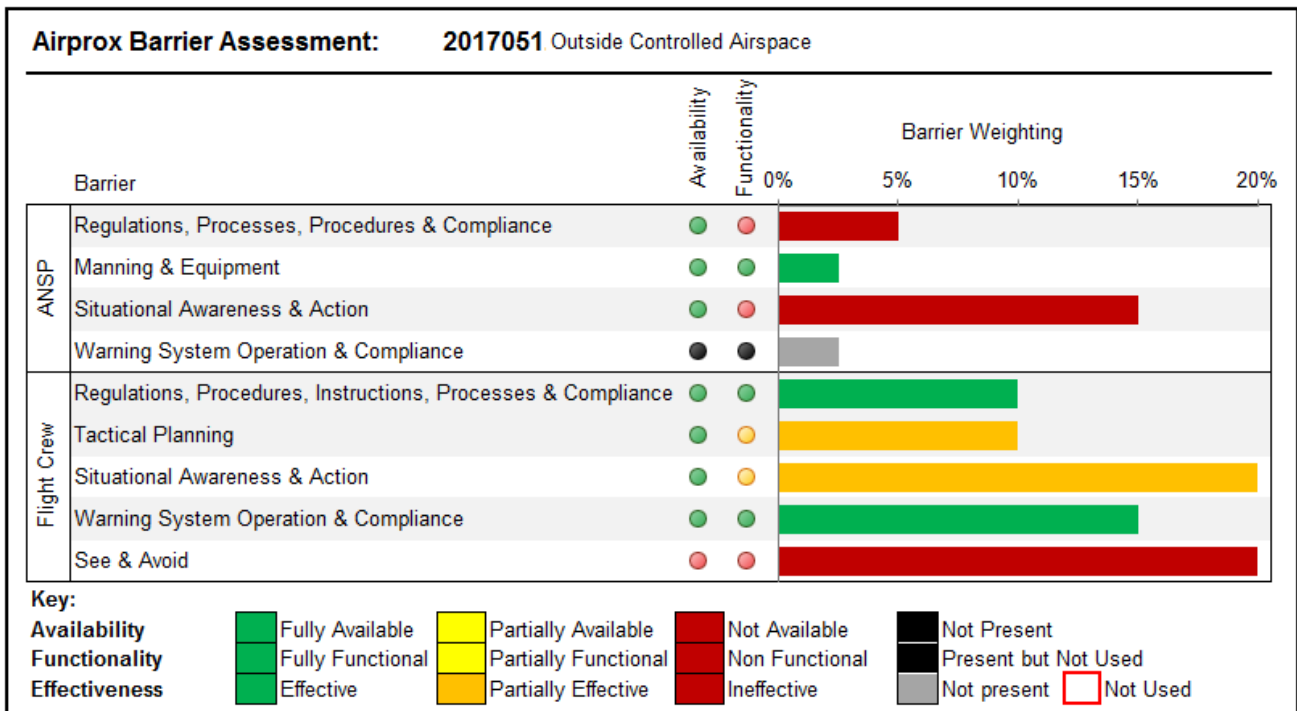
In assessing the effectiveness of the safety barriers associated with this incident, the Board concluded that the key factors had been that:

ANSP Regulations, Processes, Procedures & Compliance was considered to be **ineffective** because the Coningsby controller had allowed a confliction to be introduced by allowing the Typhoons to turn towards and then clearing them to climb through the level of the King Air.

ANSP Situational Awareness and Action was considered to be **ineffective** because the Cranwell controller did not provide avoiding action to the King Air pilot early enough to ensure sufficient separation from the Typhoons, and the Coningsby controller had allowed the Typhoons to climb into conflict with the King Air.

Flight Crew Tactical Planning was considered to be **partially effective** because although the Typhoon pilots were aware of the King Air on their radar, they climbed and flew towards the King Air whilst in IMC.

Flight Crew Situational Awareness and Action was also considered to be **partially effective** because although the Typhoons were aware of the King Air they did not alter their trajectory to avoid the King Air by a sufficient margin.

See and Avoid was considered to be **ineffective** because both pilots were IMC and therefore unable to see the other aircraft.
