**AIRPROX REPORT No 2017060**

Date: 09 Apr 2017 Time: 1706Z Position: 5250N 00011W Location: 3nm E East Midlands airport

**PART A: SUMMARY OF INFORMATION REPORTED TO UKAB**

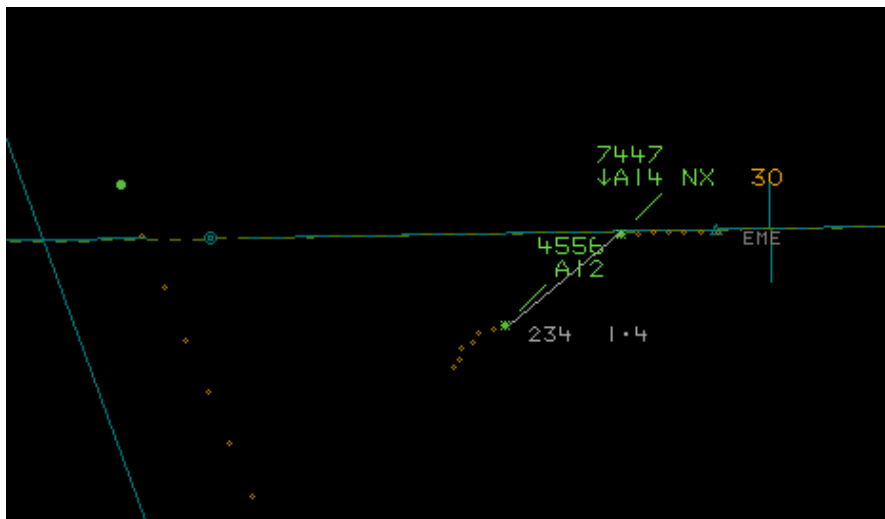
Figure 4 – 1705:28.

At 1705:28 (Figure 4), the controller asked the PA28 pilot if they were visual with the B737 and to confirm that they were still in the orbit. There was 1.4nm horizontal and 200ft vertical between the two aircraft at this time. As the PA28 pilot continued in the orbit the aircraft appeared to continue eastbound before the pilot confirmed they were visual with the B737.

Radar analysis of the PA28 pilot's orbits reveal that prior to commencing the second orbit, the PA28 appeared to continue downwind on a slightly converging track with the opposite direction B737 on final approach. The controller appeared to notice this, and confirmed with the pilot that they were still orbiting. There was a strong westerly wind at the time.
