AIRPROX REPORT No 2018007

Date: 14 Jan 2018 Time: 1510Z Position: 5138N 00120W Location: 3nm SW Abingdon

PART A: SUMMARY OF INFORMATION REPORTED TO UKAB

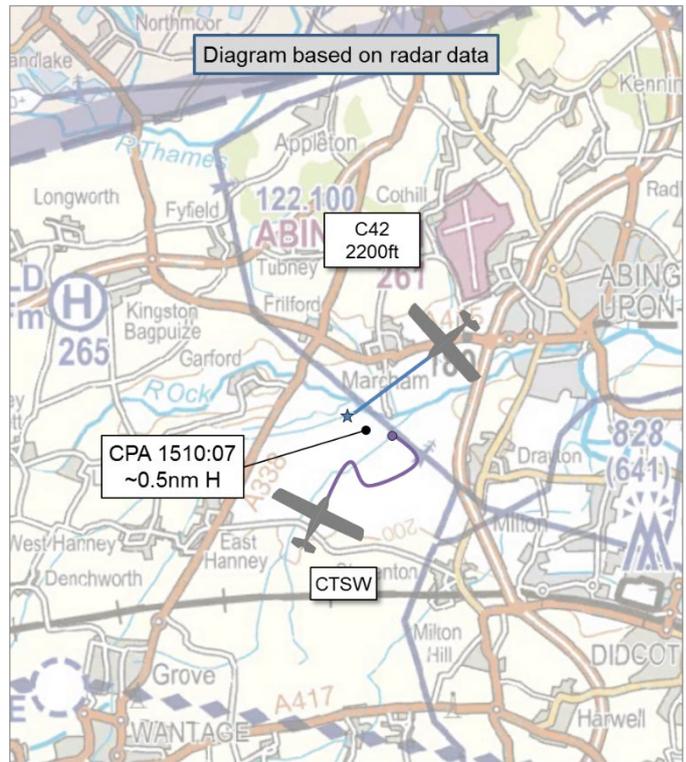
Recorded	Aircraft 1	Aircraft 2
Aircraft	Ikarus C42	CTSW
Operator	Civ Pte	Civ Pte
Airspace	London FIR	London FIR
Class	G	G
Rules	VFR	VFR
Service	Basic	None
Provider	Brize	
Altitude/FL	2200ft	NK
Transponder	A,C,S	Off.
Reported		
Colours	White	White
Lighting	Strobe, Landing	N/K
Conditions	VMC	VMC
Visibility	5km	10km
Altitude/FL	2000ft	2000ft
Altimeter	QNH (1016hPa)	QFE
Heading	270°	180°
Speed	75kt	80kt
ACAS/TAS	Not fitted	Not fitted
Separation		
Reported	0ft V/70m H	150ft V/300m H
Recorded	NK

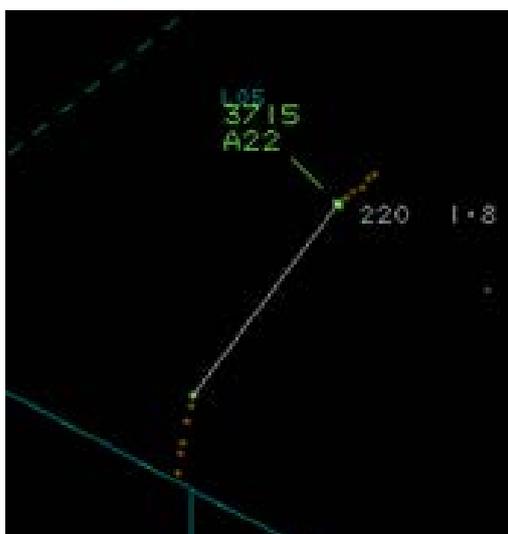
Figure 1: Geometry at 15:09:13

Figures 1-3 show the positions of the C42, and a primary radar contact believed to be the CTSW, in the lead up to the Airprox. The pictures are taken from a NATS radar feed, which is not utilised by Brize ATC, therefore does not represent the picture available to the controller.

At 15:09:13 (Figure 1), the Brize LARS controller passed Traffic Information (TI) to the C42 pilot. The pilot responded that he was looking for the traffic.

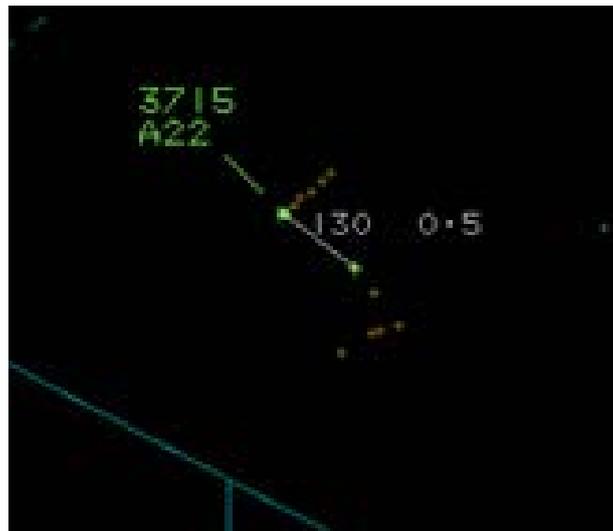
Figure 3: Geometry at 15:10:05 (CPA seen on radar replay)

The C42 was receiving a Basic Service and therefore the Brize LARS controller was only required to provide TI to the pilot if they identified a definite risk of collision. In this instance, the two aircraft still had 1.8nm lateral separation when TI was passed, which is not a definite risk of collision, but the controller interpreted the dynamic scenario as warranting TI provision. Because the CTSW did not have its transponder turned on, the controller was not able to pass accurate altitude information. Additionally, the primary return was intermittent. However, the TI passed did enable the C42 pilot to visually acquire the CTSW.

The Board first looked at the actions of the C42 pilot. He was flying at 2000ft and receiving a Basic Service from Brize Radar. Although only a Basic Service (and therefore the controller was not required to give Traffic Information unless he considered there to be a definite risk of collision), the Brize controller provided Traffic Information and the C42 pilot subsequently saw the CTSW in his 11 o'clock. Given that both pilots described a situation in which the CTSW came into formation distance with the C42, the Board noted that it was likely that the CTSW came closer to the C42 than the radar images showed, the intermittent nature of the primary-only contact meant that it faded from radar at 0.5nm.

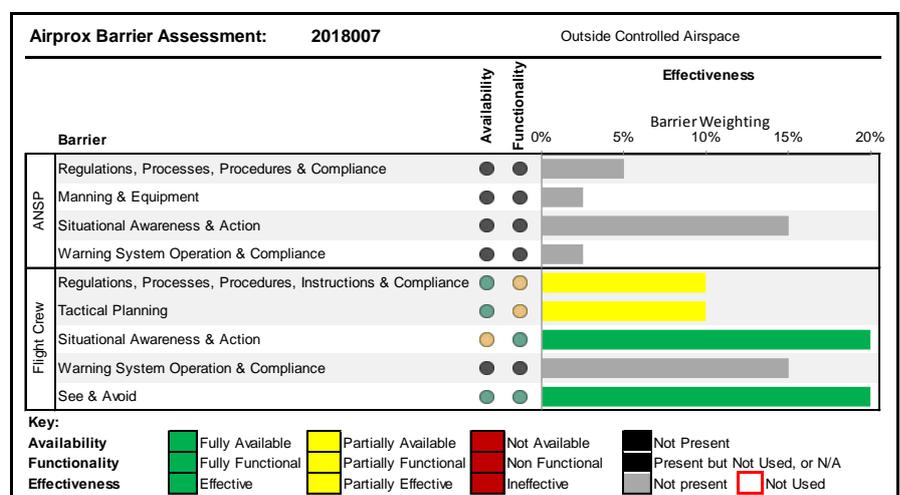
In assessing the effectiveness of the safety barriers associated with this incident, the Board concluded that the key factors had been that:

Regulations, Processes, Procedures, Instructions and Compliance were assessed as **partially effective** because the CTSW pilot was not authorised to fly in formation with the C42.

Tactical Planning was assessed as **partially effective** because the CTSW pilot should have had a more robust plan to meet up with his partner for formation flying.

² The UK Airprox Board scheme for assessing the Availability, Functionality and Effectiveness of safety barriers can be found on the [UKAB Website](#).
