AIRPROX REPORT No 2018022

Date: 16 Feb 2018 Time: 1023Z Position: 5258N 00058W Location: 5nm SW Syerston

PART A: SUMMARY OF INFORMATION REPORTED TO UKAB

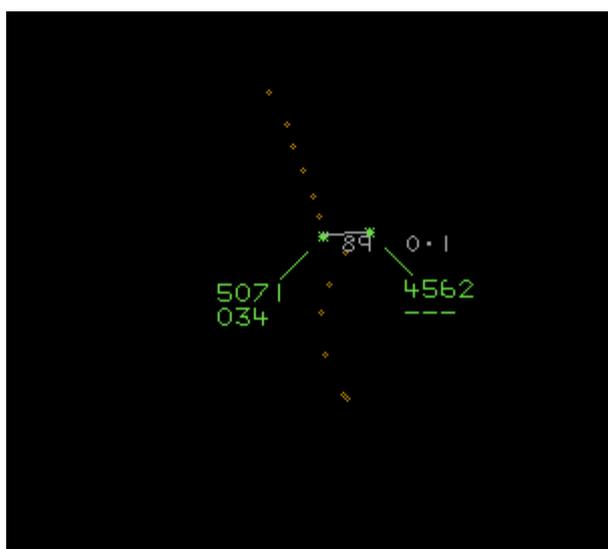
Figure 7 – 1023:05

At 1023:05 the controller confirmed the Basic Service, and advised the PA38 pilot to maintain a good lookout, advising that they had traffic in their vicinity, 600ft above (Figure 7). The PA38 pilot acknowledged this, and advised that they were visual with an aircraft towing a glider, by which point, at 1023:10, the aircraft had crossed and were diverging (Figure 8).

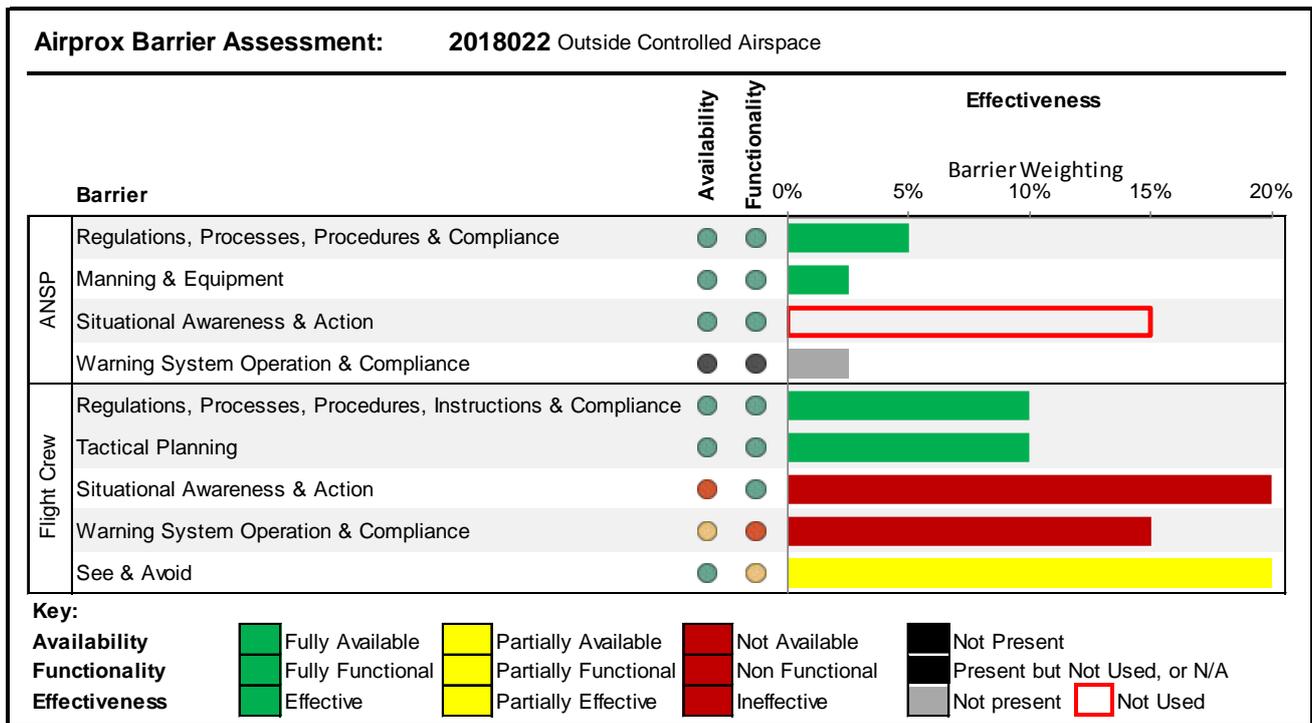
Warning System Operation and Compliance were assessed as **ineffective** because the TAS on the DR400 did not alert.

See and Avoid were assessed as **partially effective** because both pilots were able to take avoiding action, albeit late.
