AIRPROX REPORT No 2018035

Date: 10 Mar 2018 Time: ~1245Z Position: 5222N 00128W Location: Coventry ATZ

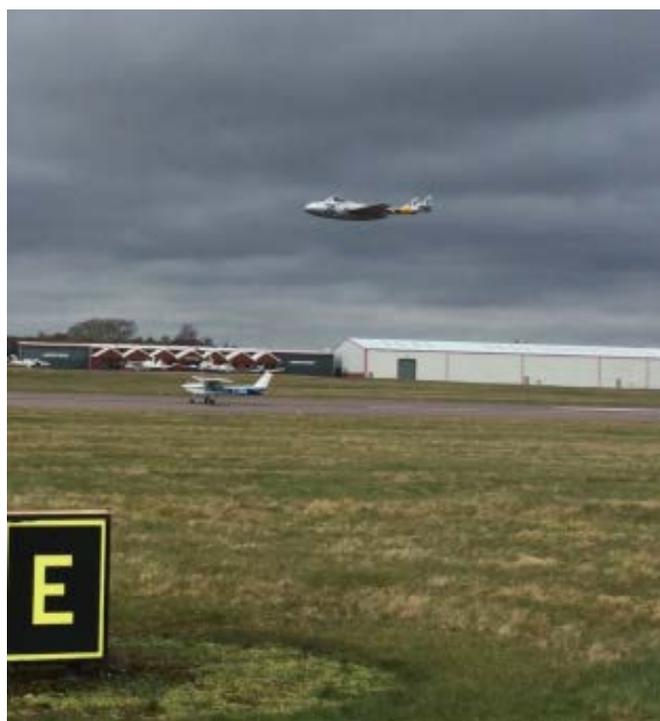
Figure 1

Figures 1 and 2 are photographs of the aircraft just prior to and after the overflight.

The Board then turned to the actions of the Vampire pilot. Members reviewed a video of the event and concluded that from this it was difficult to assess the Vampire's track relative to the runway but that it appeared to be offset by only a minor amount at best³. Using the C152 as a reference, it also appeared to the Board that the Vampire pilot was at about 75-100ft agl estimated as he flew past the C152. A member with knowledge of the Vampire opined that as the Vampire ran in at that height then its pilot would likely have had difficulty in seeing the C152 ahead or on the runway in the latter stages due to the position of the Vampire cockpit in relation to the nose, which restricts lookout in-front and below the pilot's line of sight. However, the Vampire pilot subsequently reported that he had been seated in the left-hand seat and could see the C152 at all times. He also reported that the pilot in the right-hand seat could see the C152 for the majority of the time, and only lost sight of the C152 in the latter stages of the approach. The Vampire pilot also commented that, in his opinion, the C152 could not have manoeuvred into a conflict position during the latter stages of his run in due to its poor climb gradient and so there was no risk associated with his run-and-break at that height. Board members disagreed and felt that, had the C152 pilot gone around in the latter stages of the Vampire pilot's run in then there would have been a serious risk of collision; in their opinion the Vampire pilot should not have flown so close to the C152. Members with military experience commented that, notwithstanding the low height of the Vampire's run-in, a standard military run-in-and-break was always conducted well offset to the runway for the very reason that this was the only way that aircraft on or approaching the runway could be reliably observed and avoided.

³ Using the Vampire length (9.37m) compared to the C152 length (7.3m), if the aircraft were equidistant from the observer then the Vampire would be 1.28 times the length of the C152. Although not able to take exact measurements, and within the bounds of slight error, the video stills depict the Vampire as being 1.3 times the length of the C152, which indicates that it was pretty much equidistant from the observer and therefore near to overhead the C152.
