Avoiding collisions – a monthly update from Director UK Airprox Board giving some learning themes for recreational pilots.

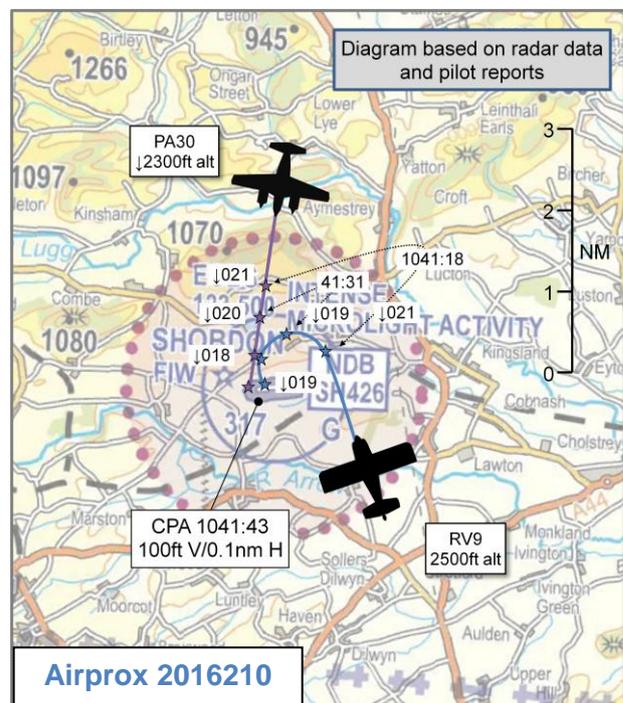
My **Airprox of the month** was one of these joining incidents. **Airprox 2016210** was a Category A incident involving a PA30 and an RV9 that were both joining runway 27LH at Shobden. The RV9 pilot was joining from the south and conducted an overhead join as he stated on the radio. The PA30 initially wanted to join effectively crosswind from the north but agreed also to conduct an overhead join when requested by the AFISO. Unfortunately, the PA30 pilot then subsequently reverted to a crosswind join rather than flying through the overhead, and the 2 aircraft came into proximity near the upwind threshold. The PA30 pilot was of course perfectly entitled to join crosswind, but should have made his revised intention to do so clear to all, and should have avoided the RV9. The full report can be found on the UKAB website at (www.airproxboard.org.uk) in the 'Airprox Reports and Analysis' section within the appropriate year in the 'Individual Airprox reports' tab.
