AIRPROX REPORT No 2020001

Date: 03 Jan 2020 Time: 1252Z Position: 5233N 00231W Location: 3NM NE Bridgnorth

PART A: SUMMARY OF INFORMATION REPORTED TO UKAB

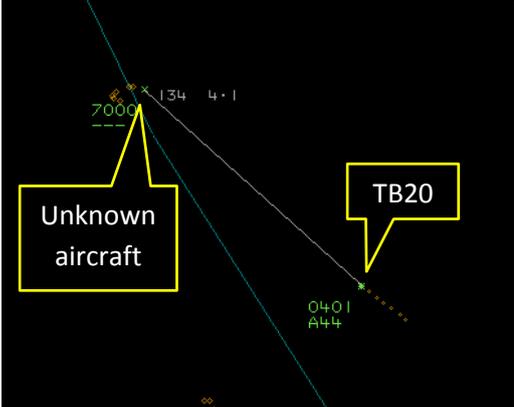
Figure 1 - 1250:04

Although the TB20 pilot was not receiving an ATS (RAF Shawbury was closed at the time), the incident could be seen on the NATS radars. Figures 1 and 2 show the TB20 as it tracks north-west. The unknown aircraft can be seen manoeuvring 4NM away in Figure 1, but without Mode C the height cannot be ascertained.

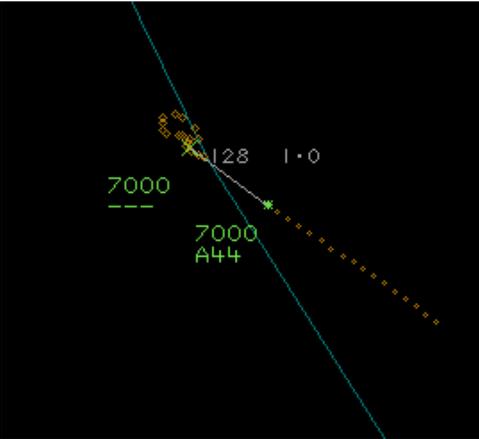
Figure 3-1251:32

Figures 3 and 4 show the two aircraft as they close to 0.5NM. Figure 5 shows CPA, less than 0.1NM laterally, but vertical separation unknown.
