AIRPROX REPORT No 2020056

Date: 25 Jun 2020 Time: 1417Z Position: 5131N 00042E Location: Southend

PART A: SUMMARY OF INFORMATION REPORTED TO UKAB

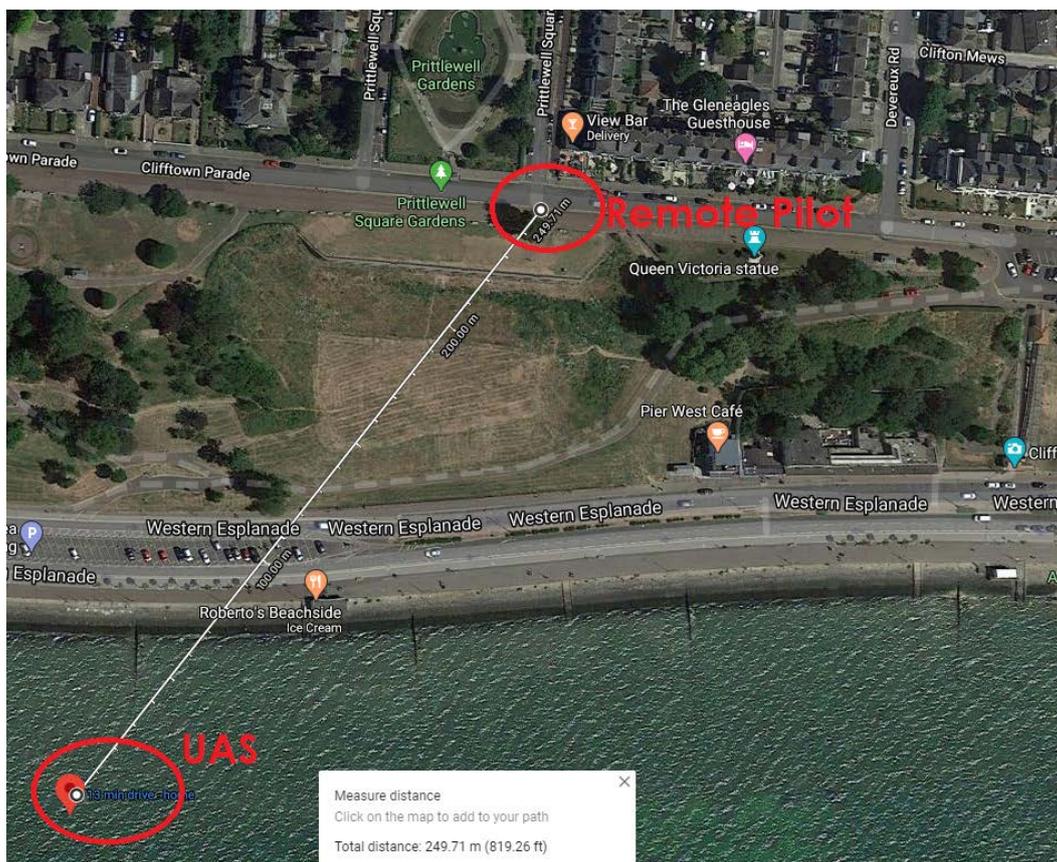
Figure 1: Position given by the drone operator

THE UAS OPERATOR reports operating the UAS in accordance with the ANO and with approval from Southend ATC whilst in the FRZ (ATZ), the drone was operating above the water along the Southend seafront. Whilst operating the UAS at around 350m away from the remote pilot, the remote pilot and 2 spotters heard a helicopter. The UAS was held in position whilst visual line of sight (VLOS) was maintained at all times. The helicopter appeared from east to the west, travelling slowly (approx 50kt) at a similar height of 300ft AMSL. The UAS was immediately operated into Sports Mode (45mph) away from the helicopter. The helicopter continued on its course. The UAS returned to capture the shot, the helicopter and UAS were both in VLOS of the remote pilot. The helicopter made a 180° turn and flew back towards position of UAS at a lower height than the UAS, over the water, now heading from west to east. The UAS was again moved in Sports Mode back to overhead the remote pilot, held in position and a visual inspection carried out to ensure the helicopter had flown away. When visual confirmation was maintained that the helicopter had flown away and continued to fly away, UAS was operated back over water again. The mission continued safely with no further incident. The remote pilot opined that should the UAS not have been moved there may have been a collision, or extremely close to a collision. The helicopter at some points was lower than the UAS. At the end of the mission, the remote pilot called ATC to close down the mission and inform them of the incident. ATC confirmed that the helicopter crew had a Traffic Service and were aware of the UAS operation. A diagram showing the position of the remote pilot and the UAS is at Figure 1, the UAS operator estimated the drone was operating around 60m out over the sea.

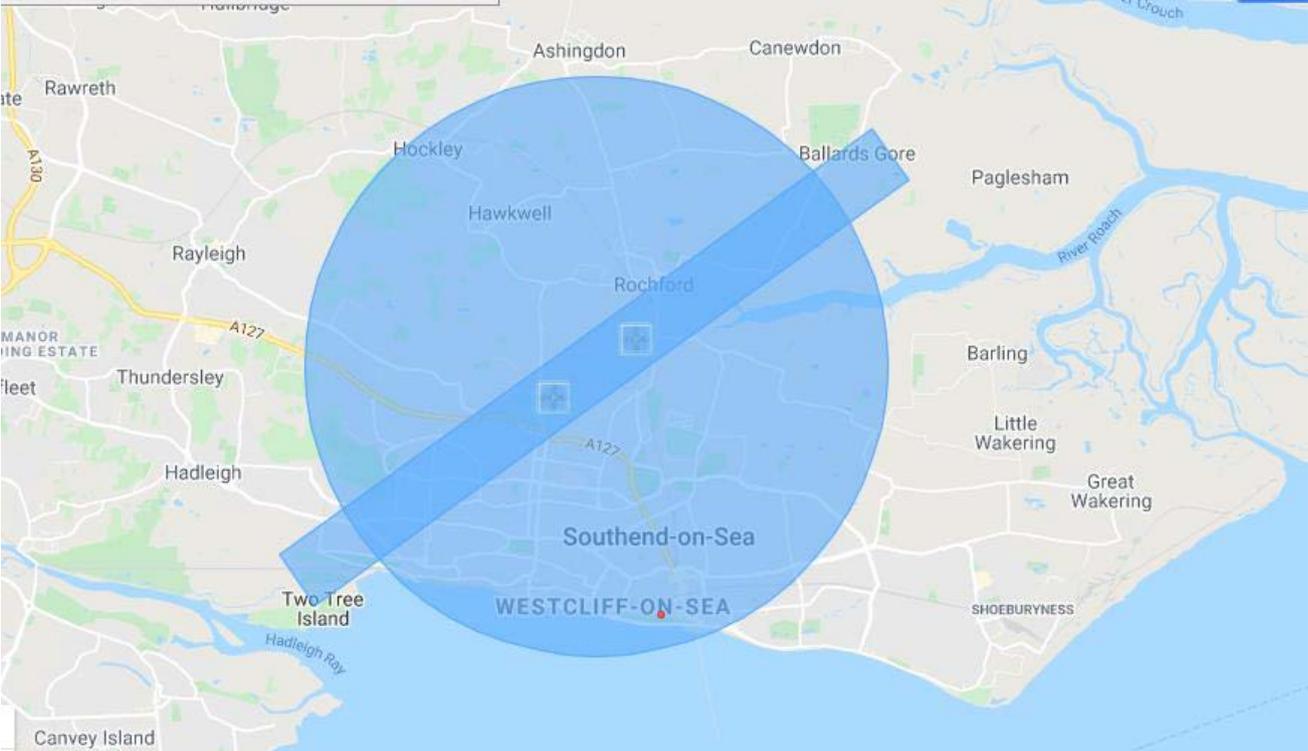
Figure 2: Drone site indicated by red dot.

The AS355 pilot was in receipt of a Radar Control Service from Southend Radar at time of incident. The drone was operating under an approved application (LSA ref 20/046) to operate not above 400ft at the following site in Westcliff-on-Sea, Essex.

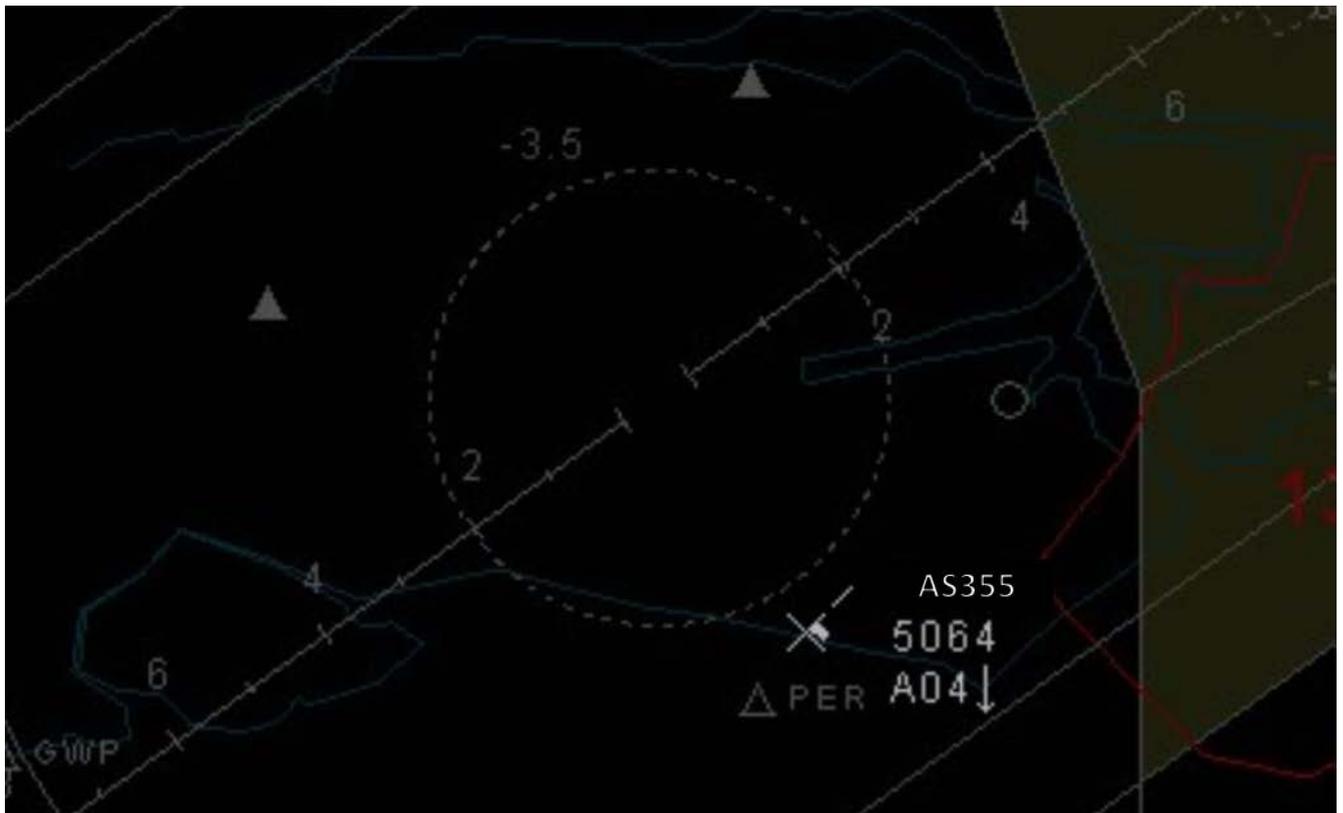
Figure 4:1410:13Z Traffic Information passed on drone (1NM west of AS355's position)

1410:13: AS355 pilot cautioned about "*drone activity approx. one mile of your present position, not above 400ft*" (figure 4)

APC were told in a timely manner about the drone operation but did not pass the information to the AS355 pilot initially. This was partly due to not having the full information on a Flight Progress Strip and partly forgetting about the initial information received from ADC. Upon receiving an update from ADC this triggered the Traffic Information to the AS355 pilot. Based on the reported time of the Airprox by the drone operator, it would appear the pilot was advised of the drone prior to the incident. The surveillance recording would concur with this based on the position and altitude of the AS355 when the Traffic Information was passed.

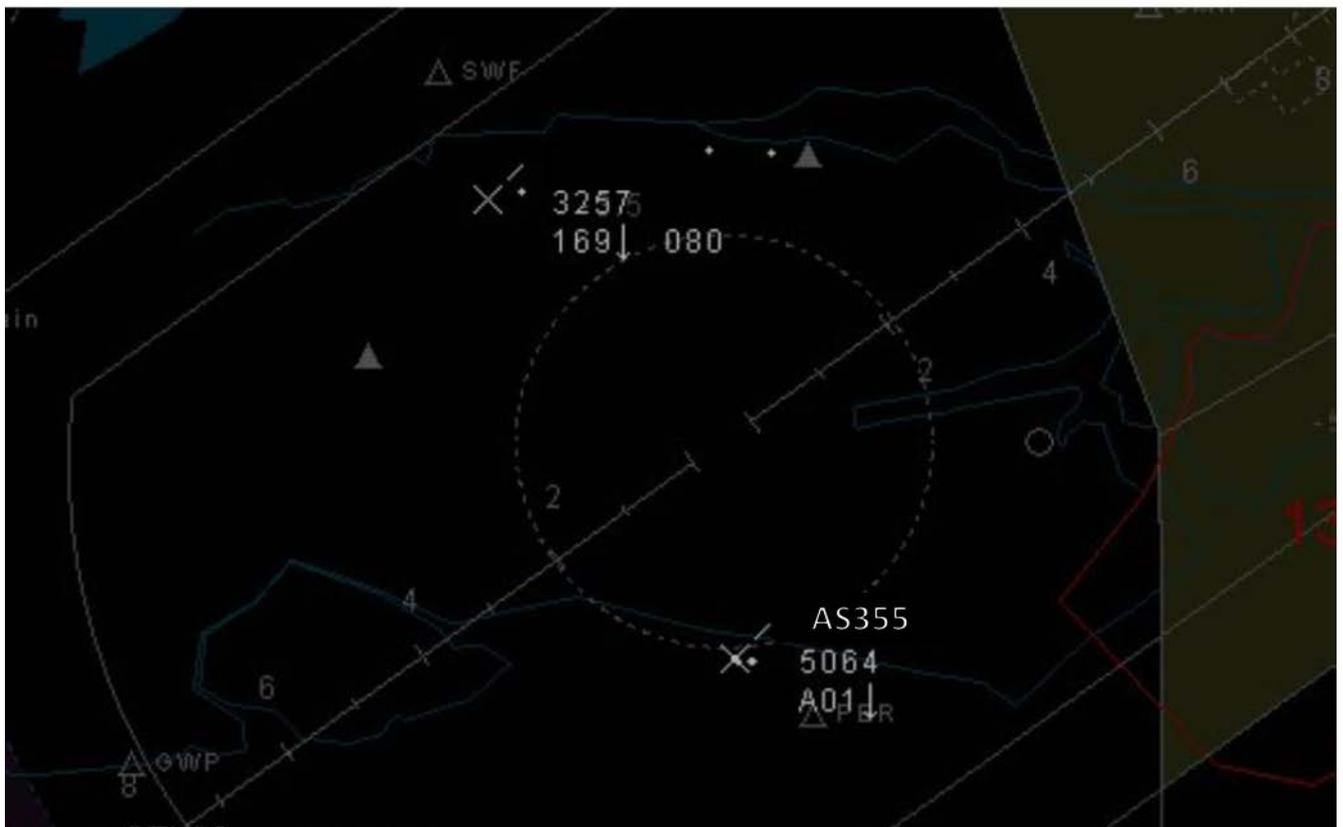
Figure 5: 1418:14Z

The helicopter approached the area concerned at around 1417:55Z. The AS355 commenced a descent whilst still over water, and was last seen at 1418:29Z, still over water, but possibly converging slightly inland. However, it was still over water when it re-appeared at 1418.52, having turned more south westerly. Therefore, it was below radar cover for 23 seconds, very low level. It would appear likely that the helicopter must have remained over water given the short time radar contact was lost based on the aircraft's performance. The AS355 pilot did not mention anything to APC about a sighting of the drone.
