AIRPROX REPORT No 2019044

Date: 20 Mar 2019 Time: 1338Z Position: 5209N 00049W Location: 7nm E DTY

PART A: SUMMARY OF INFORMATION REPORTED TO UKAB

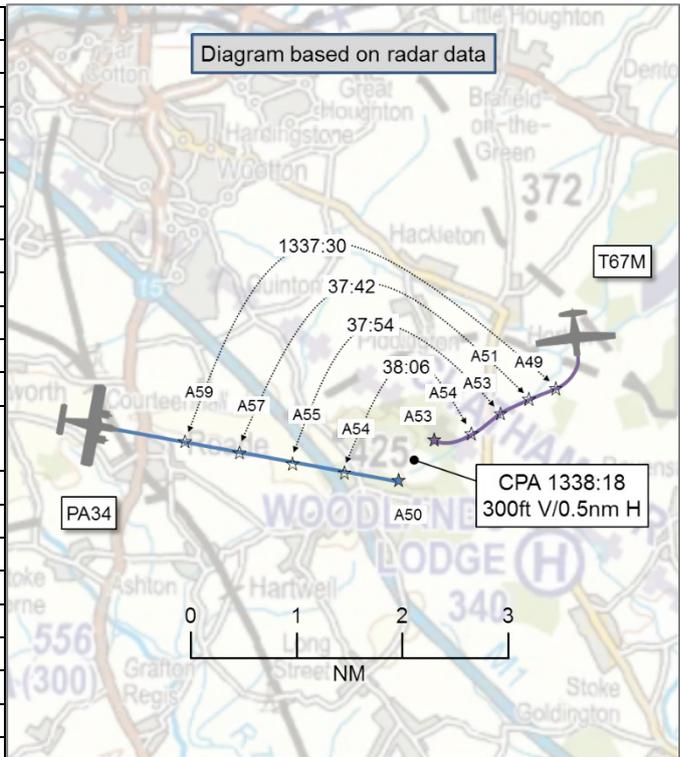
Recorded	Aircraft 1	Aircraft 2
Aircraft	PA34	T67M
Operator	Civ FW	Civ FW
Airspace	London FIR	London FIR
Class	G	G
Rules	IFR	VFR
Service	None ¹	Basic
Provider	N/A	Cranfield
Altitude/FL	5000ft	5300ft
Transponder	A,C,S	A,C,S
Reported		
Colours	White/Blue	Yellow
Lighting	Anti-coll, landing, taxi, nav	Strobes, landing
Conditions	VMC	VMC
Visibility	>10km	10km
Altitude/FL	4000ft	5000ft
Altimeter	QNH (1032hPa)	QNH
Heading	099°	280°
Speed	140kt	110kt
ACAS/TAS	TAS	PowerFLARM
Alert	TA	Information
Separation		
Reported	0ft V/1nm H	0ft V/0.25nm H
Recorded	300ft V/0.5nm H

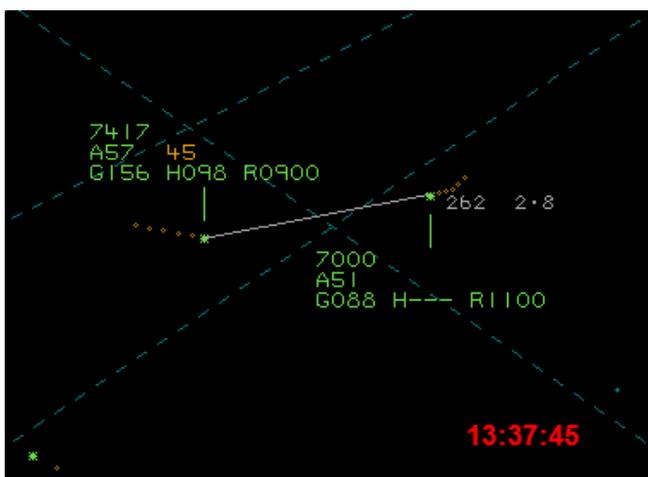
Figure 1

The PA34 continued on the previous track in the descent to the agreed 4500ft. The T67M pilot however initiated a sharp right turn and continued climb on a track that took the aircraft into proximity with the PA34 as the tracks converged (see Figure 1, PA34 squawk 7417).

As the aircraft came into close proximity, the T67M pilot initiated a right turn of approximately 80°. The pilot’s Airprox report stated this was not a critical avoidance manoeuvre. The rate of descent of the PA34 increased, briefly indicating a descent rate of 3200fpm.

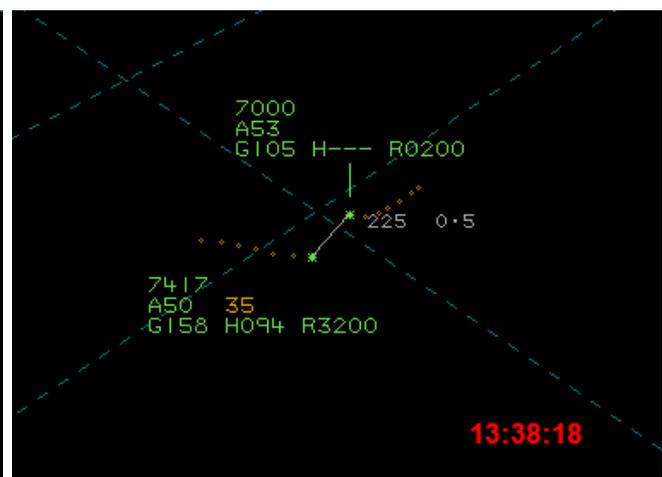
Figure 2

ATSI assessed that the closest point of approach occurred at **13:38:18** (see Figure 2), and was recorded on the LTC Multi-Track radar as **0.5nm** and **300 feet**.
