**AIRPROX REPORT No 2019328**

Date: 05 Dec 2019 Time: 1328Z Position: 5113N 00040W Location: 5NM SE of Farnborough

**PART A: SUMMARY OF INFORMATION REPORTED TO UKAB**

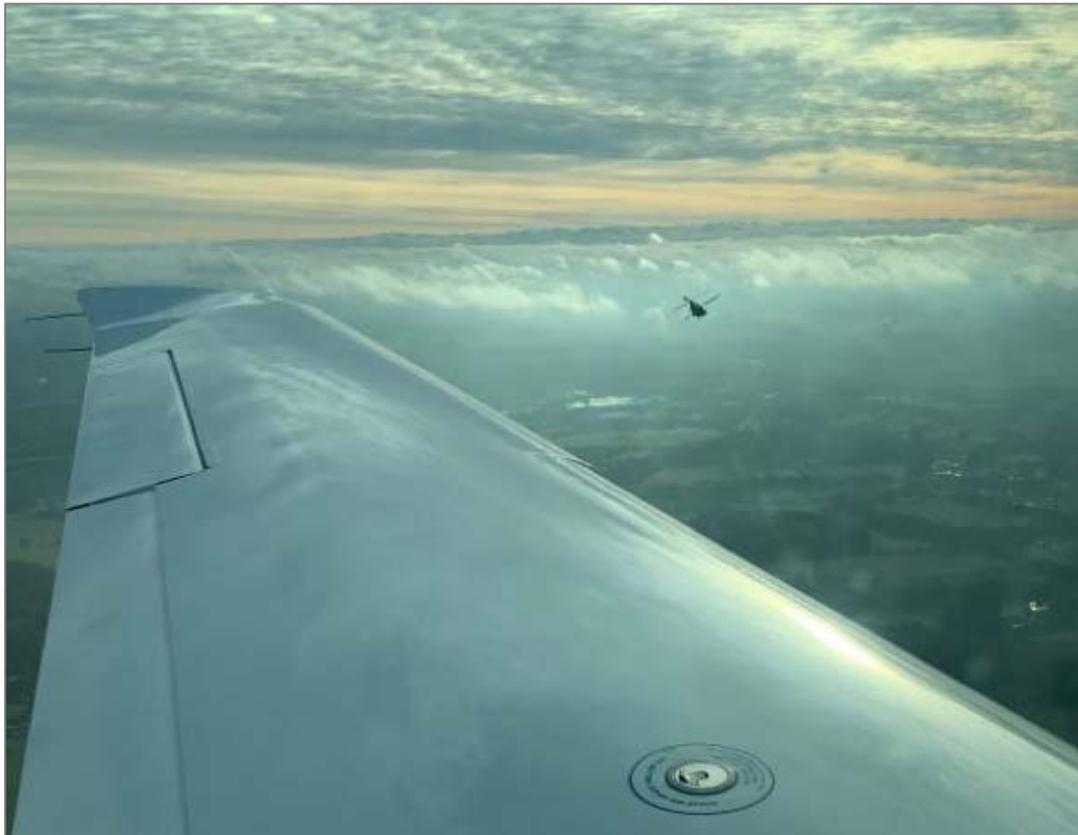
**THE SR20 PILOT** reports that he was flying west with 3 qualified pilots on board, having agreed a Traffic Service from Farnborough Radar. They heard a similar callsign on the radio with an advisory, but it was not their callsign. They saw the Chinook to the left and below their flightpath and remained in visual contact. The Chinook took a turn to the right to pass behind and below their aircraft. No avoiding action was taken as they were visual and, according to the right-of-way rules, had right of way.

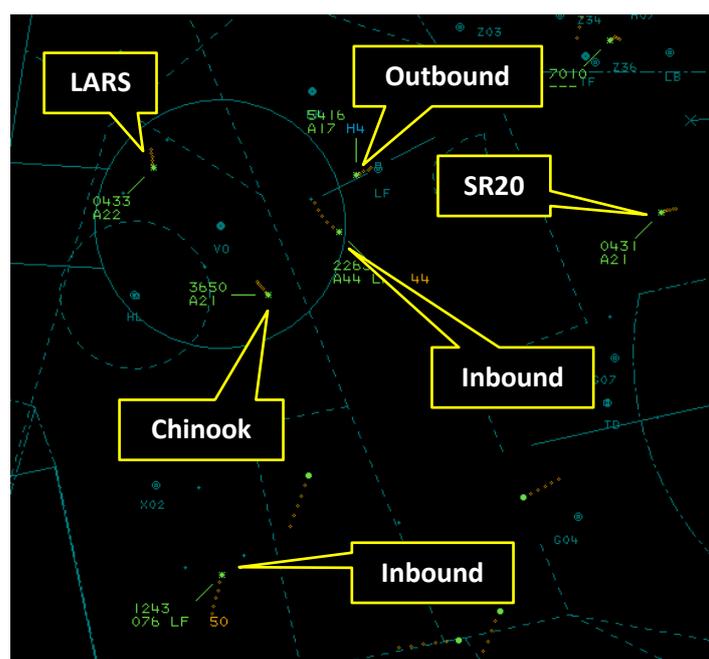
Figure 1 – 1323:41

The Cirrus SR20 pilot was working LARS W with a Traffic Service, squawking 0431. The Chinook pilot was working Odiham Approach, being vectored for an instrument approach to RW27 and squawking 3650. The LARS W controller was band-boxed with Approach and the traffic loading was medium with two inbounds and an outbound from Farnborough, and 4 LARS tracks (Figure 1).

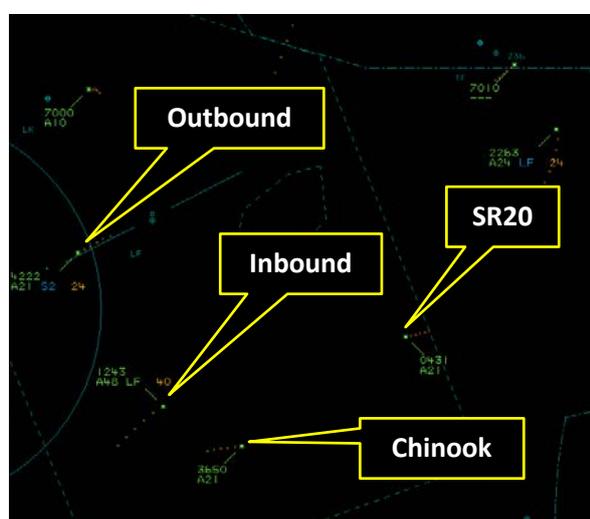
Figure 2 – 1326:44

The Cirrus continued on a south-westerly track as Odiham Approach vectored the Chinook downwind. The workload of the LARS W controller increased because they had another departure and aircraft requesting to leave the frequency (Figure 2). Traffic Information was not initially called to the Cirrus pilot on the Chinook, but was passed by the LARS W controller at 1327:56 “[Cirrus C/S], traffic to the South of you, range half-a-mile, northbound, type rotary, 2000ft”. The Cirrus pilot did not reply to this transmission (Figure 3).

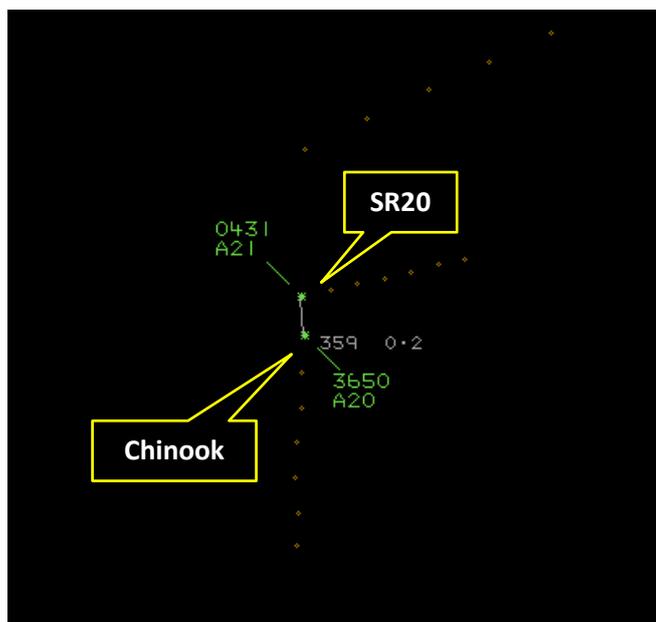
Figure 4 – 1328:04 CPA

At 1328:13, the LARS W controller again passed Traffic Information to the Cirrus pilot “[Cirrus C/S], military rotary traffic passing behind you, 2000ft, has you visual”; no reply was received from the Cirrus pilot. On the third attempt, the LARS W controller received a response from the Cirrus pilot and so re-issued Traffic Information: “Been trying to call you sir, there is military rotary traffic to the east of you now, 1 mile, eastbound, similar level, has you visual.” The Cirrus pilot responded “Err, we are visual with the traffic” at 1328:32.

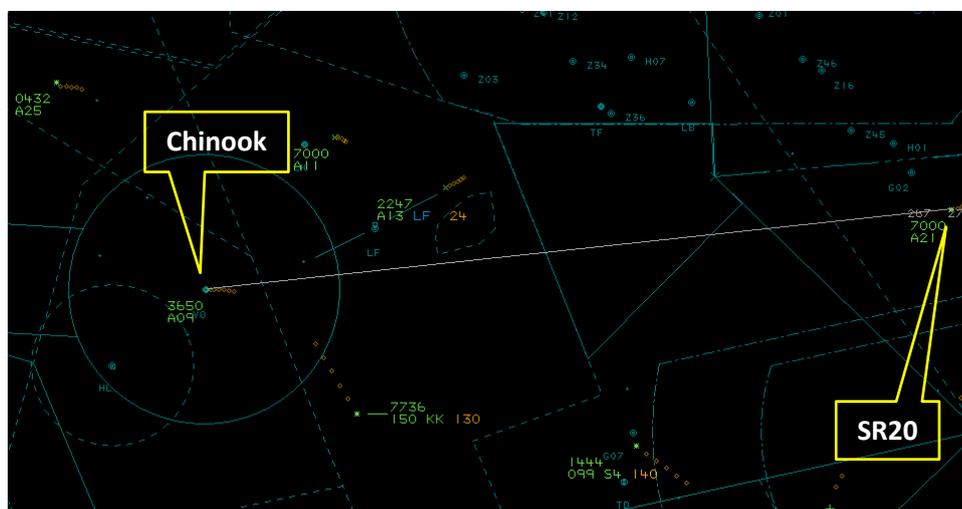
Figure 5 – Chinook climb-out

The Chinook climbed-out from Odiham having completed an instrument approach and was in receipt of a reduced Traffic Service due to Odiham operating SSR only. The Chinook pilot requested a practise NCNG approach culminating in an ILS. At the time the Chinook climbed-out, the SR20 was 27NM to the E of Odiham (Figure 5).

Figures 5-9 show the positions of the Chinook and SR20 at relevant times in the lead-up to, and during, the Airprox. The screenshots are taken from a replay using the Pease Pottage radar, which is not utilised by RAF Odiham, therefore is not representative of the picture available to the Odiham Approach controller.

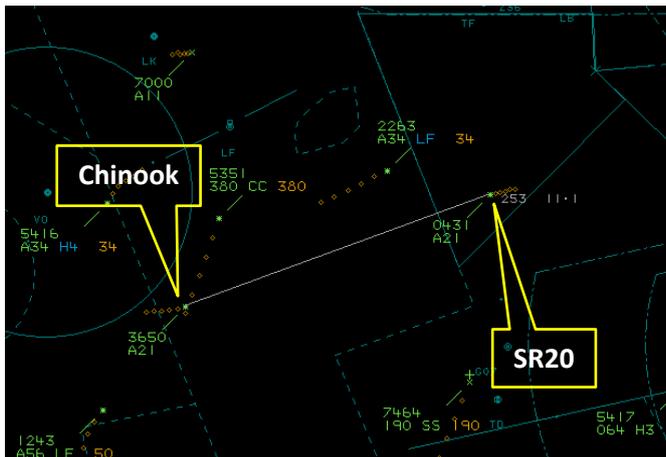
Figure 6  
TI between Odiham and Farnborough

At 1325:20, Farnborough contacted Odiham to advise that an aircraft would be departing ahead of the Chinook. The Odiham Approach controller requested Traffic Information on the SR20 and was told that it was routing to the south-west at 2400ft. Separation at this point was 11NM (Figure 6). The Odiham Approach controller passed Traffic Information to the Chinook pilot for the first time at 1326:26. Separation at this point was 8NM (Figure 7).

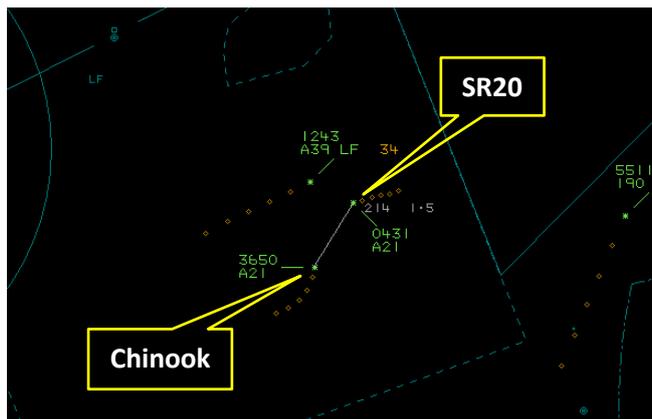
Figure 8 - 2<sup>nd</sup> TI to the Chinook pilot

The Odiham Approach controller passed Traffic Information for a second and final time at 1327:37. Separation had decreased to 1.5NM but, by this point, the SR20 pilot noted in their report that they were already visual with the Chinook (at 2NM) (Figure 8). The Chinook pilot reported being visual with the SR20 some 10sec after this final piece of Traffic Information. By this point separation had decreased to 1.2NM (Figure 9).

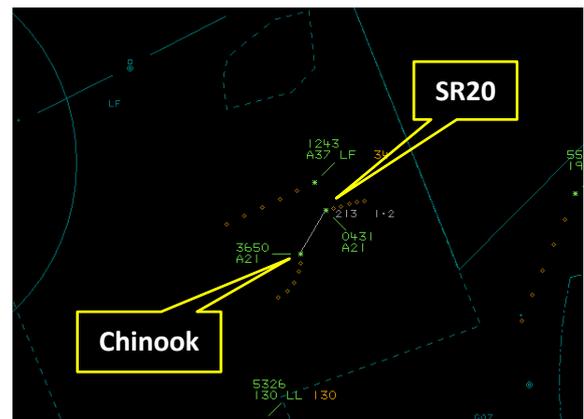
Figure 9 – Chinook pilot visual with SR20

CPA occurred approximately 15sec after the Chinook pilot reported visual and was measured at 0.2NM and 100ft.

The Odiham Approach controller stated that they intended to keep the Chinook on a reasonably tight pattern (ahead of the SR20) but ‘overshot’ a little, which placed the aircraft closer than anticipated. However, a NCNG approach is always difficult for a controller to vector and this would have been made even more so by operating SSR only with its update rate inherently slower than primary radar. Notwithstanding, Traffic Information was passed to the Chinook pilot on 2 occasions, which allowed the Chinook crew to become visual with the SR20 at 1.2NM, by which point the SR20 pilot was already visual with the Chinook.
