**AIRPROX REPORT No 2018012**

Date: 26 Jan 2018 Time: 1233Z Position: 5116N 00208W Location: Bratton Camp launch site<sup>1</sup>

**PART A: SUMMARY OF INFORMATION REPORTED TO UKAB**

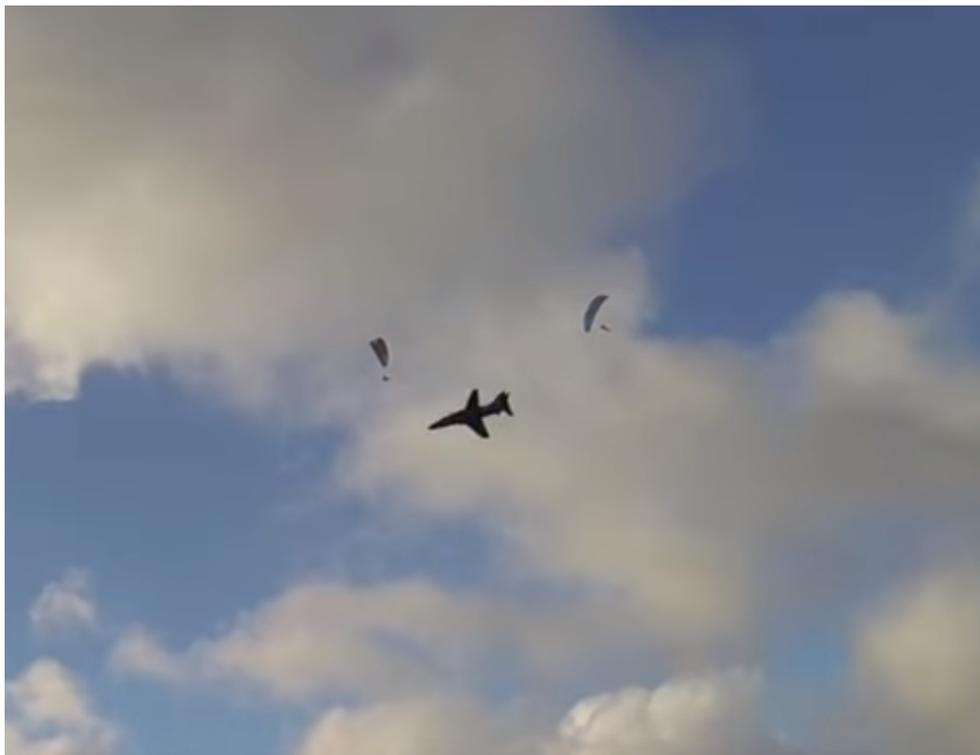
One of the paraglider pilots filmed the event<sup>6</sup>; a screenshot of part of the encounter is provided below:

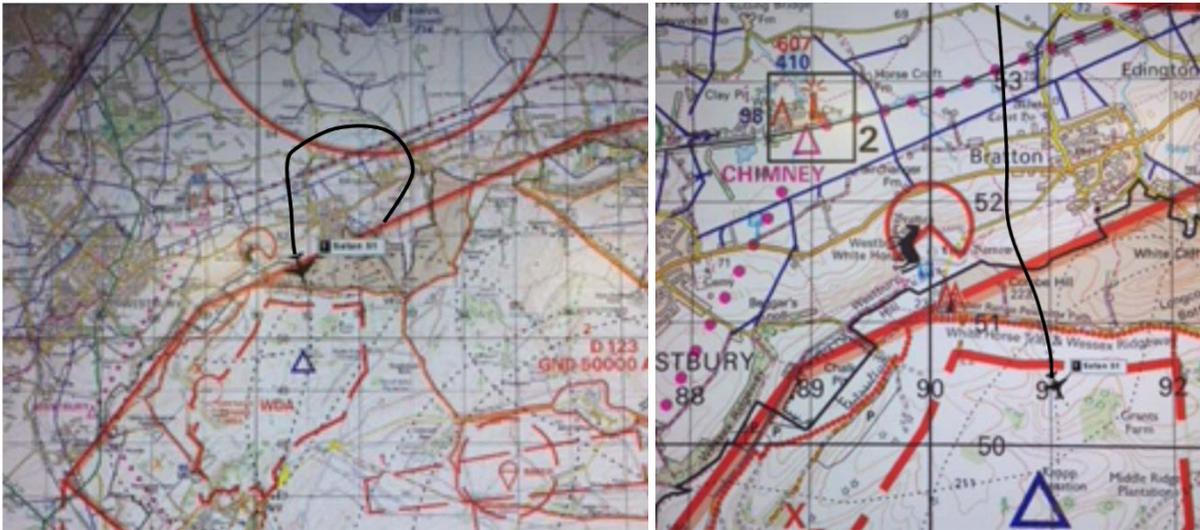
The RN Occurrence Investigation provided a number of GPS derived screenshots of the Hawk's ground track, 2 of which are reproduced in part below with the track highlighted:

The Salisbury Plain Danger Area is surrounded by numerous GA landing sites; without the benefit of FLARM or TCAS the see-and-avoid principle is the primary MAC mitigation conducted by all aircrew. This sortie was therefore planned to remain at height as much as possible, with low-level (Not Below 250 ft) to be conducted only within the confines of D123 given the protection it affords as segregated airspace. In this instance, the pilot was attempting to stay within the confines of the danger area whilst descending to low-level in order to prosecute the attack as requested by the FAC; this action led to the unintentional spill-out through the BHPA/paraglider site.

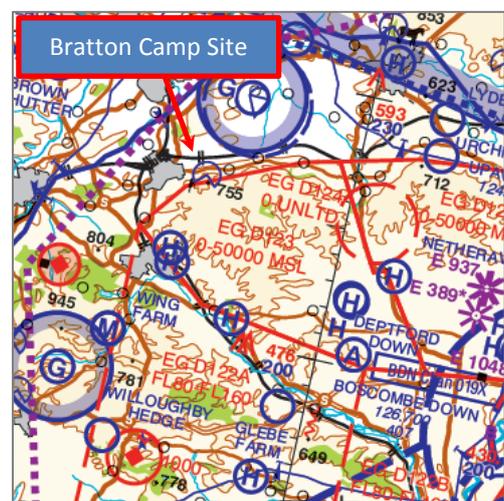
Some members wondered whether the Hawk pilot had assimilated that the paragliding site was there, given that he had not been specifically informed of it during the range brief and that, although it appeared on the 1:50,000 map and low-level chart (see diagram), it could easily be overlooked in a high-workload sortie that would presumably have included target runs from a number of IPs and directions. In this respect, some members commented that the TACP should have been aware of the site and, given its likely activity in the conditions pertaining, could have deduced that it might be active and should have warned against using that IP/target attack direction on that day. After considerable further discussion, members agreed that this incident had come about due to sub-optimal communication rather than the Hawk pilot's navigation (for which the RN maps showed that the Hawk pilot did not technically fly over the site's location, albeit greater avoidance would have been merited). Frustratingly, the Hawk pilot did not know that the Bratton Camp paragliding site was active; members agreed that this was contributory and resolved to recommend that, 'The Avon Hang Gliding

& Paragliding Club and SPTA Ops refresh their LoA to cover usage of the Bratton launch site and how that information is conveyed’.

<u>Cause:</u>	Effectively a non-sighting by the Hawk pilot.
<u>Contributory Factor:</u>	The Hawk pilot did not know that the Bratton Camp paragliding site was active.
<u>Degree of Risk:</u>	A.
<u>Recommendation:</u>	The Avon Hang Gliding & Paragliding Club and SPTA Ops refresh their LoA to cover usage of the Bratton launch site and how that information is conveyed.

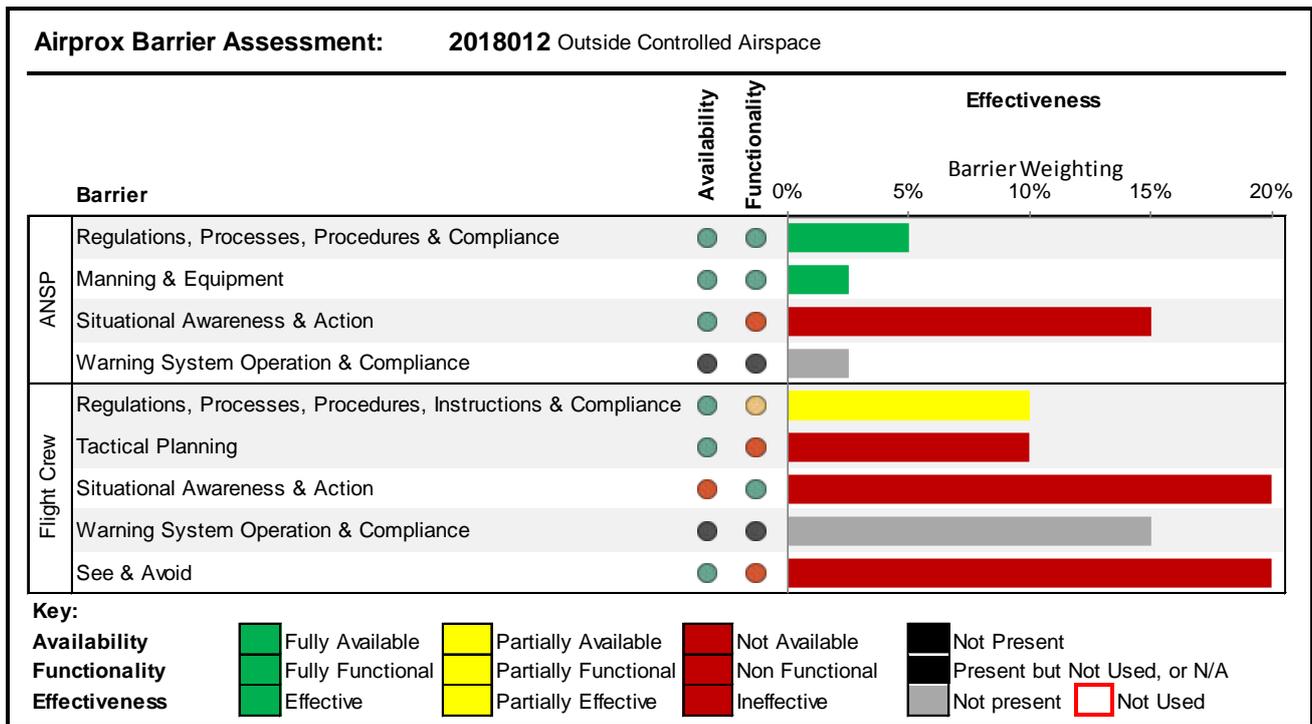
In assessing the effectiveness of the safety barriers associated with this incident, the Board concluded that the key factors had been that:

**Situational Awareness and Action** were assessed as **ineffective** because the paragliders were not radar significant and did not appear to the Boscombe controller, who therefore could not provide Traffic Information. SPTA Ops and the TACP were also not aware of the paragliding activity and could not warn the Hawk pilot or Boscombe ATC.

**Regulations, Processes, Procedures, Instructions and Compliance** were assessed as **partially effective** because the Hawk pilot inadvertently entered the Low Flying System without previously obtaining clearance; had he maintained 2000’ agl he would probably not have flown through the paraglider group.

**Tactical Planning** was assessed as **ineffective** because the paragliding site was depicted on the Hawk pilot’s map and the conditions were such that it was likely the site would be active.

**Situational Awareness and Action** were assessed as **ineffective** because the Hawk pilot was not aware of the presence of the paragliders.

**See and Avoid** were assessed as **ineffective** because the Hawk pilot did not see the paragliders in time to take effective avoiding action, and the paragliders were not able to manoeuvre out of the way in the time available once the Hawk’s flight path was detected.
