AIRPROX REPORT No 2017006

Date: 06 Jan 2017 Time: 0839Z Position: 5744N 00046E Location: 95nm NE Aberdeen

PART A: SUMMARY OF INFORMATION REPORTED TO UKAB

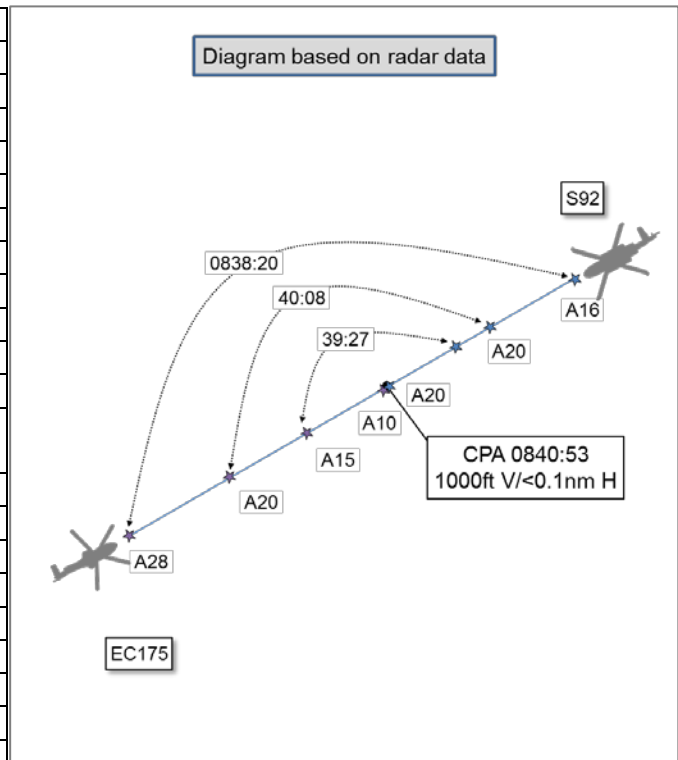
Recorded	Aircraft 1	Aircraft 2
Aircraft	S92	EC175
Operator	Civ Comm	Civ Comm
Airspace	Scottish FIR	Scottish FIR
Class	G	G
Rules	IFR	IFR
Service	Offshore Traffic	Offshore Traffic
Provider	Aberdeen	Aberdeen
Altitude/FL	2000ft	1000ft
Transponder	A, C, S	A, C, S
Reported		
Colours	Company	Yellow
Lighting	Position, anti-coll, landing, HISL	Red/white strobes, nav
Conditions	IMC	IMC
Visibility	In cloud	In cloud
Altitude/FL	2000ft	1100ft
Altimeter	QNH	QNH (1022hPa)
Heading	'southwest'	067°
Speed	120kt	142kt
ACAS/TAS	TCAS II	TCAS I
Alert	TA	TA
Separation		
Reported	400ft V/0m H	1000ft V/0m H
Recorded	1000ft V/<0.1nm H

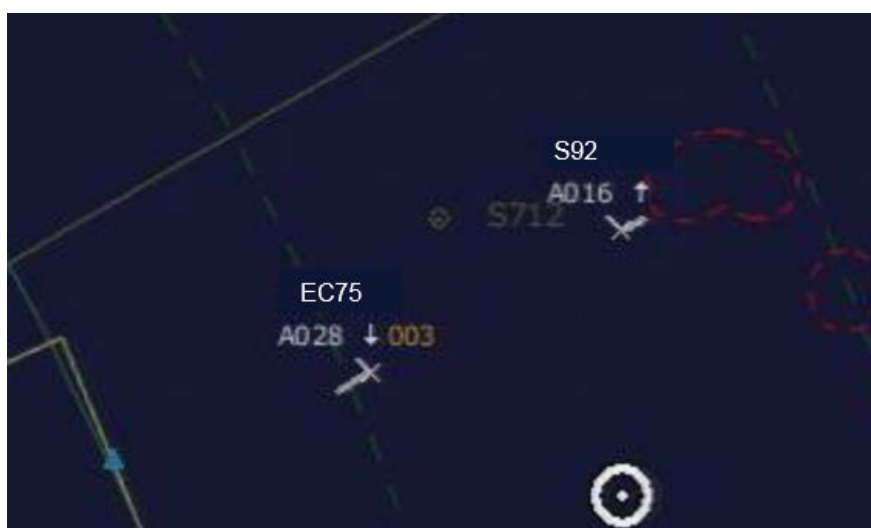
Figure 1 –0838:20 (Aberdeen WAM).

At 0838:20 (Figure 1) the EC175 pilot had commenced descent with 12nm between the aircraft.

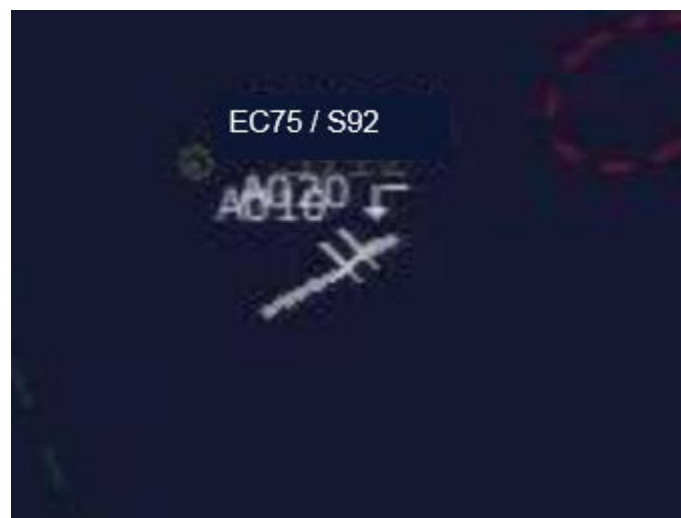
Figure 3 – 0840:53 (Aberdeen WAM).

At 0840:53 (Figure 3) the radar image indicates the aircraft were passing each other and 1000ft apart vertically.

At 0840:08 the aircraft were 500ft vertically and 4nm horizontally apart with the EC175 still descending. ATSI were not able to measure the CPA but an assessment by Aberdeen ATCU established that the minimum distance between the aircraft was 2.79nm horizontally and 600ft vertically.
