AIRPROX REPORT No 2014108

Date/Time: 13 Jul 2014 1258Z (Sunday)

Position: 5147N 00156W
(10nm SE Gloucester)

Airspace: London FIR (Class: G)

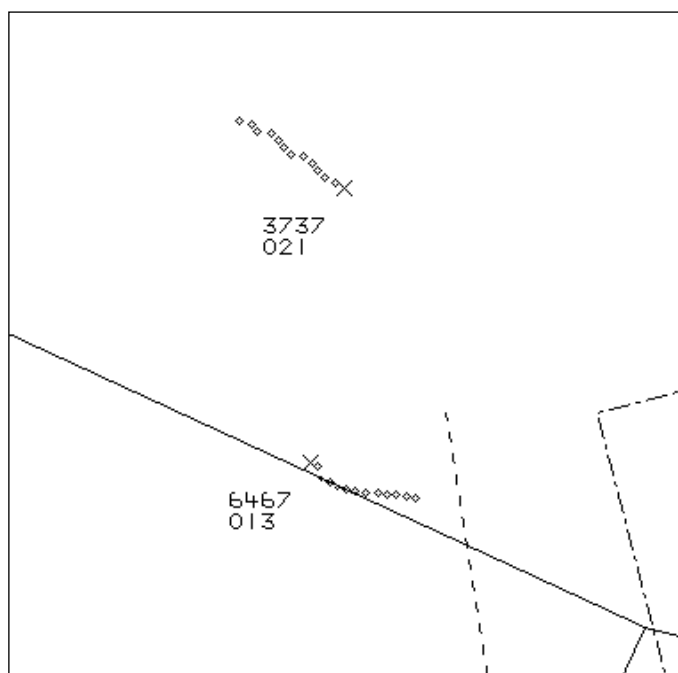
Figure 1: Geometry at 1257:02 (Dakota 6467; PA28 3737)

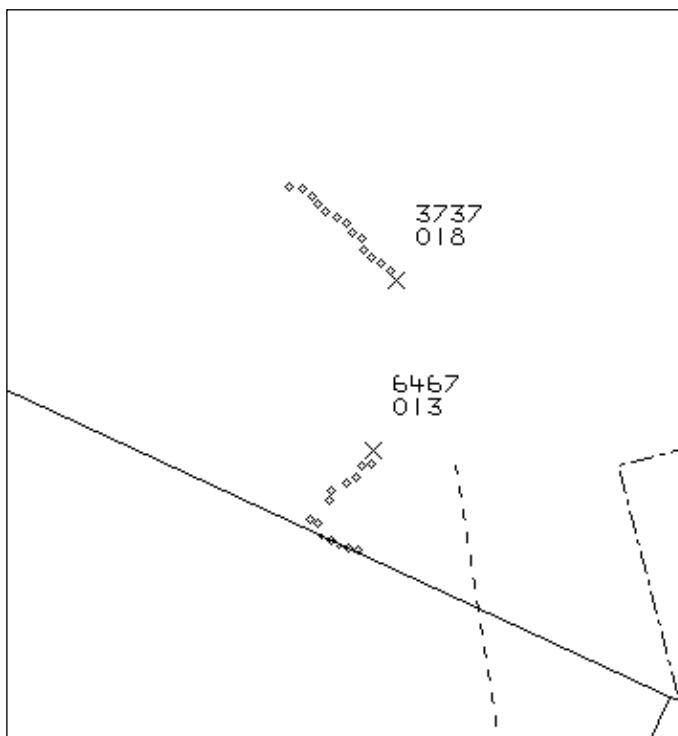
At 1257:32, Fairford Approach transmitted, “[Dakota C/S] traffic eleven o’clock, two miles, crossing left right, indicating four hundred feet above”, see Figure 2. At 1257:40, the PA28 pilot reported level at 1000ft, believed to be on 993hPa.

Figure 2: Geometry at 1257:32 Traffic Information with 2nm separation on radar

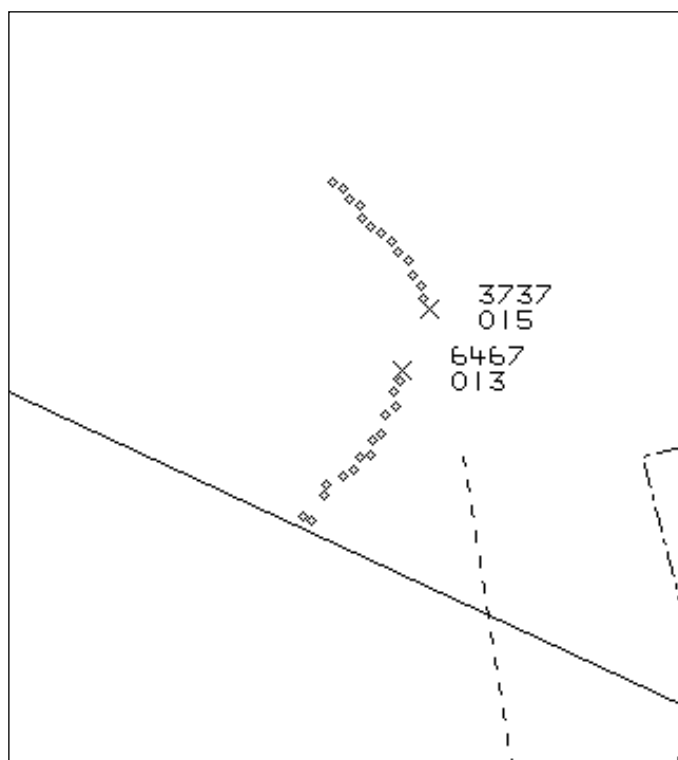
The Dakota pilot responded with ‘looking’ and declared ‘visual’ at 1257:54, see Figure 3.

Figure 3: Geometry at 1257:54 as Dakota pilot reported visual

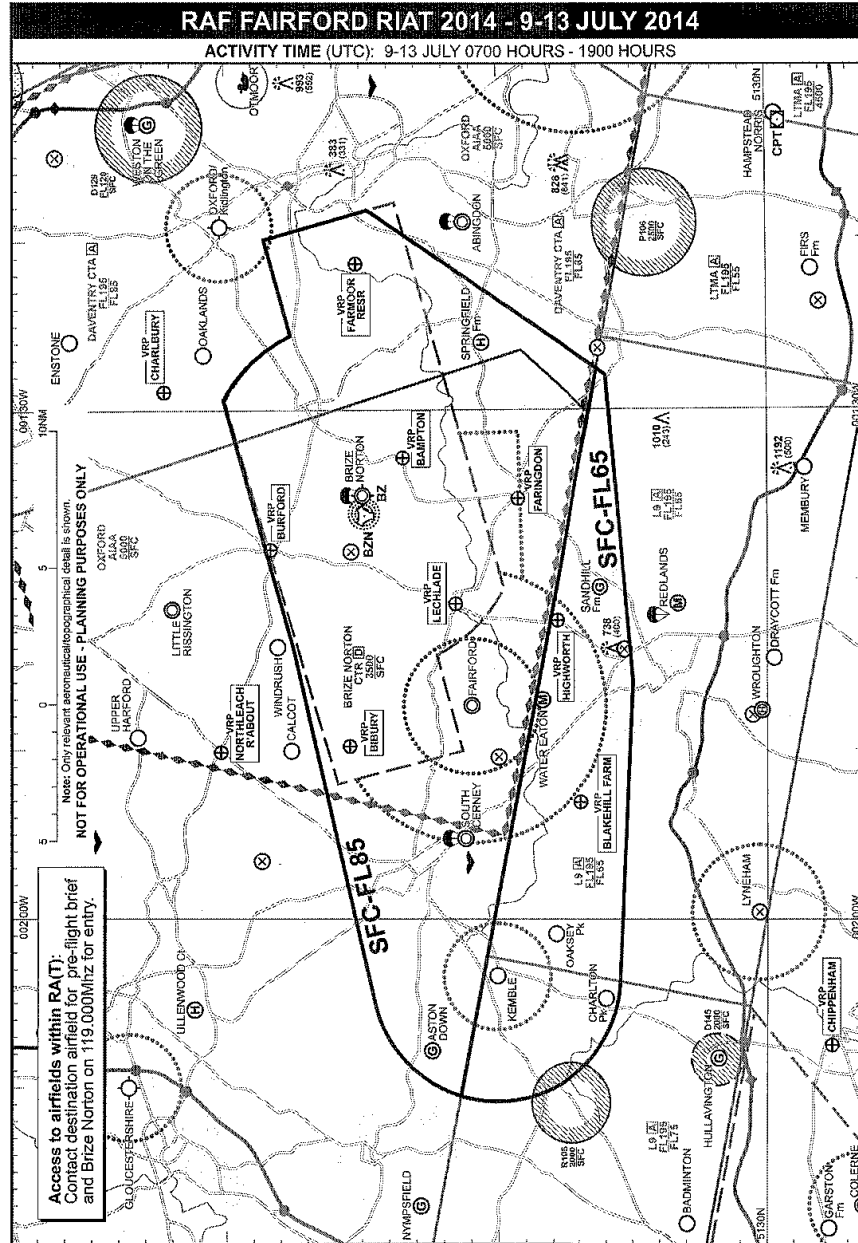
ANNEXE A

RESTRICTION OF FLYING REGULATIONS
RAF FAIRFORD RIAT 2014 - 9-13 JULY 2014

ACTIVITY TIME (UTC): 9-13 JULY 0700 HOURS - 1900 HOURS

The RIAT was subject to a Temporary Restricted Area (RA(T)), as defined in AIC M 052/2014. The AIC is reproduced at Annex A.
